# THE OLD CHAIN OF ROCKS BRIDGE INSPECTION & LOAD RATING

**TOM LOHMAN, PE, SE**  
**HORNER & SHIFRIN**  
**MARCH 8, 2018**

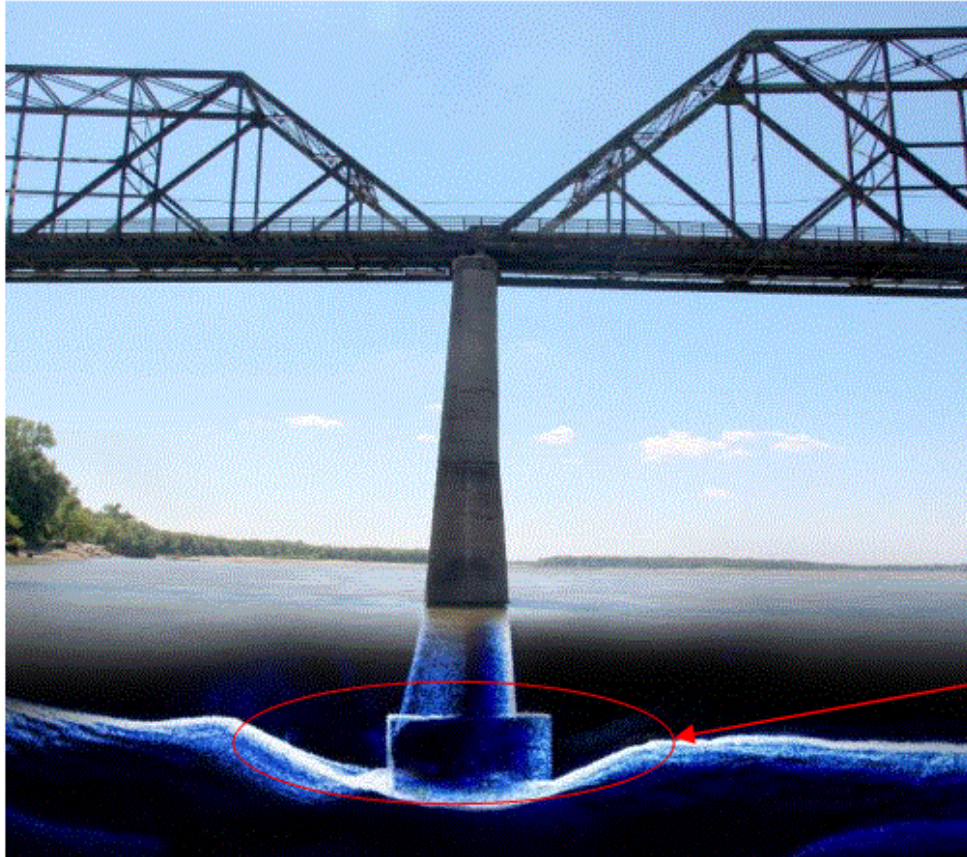
## Pier 9 Upstream (North) Face

There is a scour cone at the upstream (north) nose measuring up to 10 ft. deep x 25 ft. radius. The footing / step-out is exposed up to 10 ft. vertically at the upstream (north) face of the pier. The exposed footing / step-out concrete does not exhibit signs of deterioration.

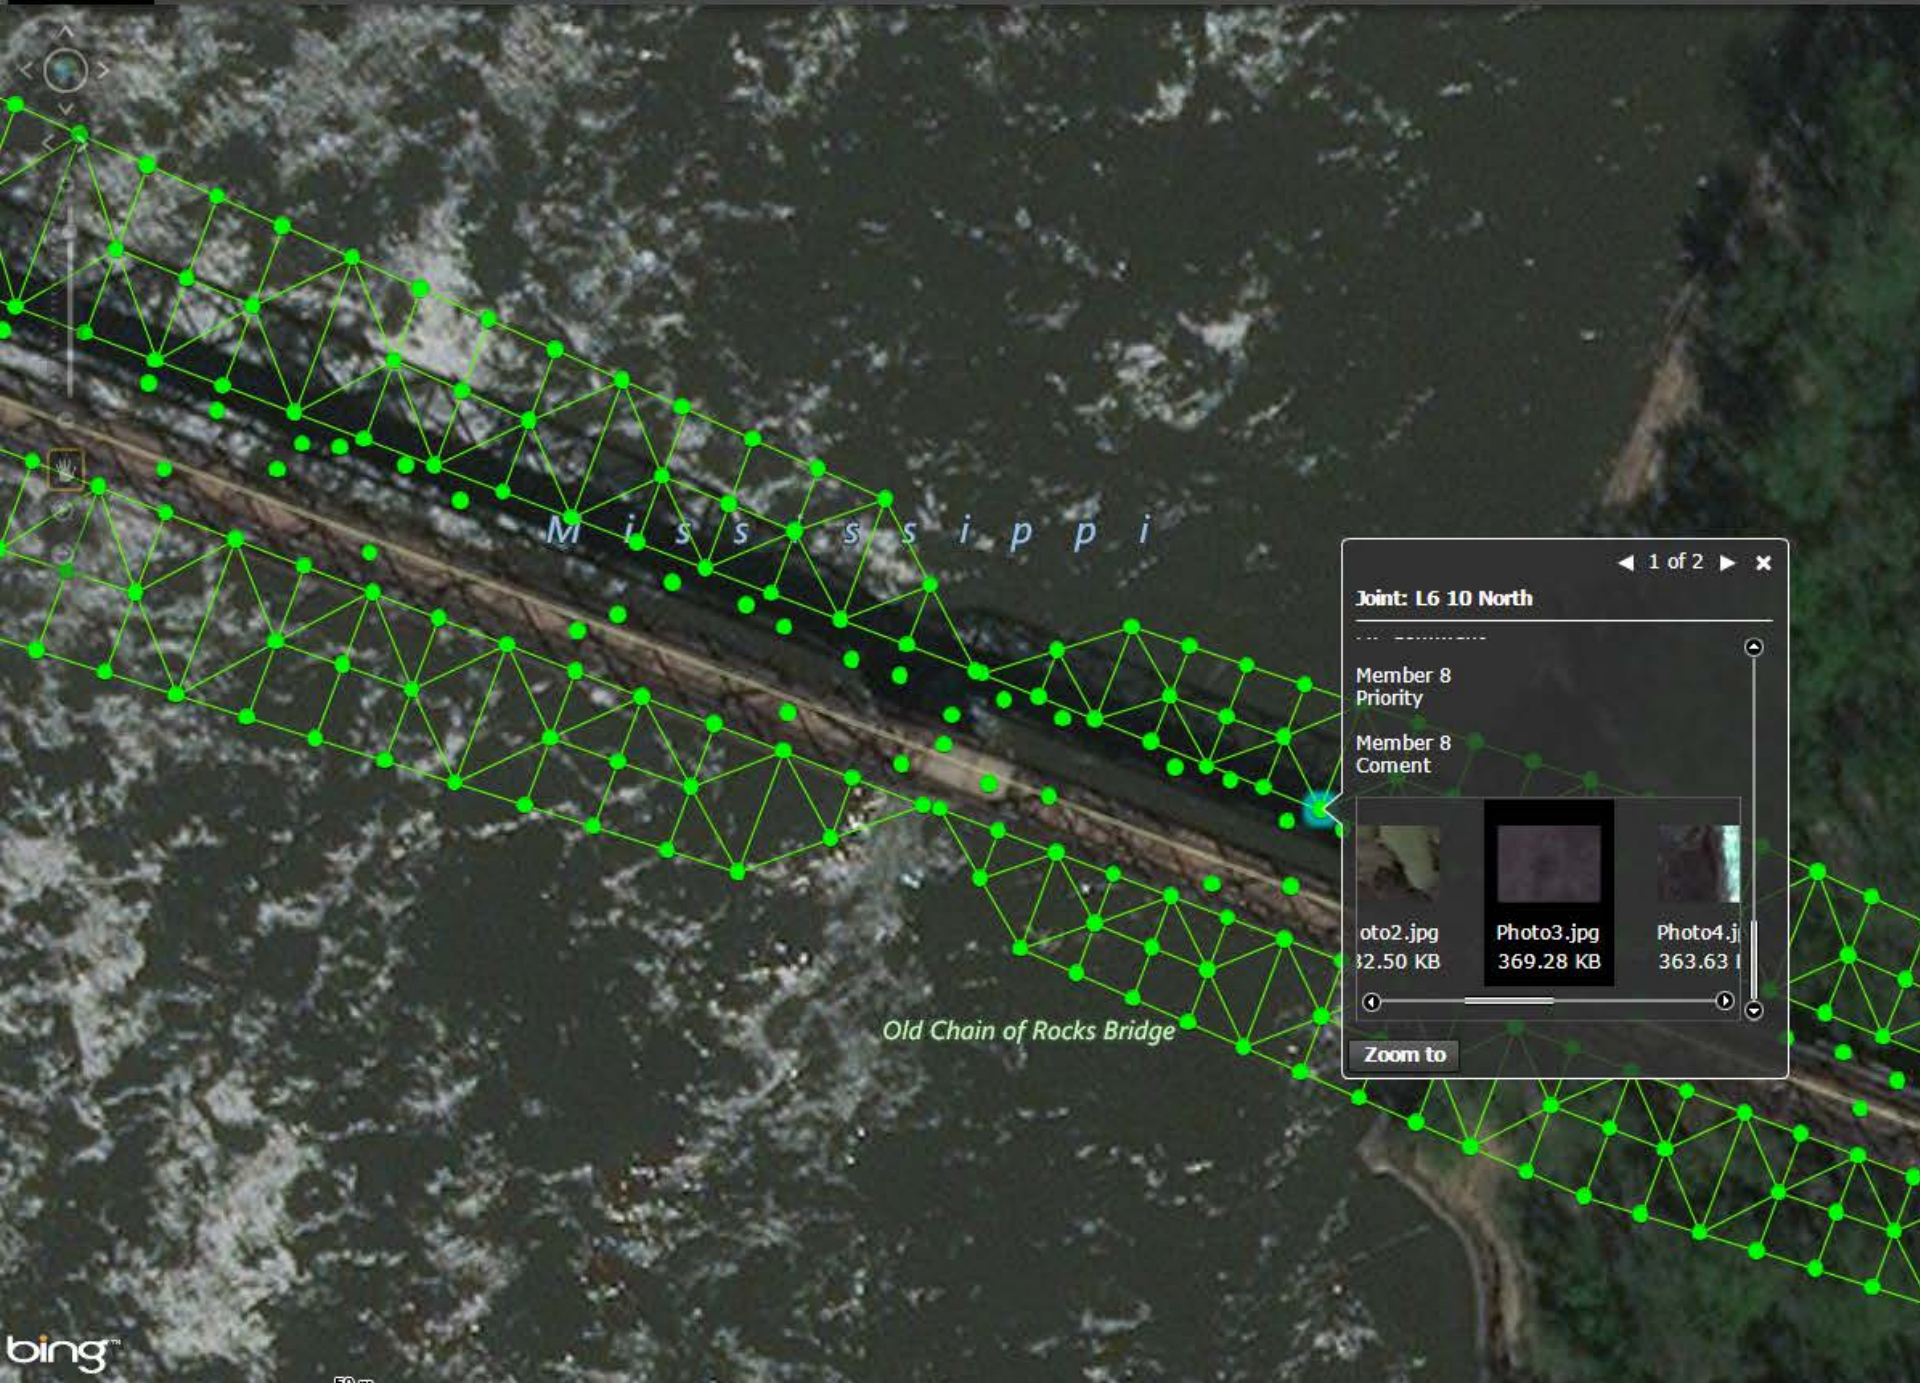
**Joint: L6 10 North**

ID	L6
Span	10
Side	North
Inspected	Inspected
GlobalID	{49379BE1-C8FE-4A1F-93EA-3176FE8914DF}
Member 1 Priority	High
Member 1 Comment	Middle stringer web hole west side
