# Unforeseen Effects of Secondary Members

MoDOT Team Conference

March 8, 2018

Natalie McCombs, PE, SE

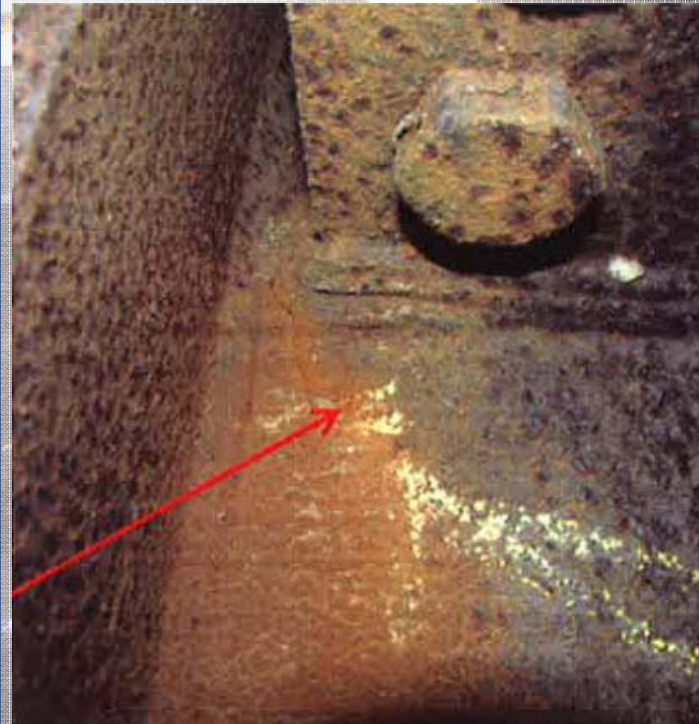
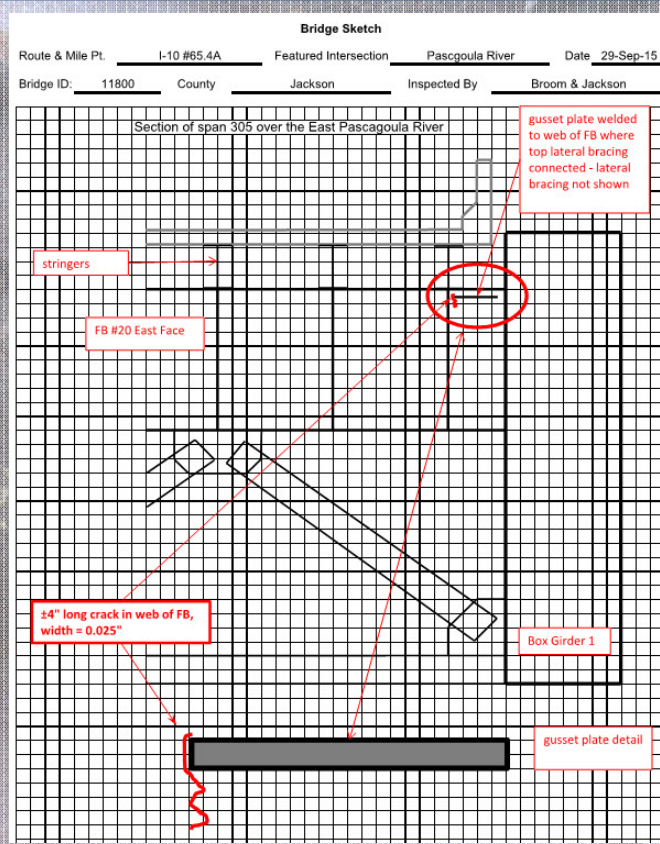
- 5 ¼" open grid deck replaced in 1991 with 7" continuous concrete deck
- Added 1,000 kips of dead load
- Bolts have been intentionally loosened
  - First bay of upper lateral bracing
  - Exterior stringers
- Cracks in floorbeam web were evident in 2013

<b>Westbound - Bridge ID 11800</b>					
Structure Number 65.4A					
Floorbeam	Girder	2014 Inspection		2015 Inspection	
		Crack Length	Crack Tip Location	Crack Length	Crack Tip Location
1	2	+/- 1/2"	toe of weld	+/- 1/2"	toe of weld
3	1	+/- 1/2"	floorbeam web	+/- 1/2"	floorbeam web
18	2	+/- 1/2"	toe of weld	+/- 1/2"	toe of weld
20	1	+/- 2 1/2" to 3"	floorbeam web	+/-4" *	floorbeam web
22	2	+/- 1/2"	toe of weld	+/- 1/2"	toe of weld

<b>Eastbound - Bridge ID 11801</b>					
Structure Number 65.4B					
Floorbeam	Girder	2014 Inspection		2015 Inspection	
		Crack Length	Crack Tip Location	Crack Length	Crack Tip Location
3	2	+/- 2"	floorbeam web	+/- 6" *	floorbeam web
16	2	+/- 1/2"	floorbeam web	+/- 4" *	floorbeam web
20	2	+/- 1/2"	floorbeam web	+/- 4 1/2" *	floorbeam web
22	1	+/- 1/2"	toe of weld	+/- 1/2"	toe of weld

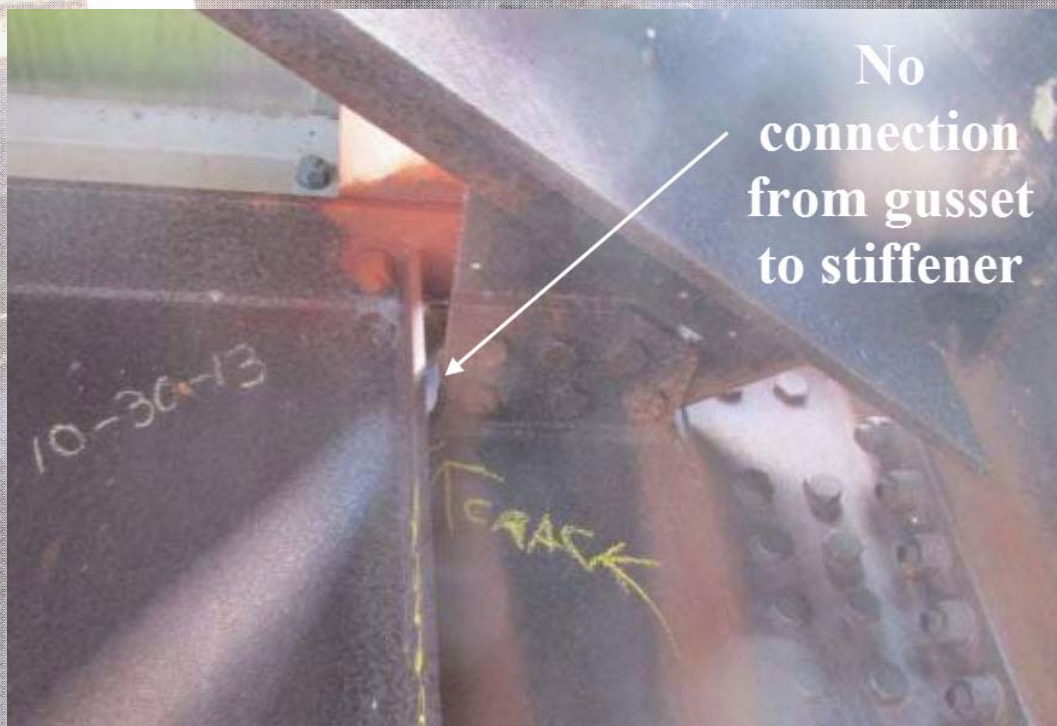
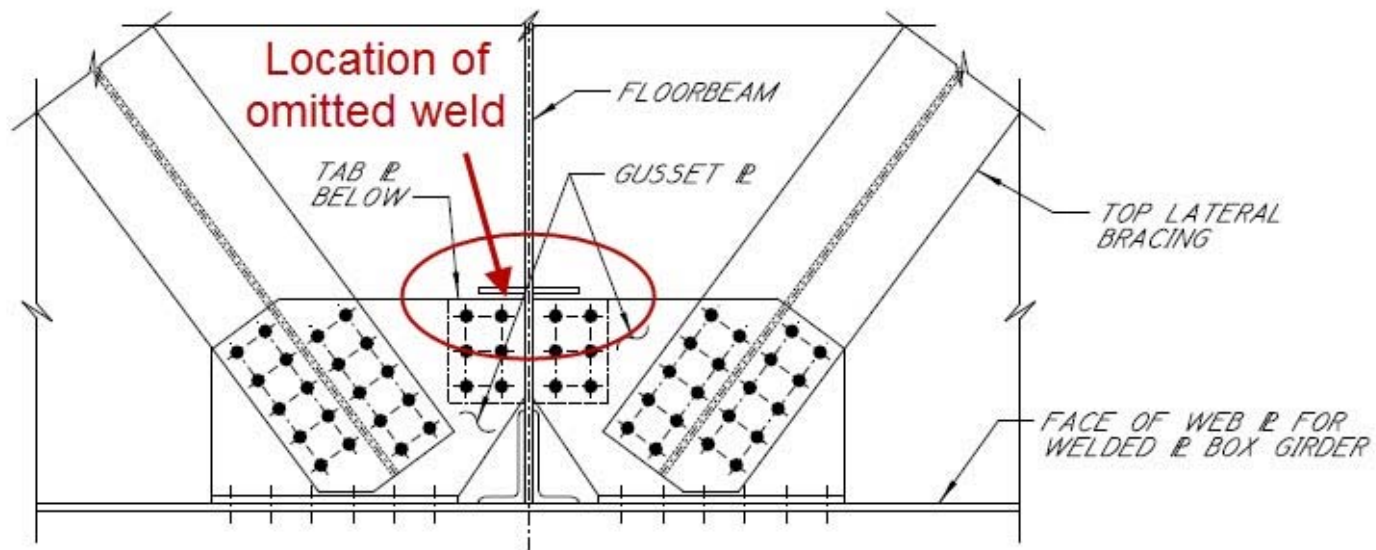
- Fatigue cracks from shortened tab plate and missing weld
- Category E detail
- Additional weight of deck decreased allowable fatigue range
- Primary cause is LL fatigue cracking

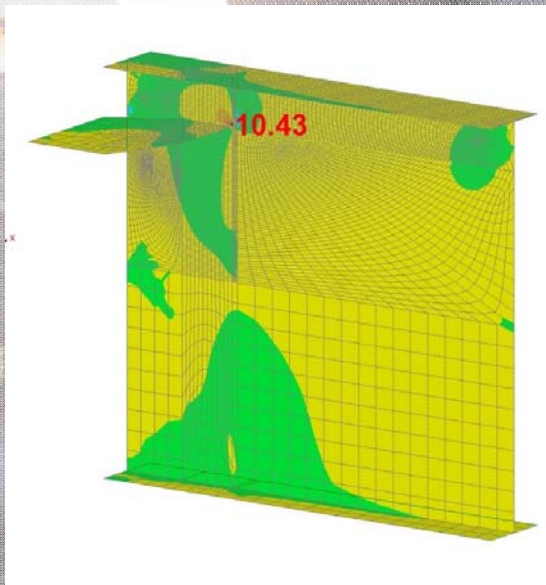
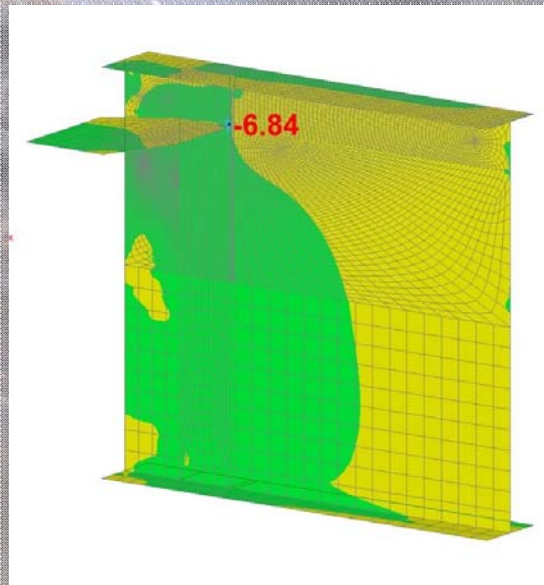
Tension Stress

Compression Stress

Total Range = 17.3 ksi

Infinite Fatigue Life = 4.5 ksi

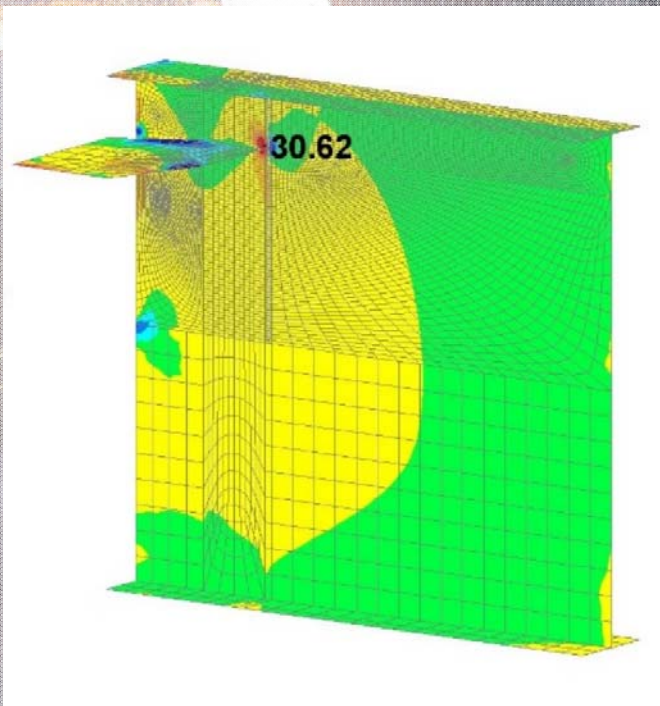
- Max Tension = 30.62 ksi
- Max range = 61.24 ksi
- Allowable range = 22 ksi
