Inspection and Non-Destructive Testing and Load Rating of Hernando De Soto Bridge

2023 TEAM Conference,
Branson, MO
March 16th, 2023

Hernando De Soto Bridge-Main Span Unit

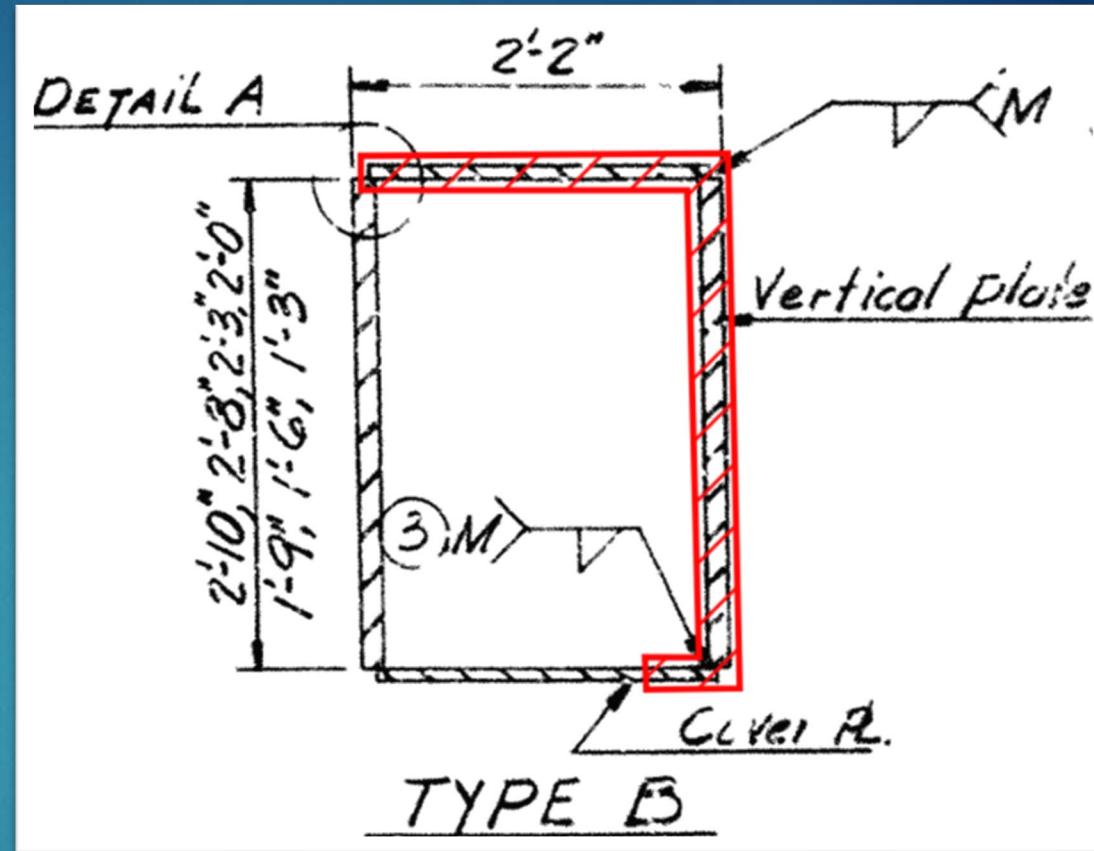
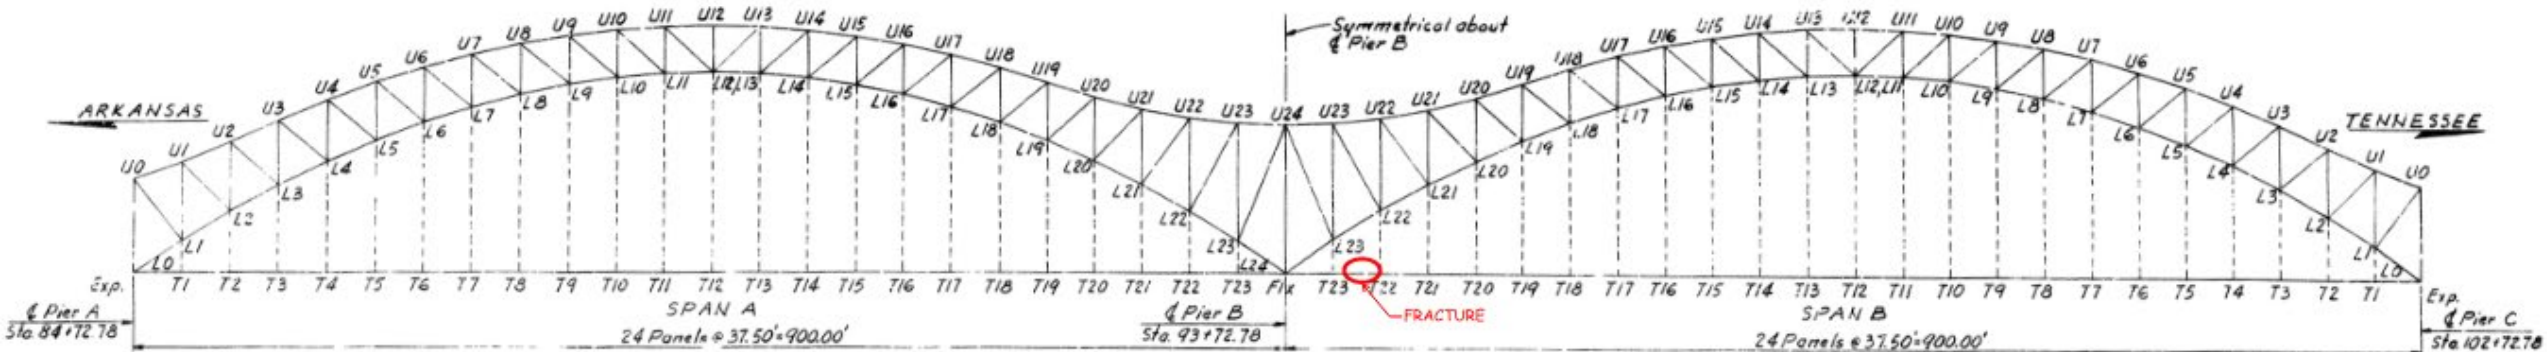
The Fracture

- Span B, North Tie Girder near T22 between T22 and T23
- 54% of Tie Girder Fractured
- Effective Area Reduced from 113 sq. in. to about 52 sq. in.

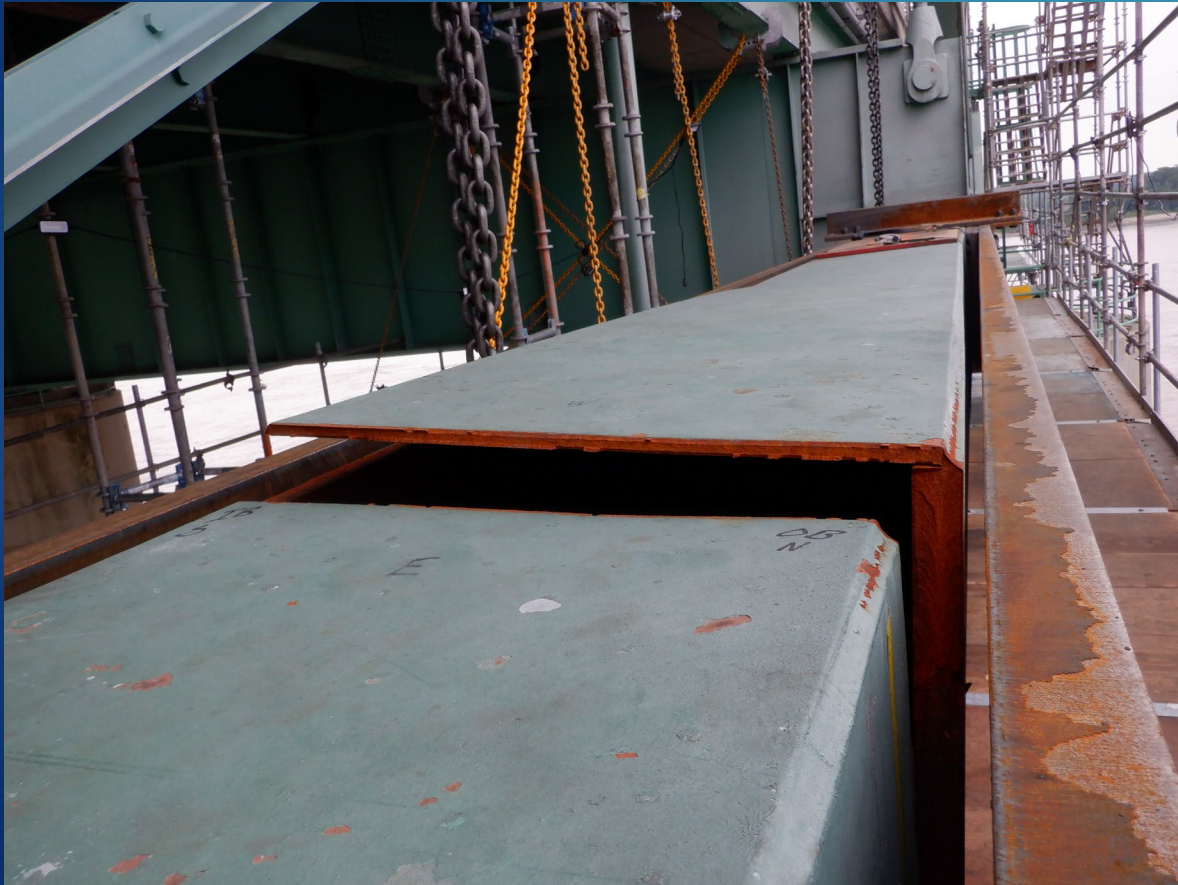
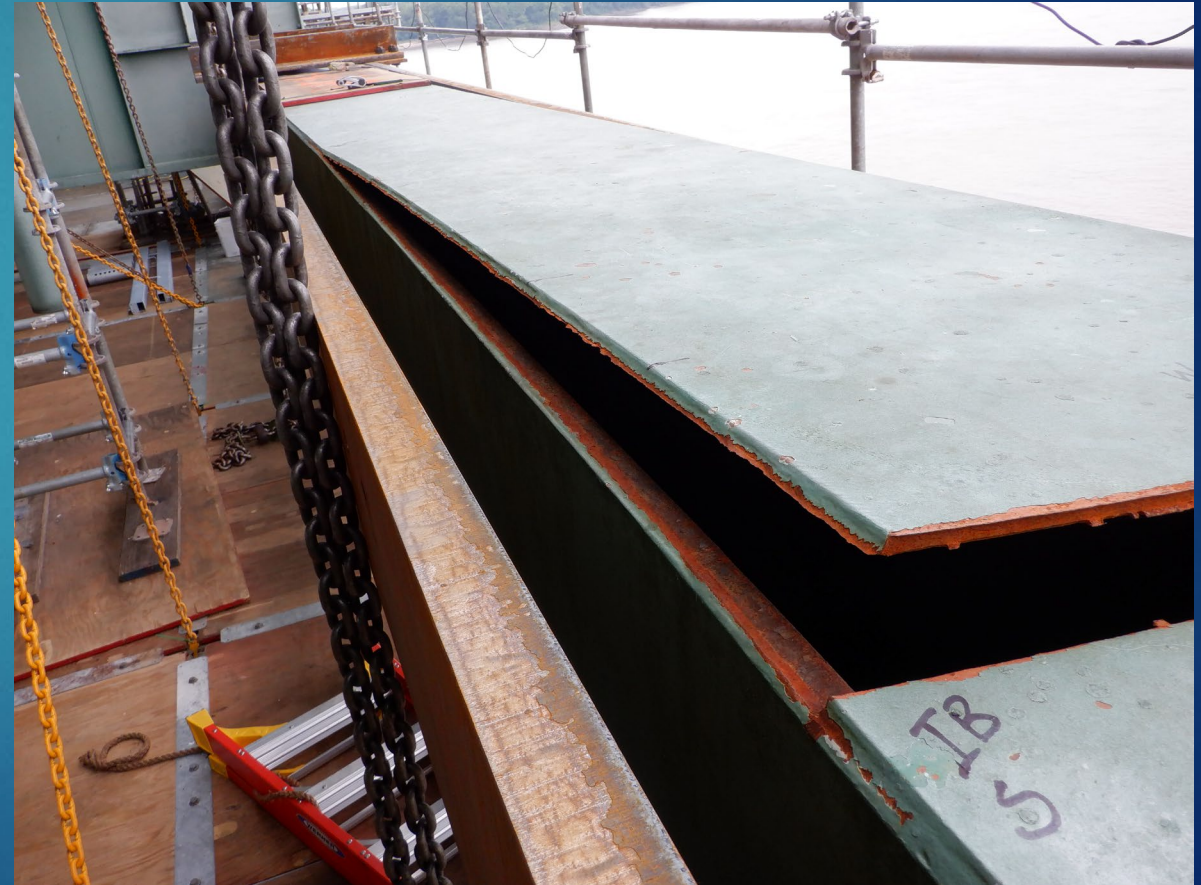
The Fracture

- ▶ Estimated Stress in Tie Girder After Fracture
 - DL = 87 ksi
 - DL + LL = 95 ksi (95% of Yield Strength of Steel)

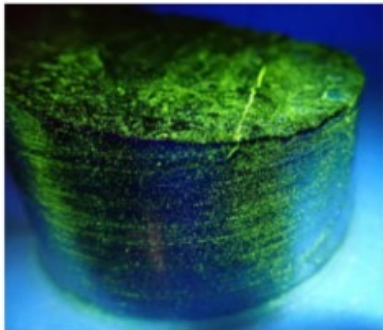
Figure 7. Specimen No. SA008E

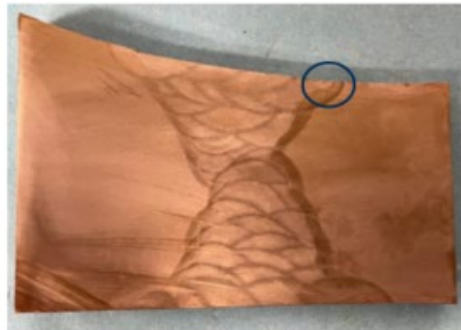
Figure 8. Specimen No. SA008E

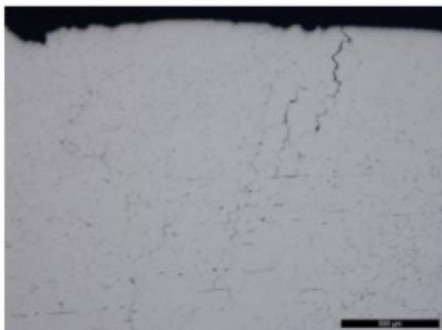
Figure 9. Specimen No. SA008E (50x)

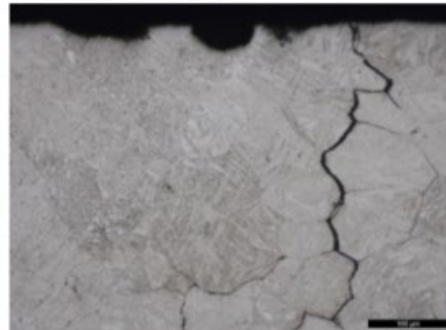
Figure 10. Specimen No. SA008E (200x etched)

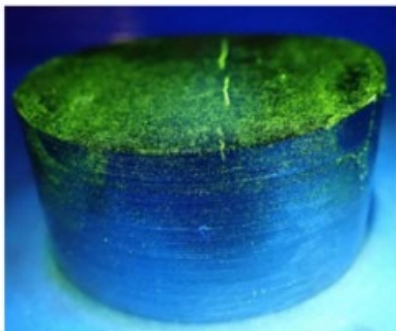
Figure 11. Sample No. SA158W

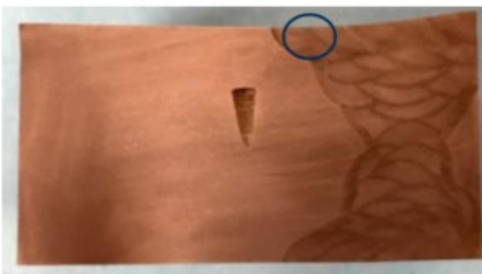
Figure 12. Sample No. SA158W

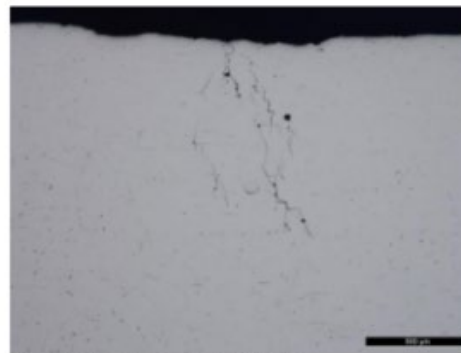
Figure 13. Sample No. SA158W (50x)

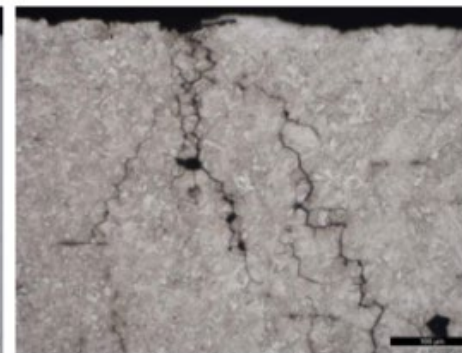
Figure 14. Sample No. SA158W (200x etched)

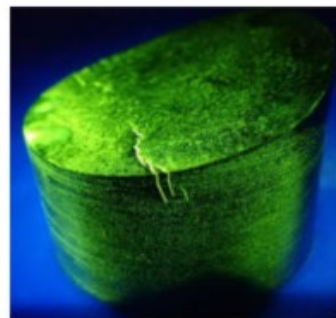
Figure 15. Sample No. SA166W

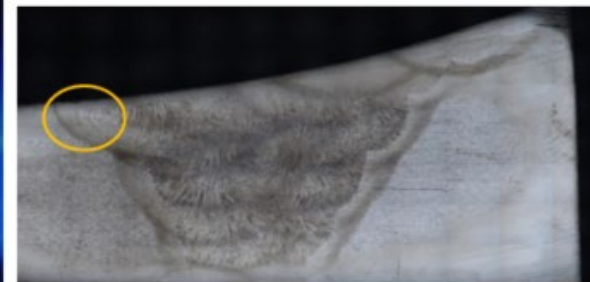
Figure 16. Sample No. SA166W

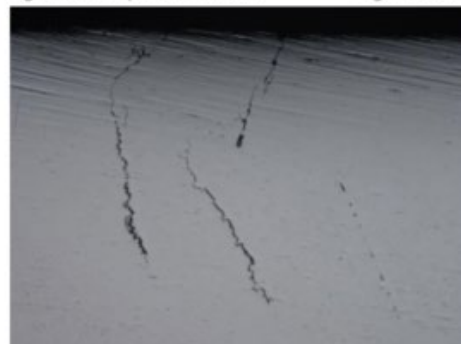
Figure 17. Sample No. SA166W (25x)

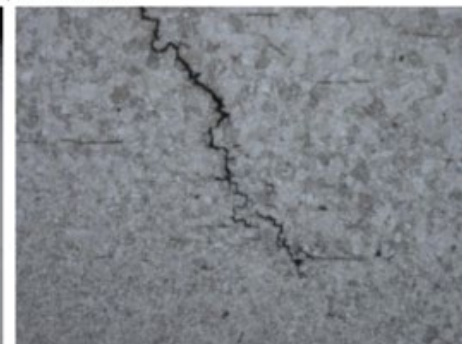
Figure 18. Sample No. SA166W (100x etched)

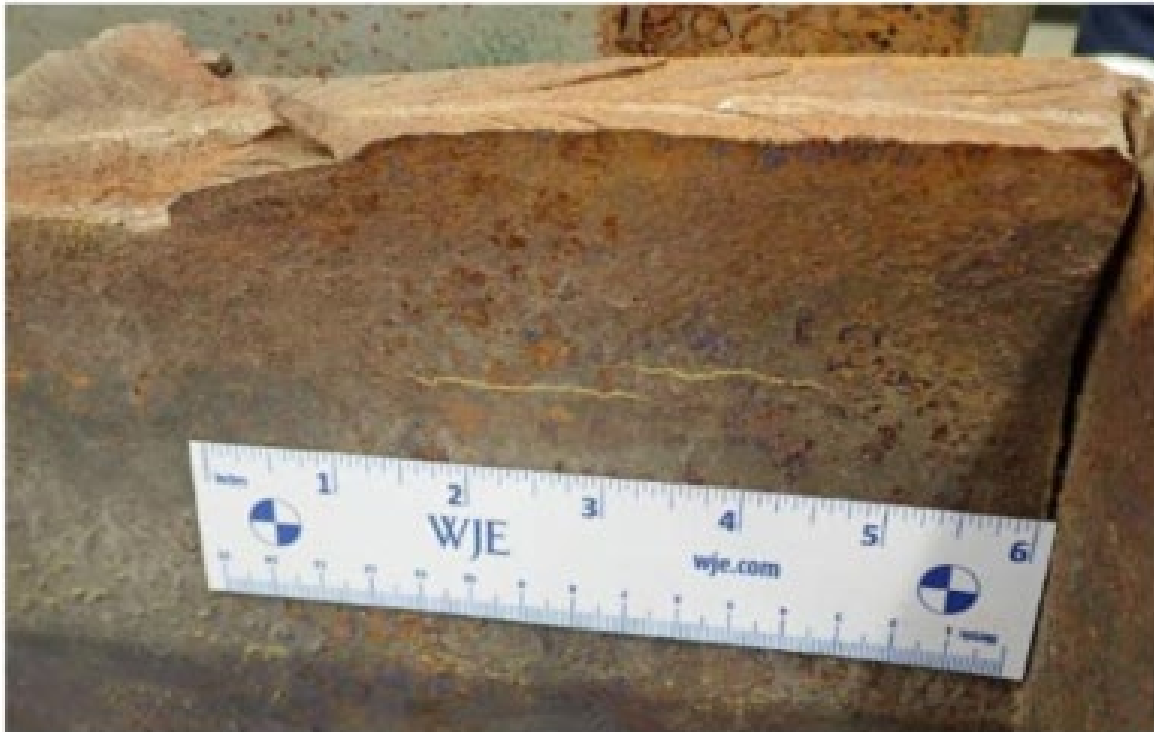
Figure 1. 2 1/4-inch thick plate side of fracture with cracks highlighted by yellow filings.

- ▶ Fabrication defect-usually at time of welding or shortly thereafter
- ▶ Normally originate in heat affected zone but can extend into weld metal
- ▶ Improper pre-heating
- ▶ Contaminated electrodes
 - ▶ I-40 fracture appears to have originated from repair welds
- ▶ Weld metal hydrogen
 - ▶ Can be as simple as moisture on electrodes or steel
- ▶ Stresses on weld due to external restraint, material thickness, joint geometry and fit-up
 - ▶ Poor fit-up greatly increases risk due to excessive root gap
 - ▶ Restraint due to lack of proper pre-heating likely cause
- ▶ Parent material-higher Carbon Equivalent value increases risk

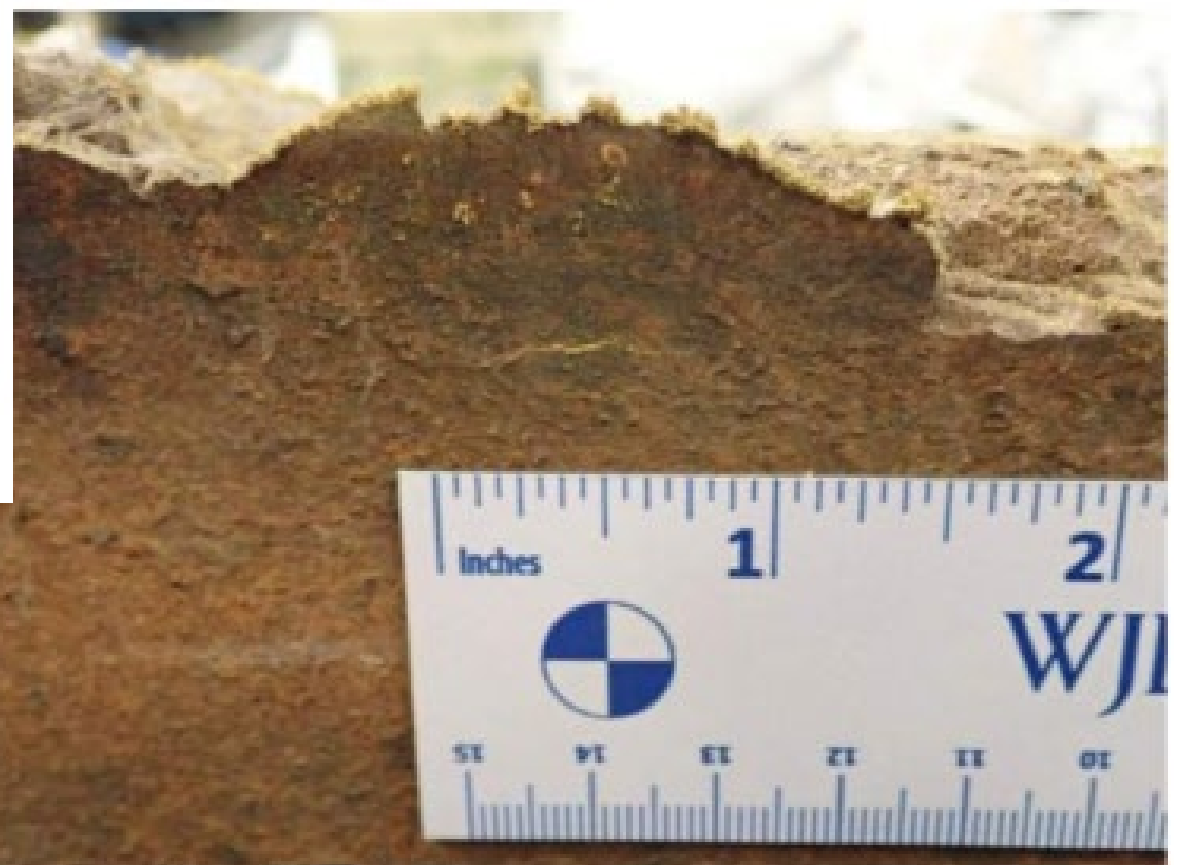
Figure 2. Crack highlighted by yellow filings in 1 3/8-inch thick plate at fracture.
