Jefferson Barracks Bridge: A Case for Rehabilitation

March 14, 2024

Wiss, Janney, Elstner Associates, Inc.

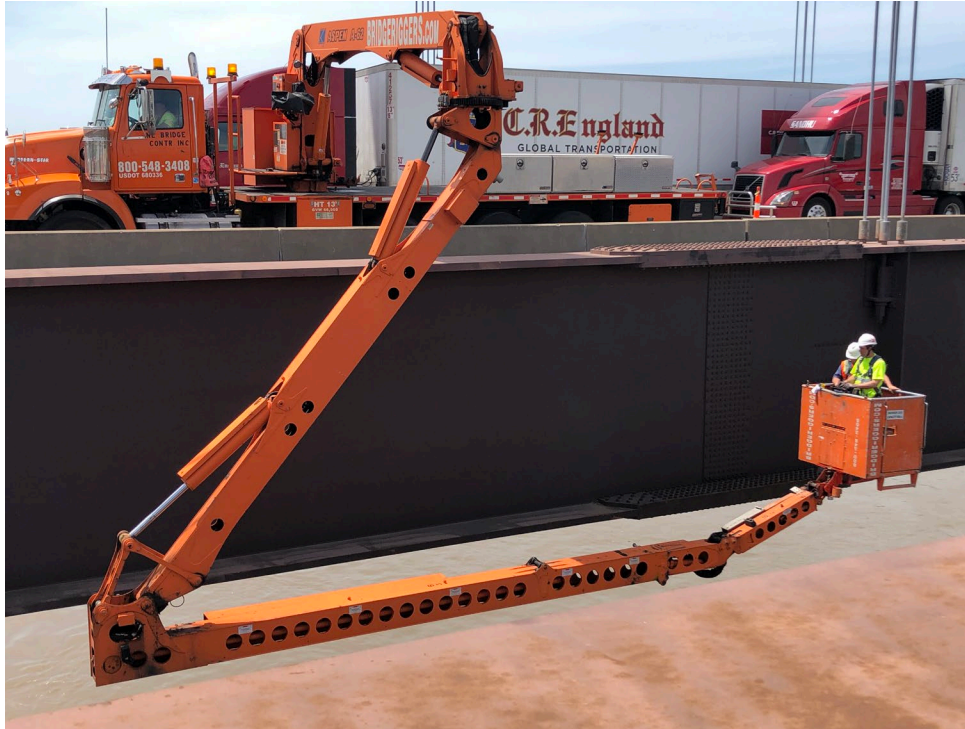
Arch to Tie Girder Connection

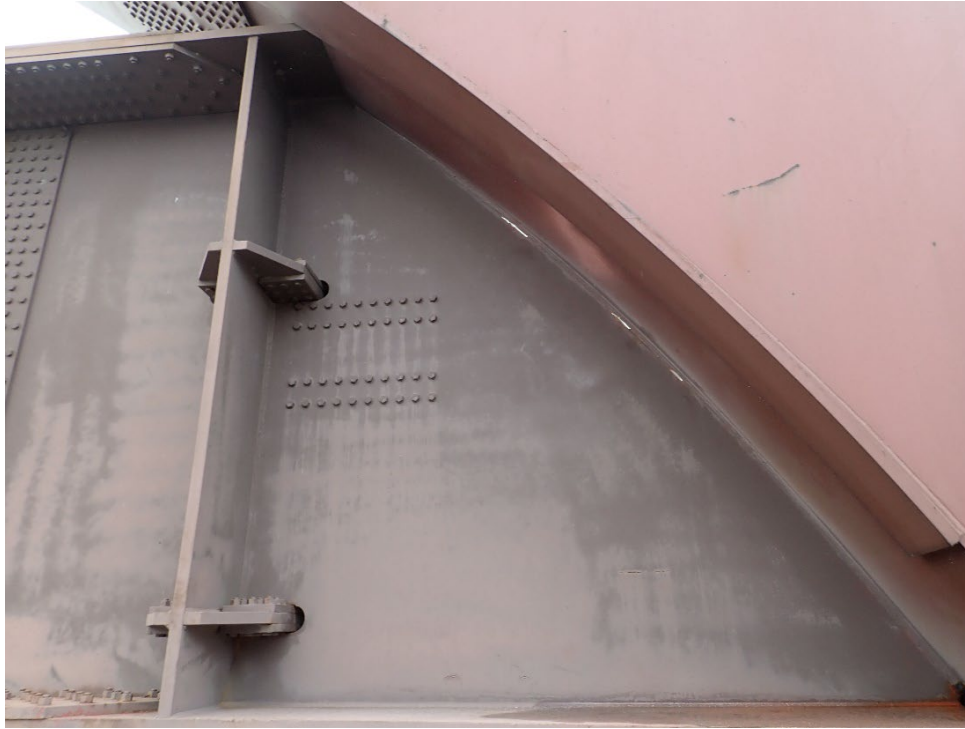
Arch to Tie Girder Connection

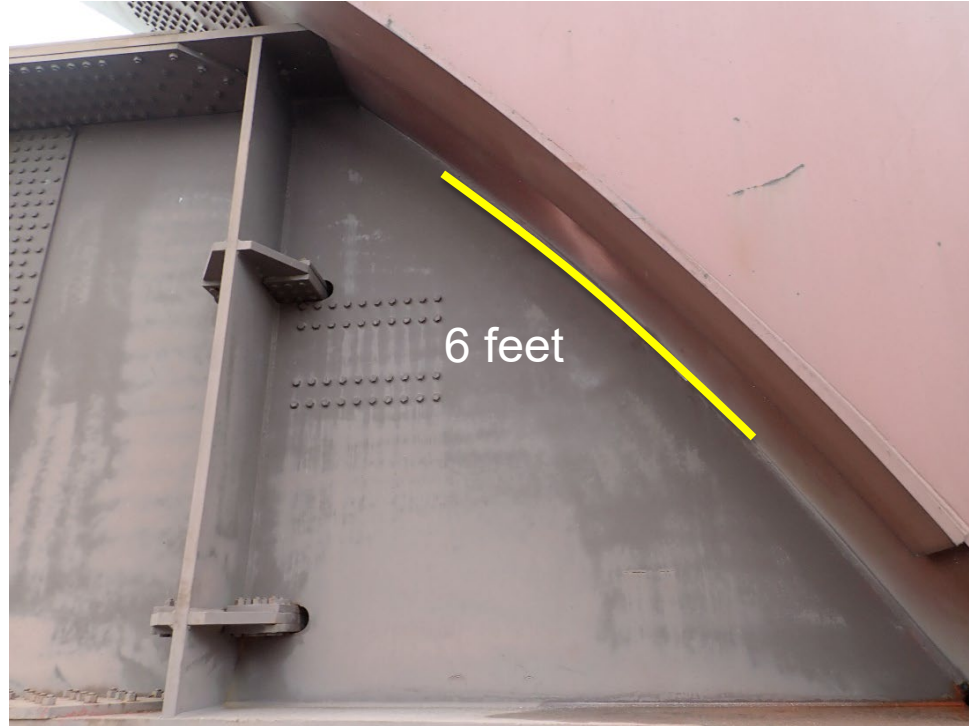
Crack Investigation

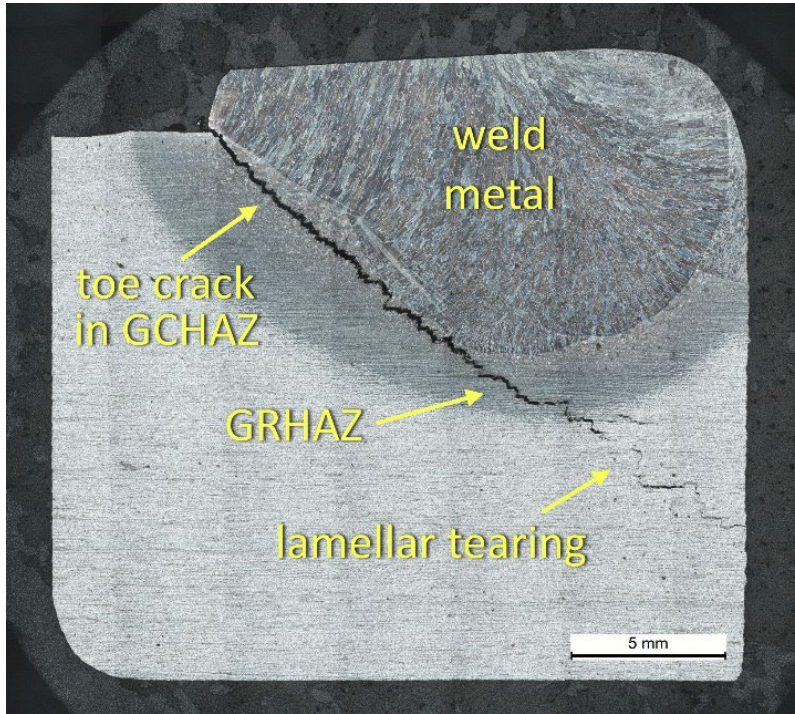
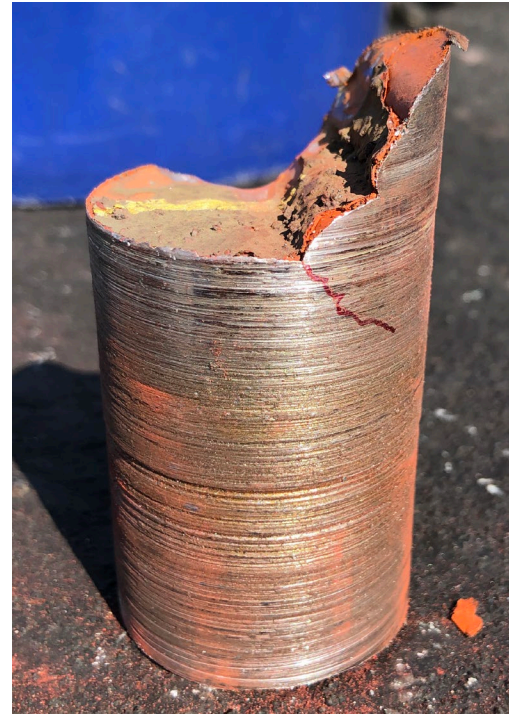
Weld Repairs

- 300 deg F preheat for 1 hour
- Shielded metal arc welding
- Low hydrogen consumables
- 3-hour bake out
- MT root pass and after cool down

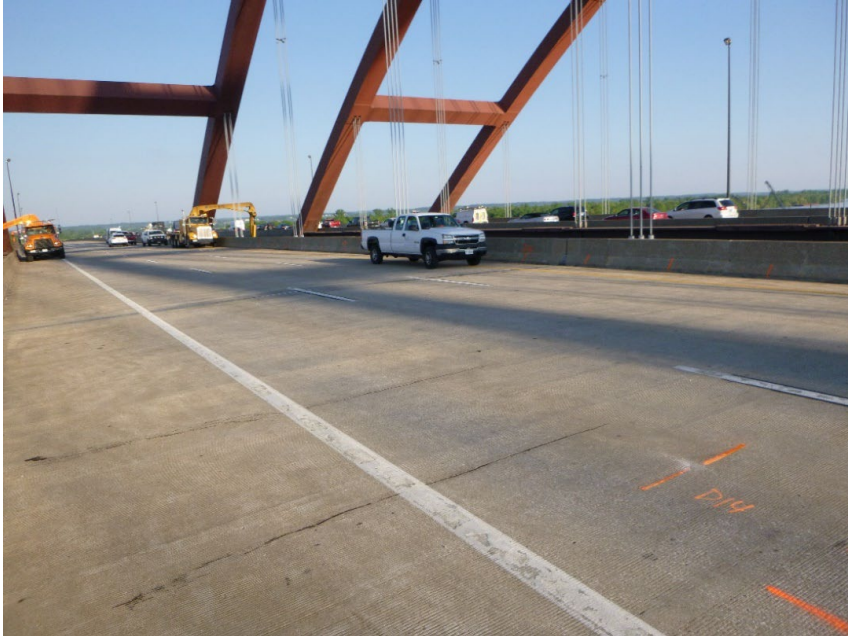
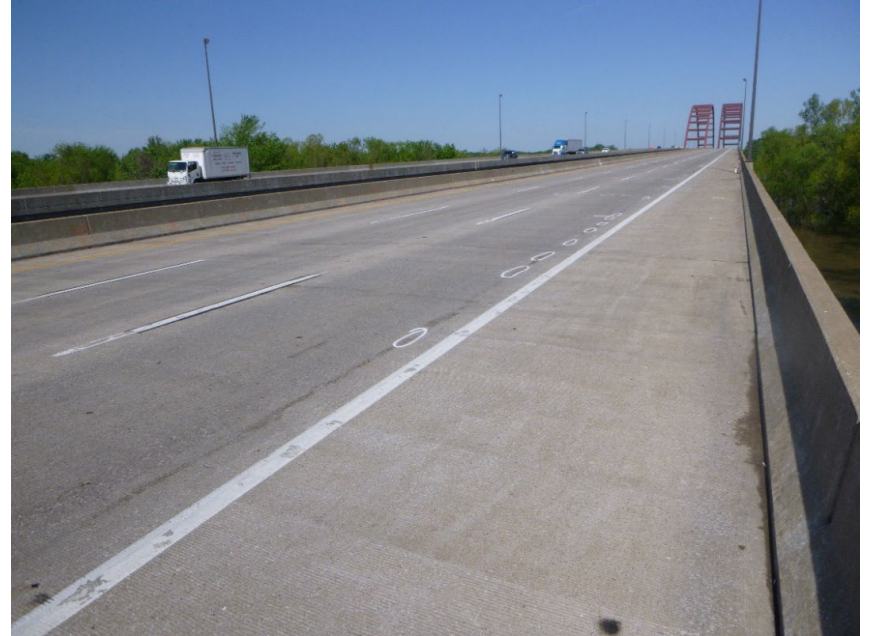
Reinforcing Steel Cover Measurements

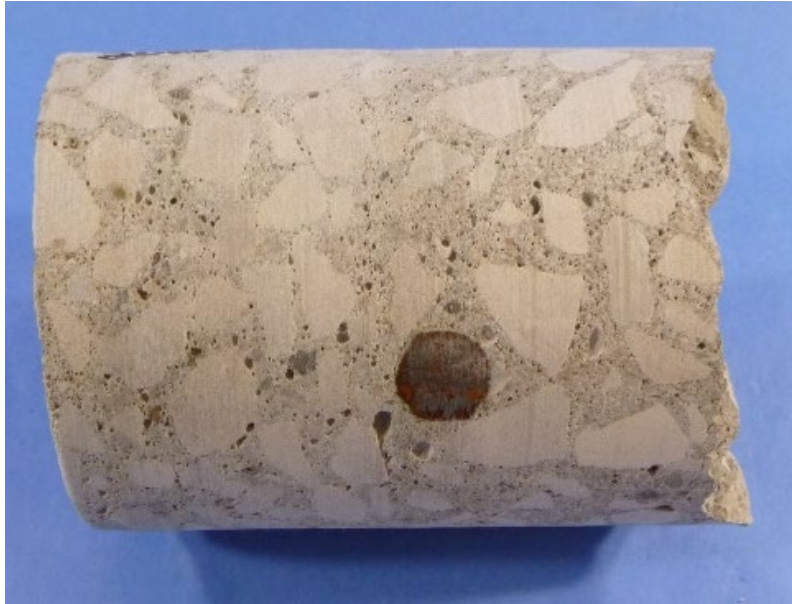
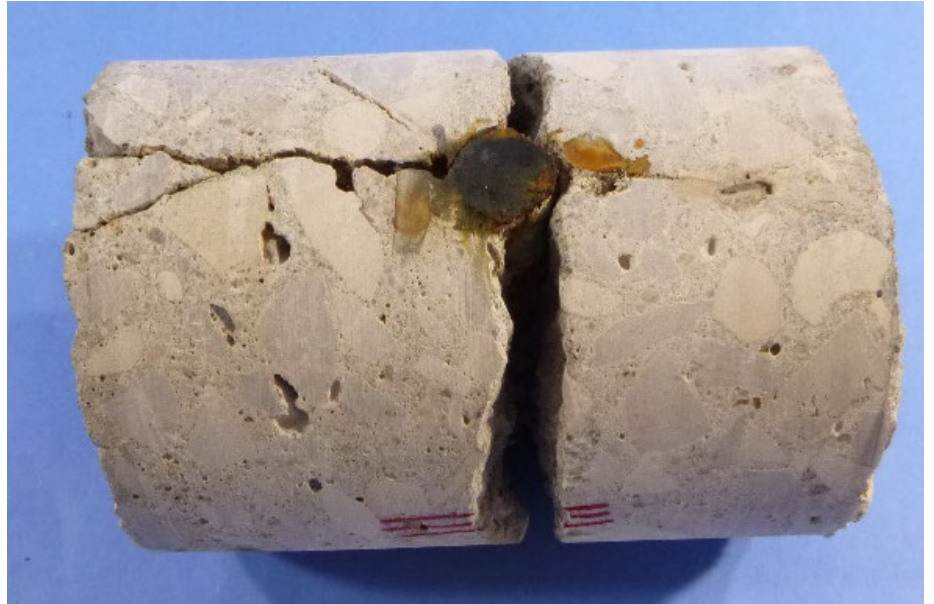
Condition of Epoxy

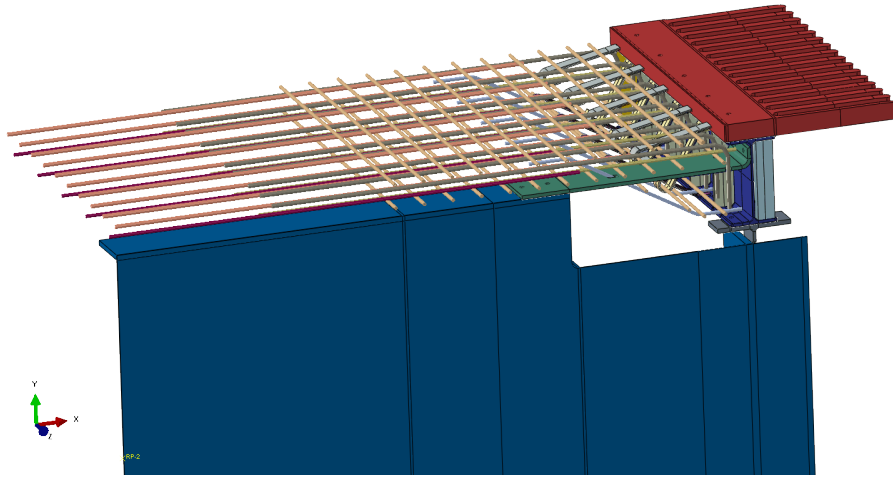
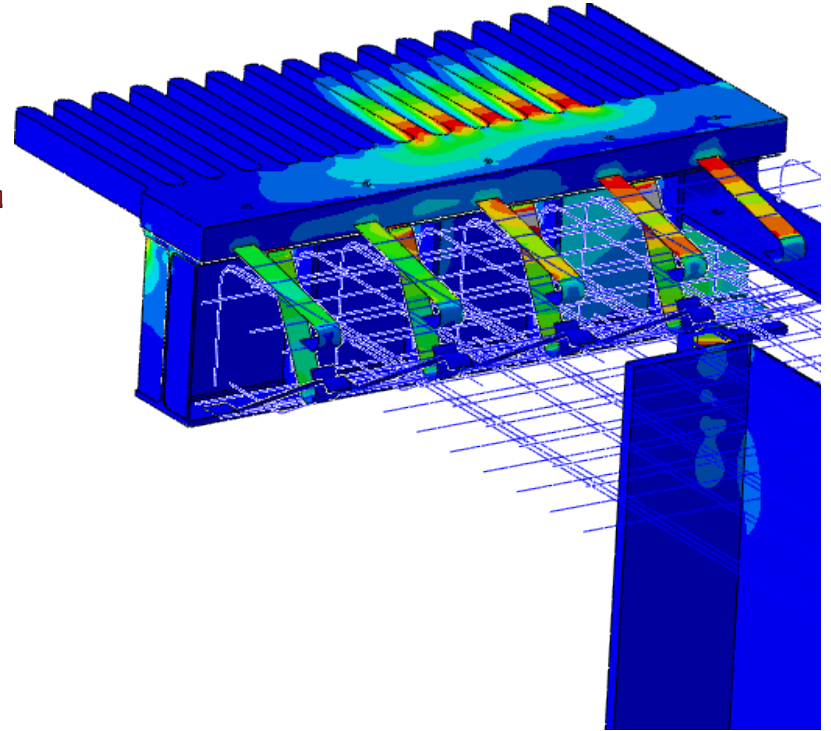
Deck Expansion Joints - Finger

- Finger joints instead of modular joints
- Design heavy duty finger joint to prevent fatigue
- Use UHPC for joint headers
- Replace joint seals

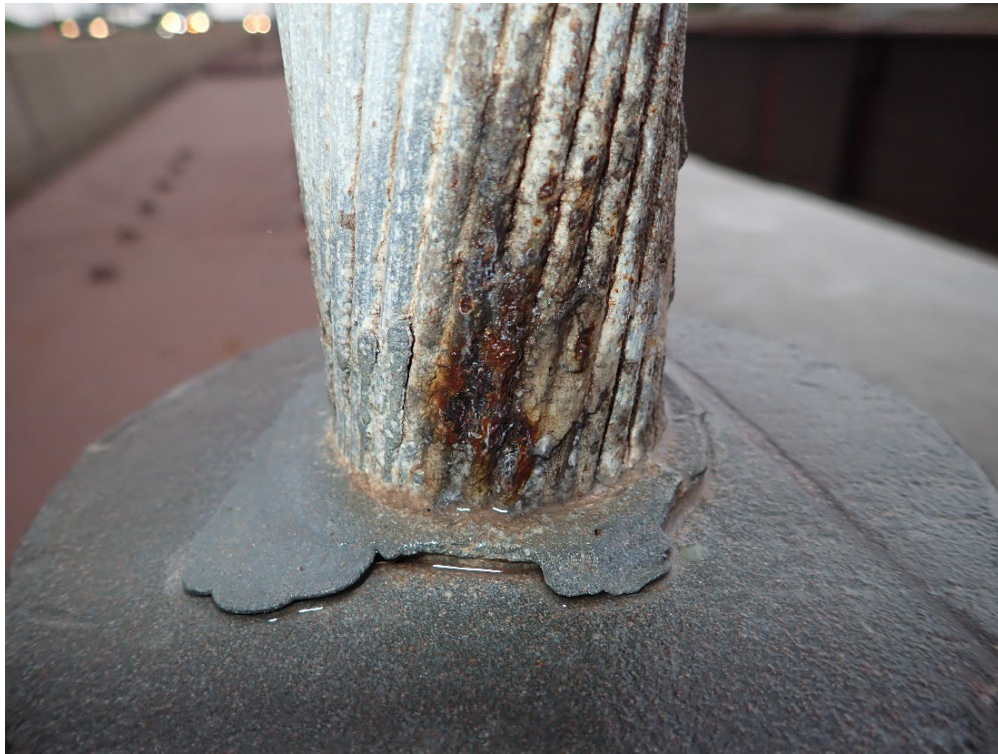
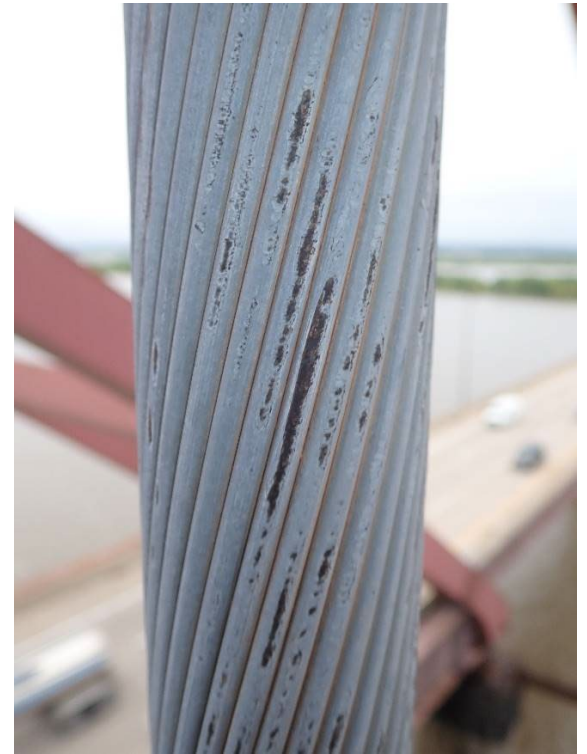
Hanger Cable Corrosion

- Replace cables
- Coat cables
- Metalize cables
 - Different abrasive media to achieve required bond

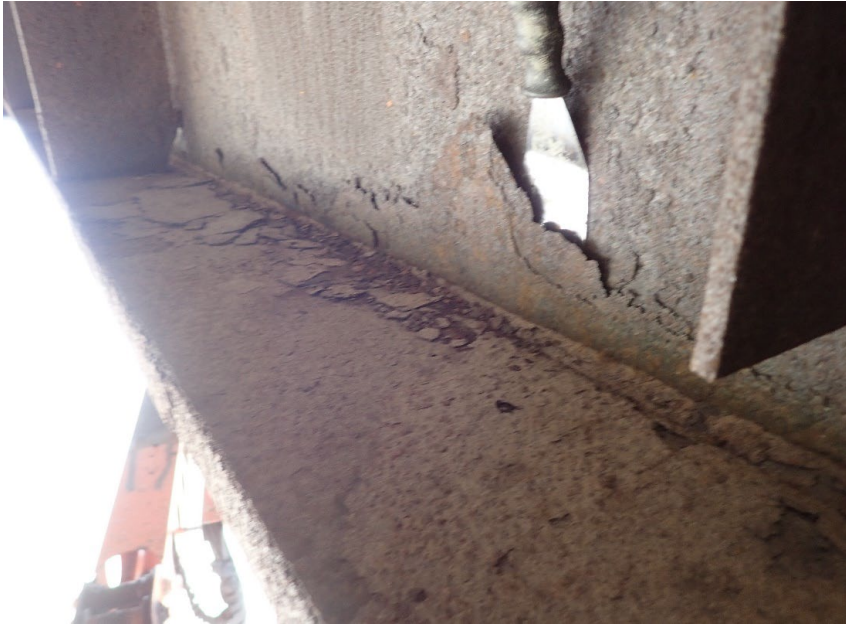
Failed Patina

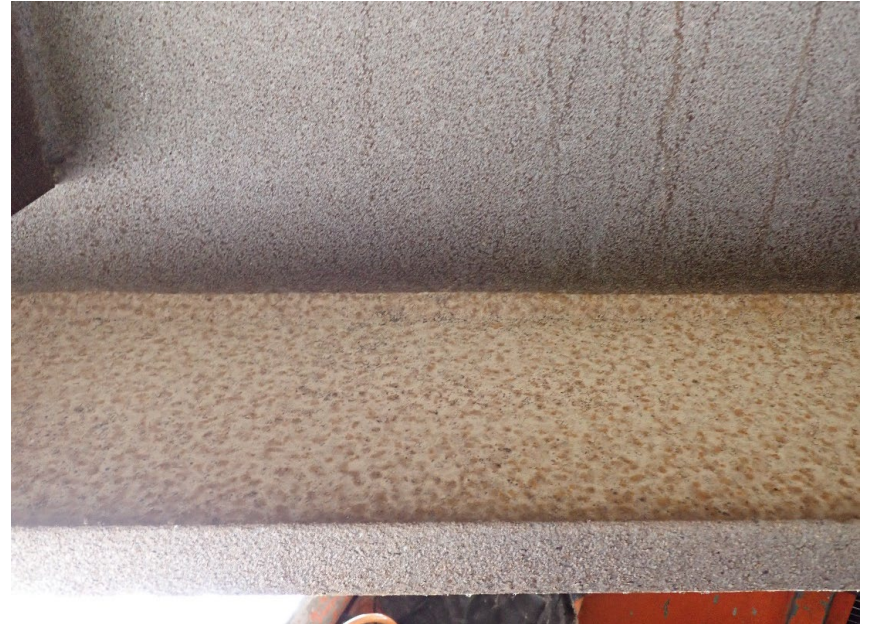
Well-developed Patina

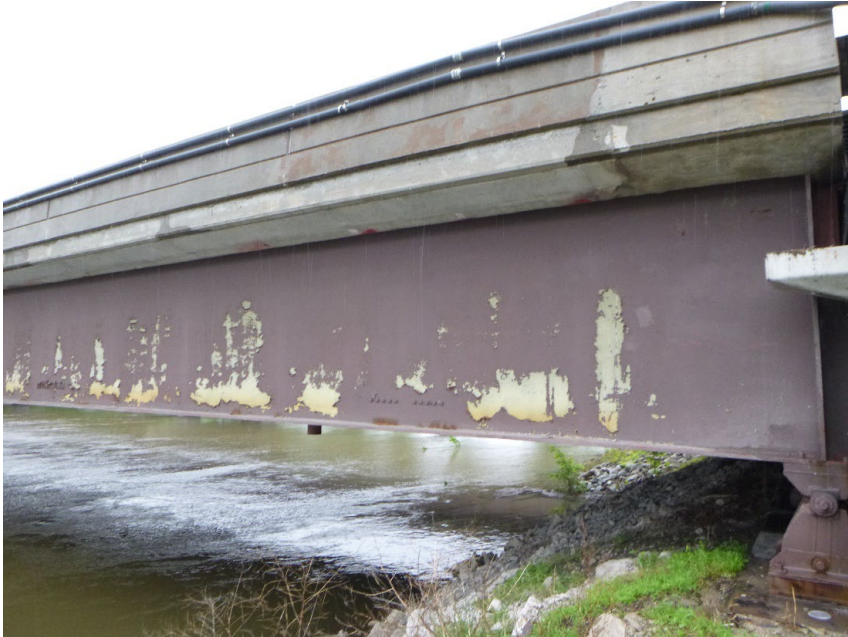
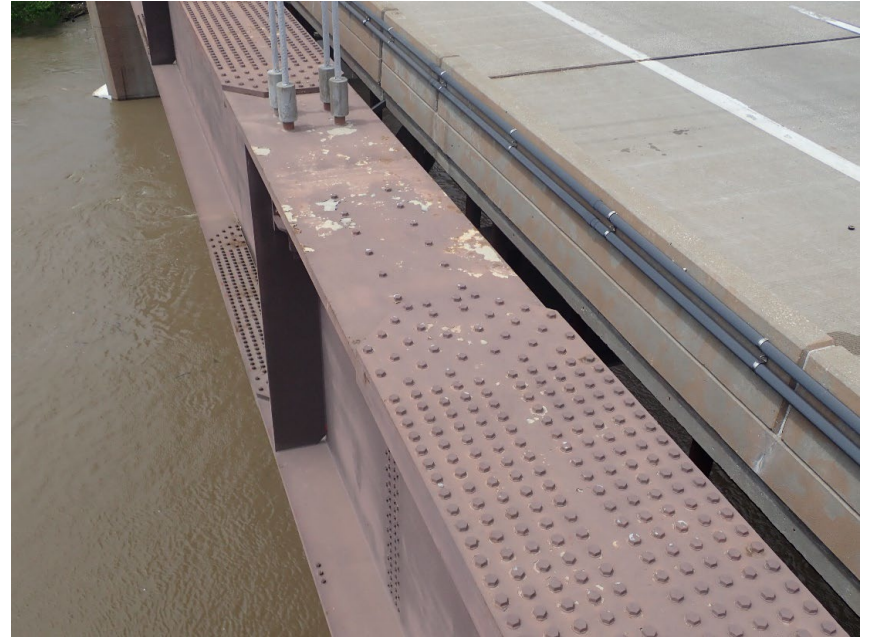
Condition of Steel Coating

- Confirmed superstructure elements are weathering steel
- Apply System H to fascia girders including top side of bottom flange
- Apply System H to arch elements from 25 ft above to below deck
- Apply System I to arches and bracing 25 ft and above deck
- Coat lower interior portions of arches

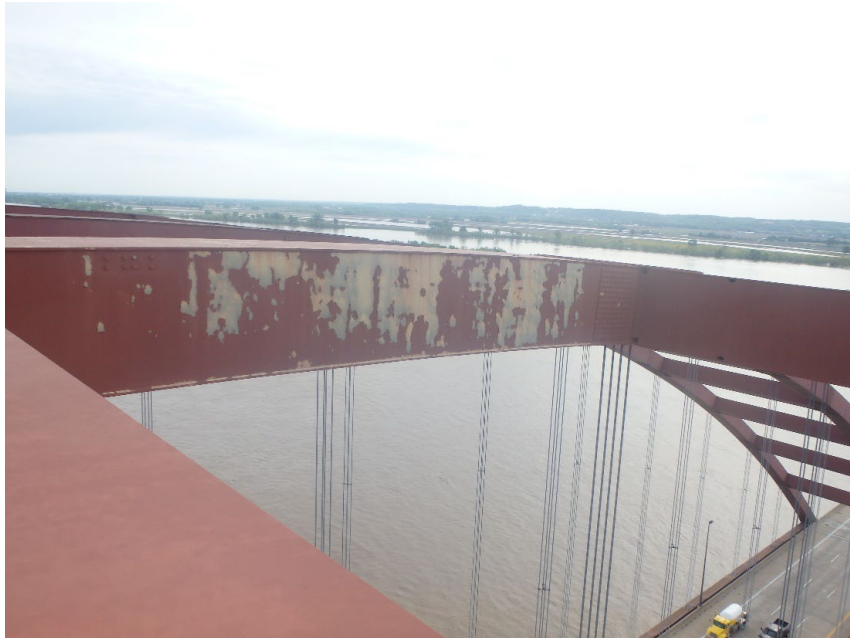
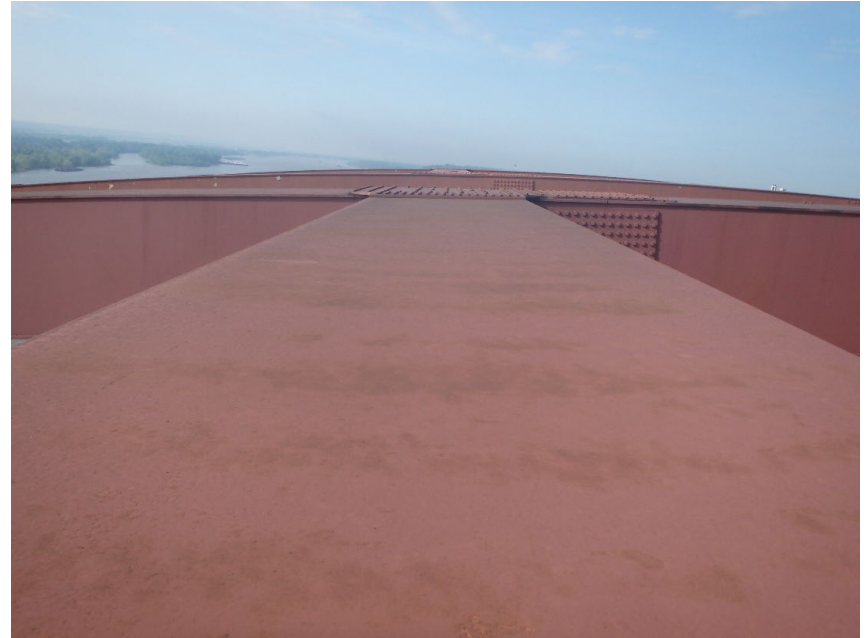
Condition of Steel Coating

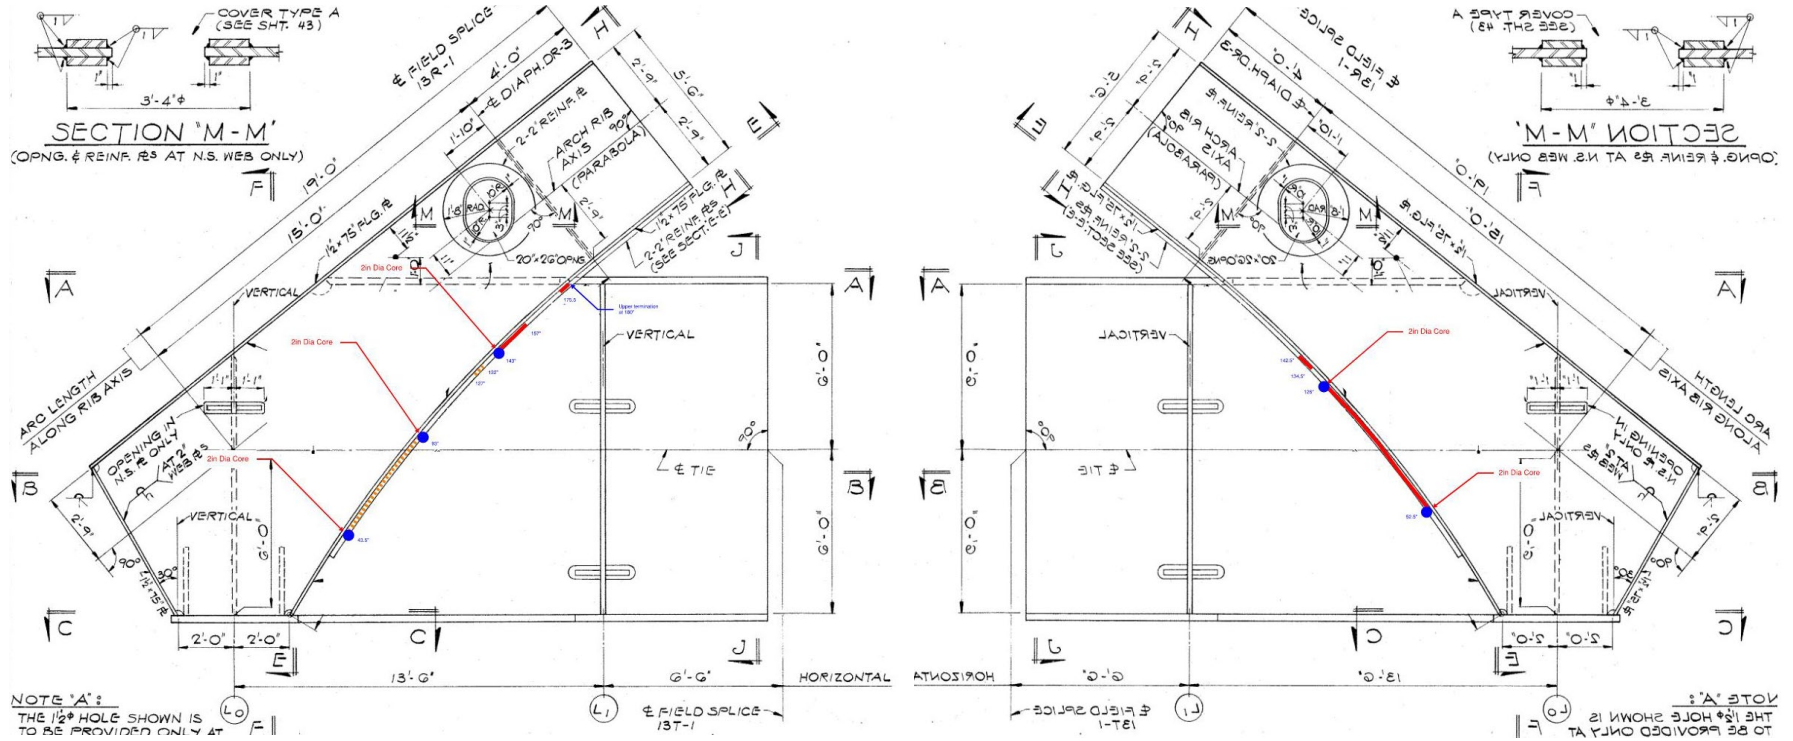
South Tie Girder (View looking North)

- Visual observations could not detect the cracks
- Hydrogen-induced cracking the likely cause
- No evidence of crack growth over nearly 40 years
- High restraint and plate thickness contributed
- No strict controls in place on base metal surface cleanliness or weld consumable moisture levels.
- Other structure constructed under FCP

1. Grind cracks to remove indications
2. Continue grinding as needed, verifying crack removed using MT
3. Preheat weld repair area to 300° F for minimum 1 hour
4. Install weld using SMAW with E7018 electrodes with H4R rating
5. MT root pass and maintain 300-450° F interpass temps.
6. MT intermittently and at completion of repair
7. Provide 3-hour bake-out at 300° F for a minimum of 3 hours
8. MT after cool down
