EMERGENCY BRIDGE REPAIRS

A look at Emergency Repairs due to Critical Findings and Truck Impacts in Missouri, Illinois and Kansas

Scott Moeder, PE & Ryan Hagerty, PE

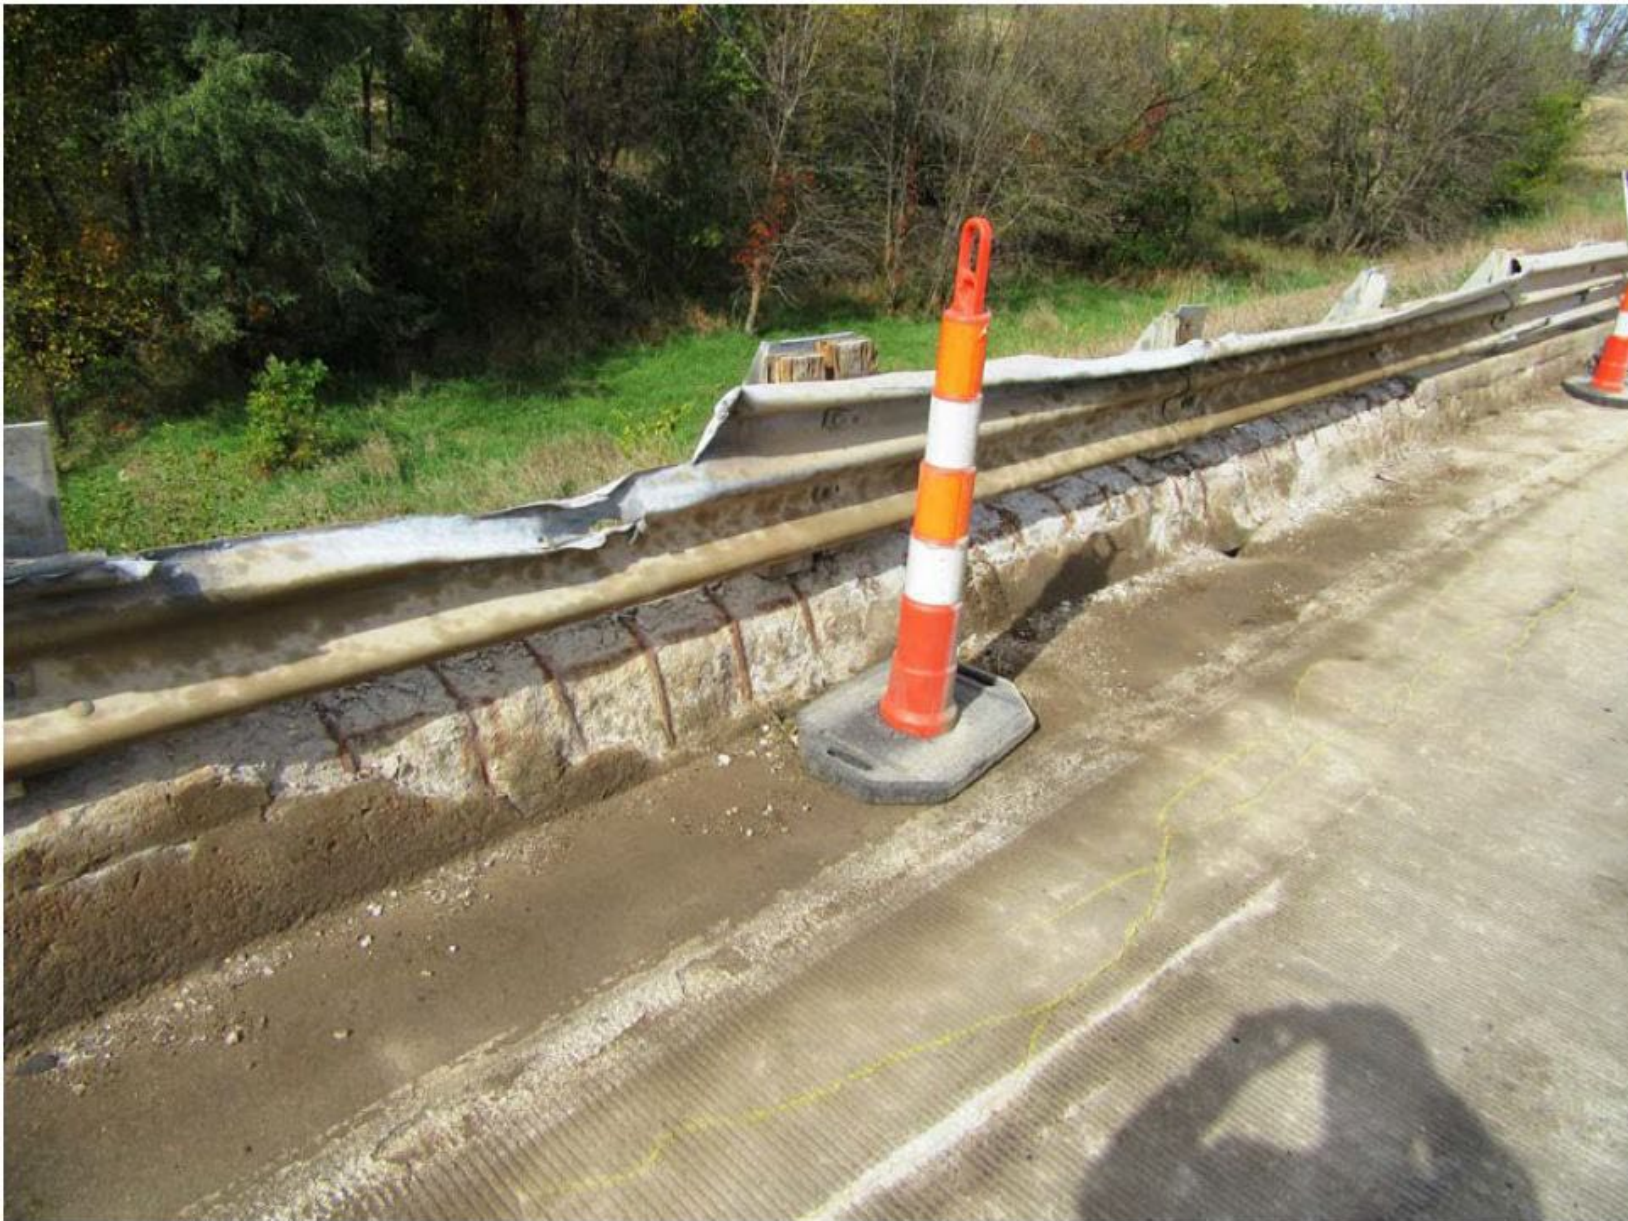
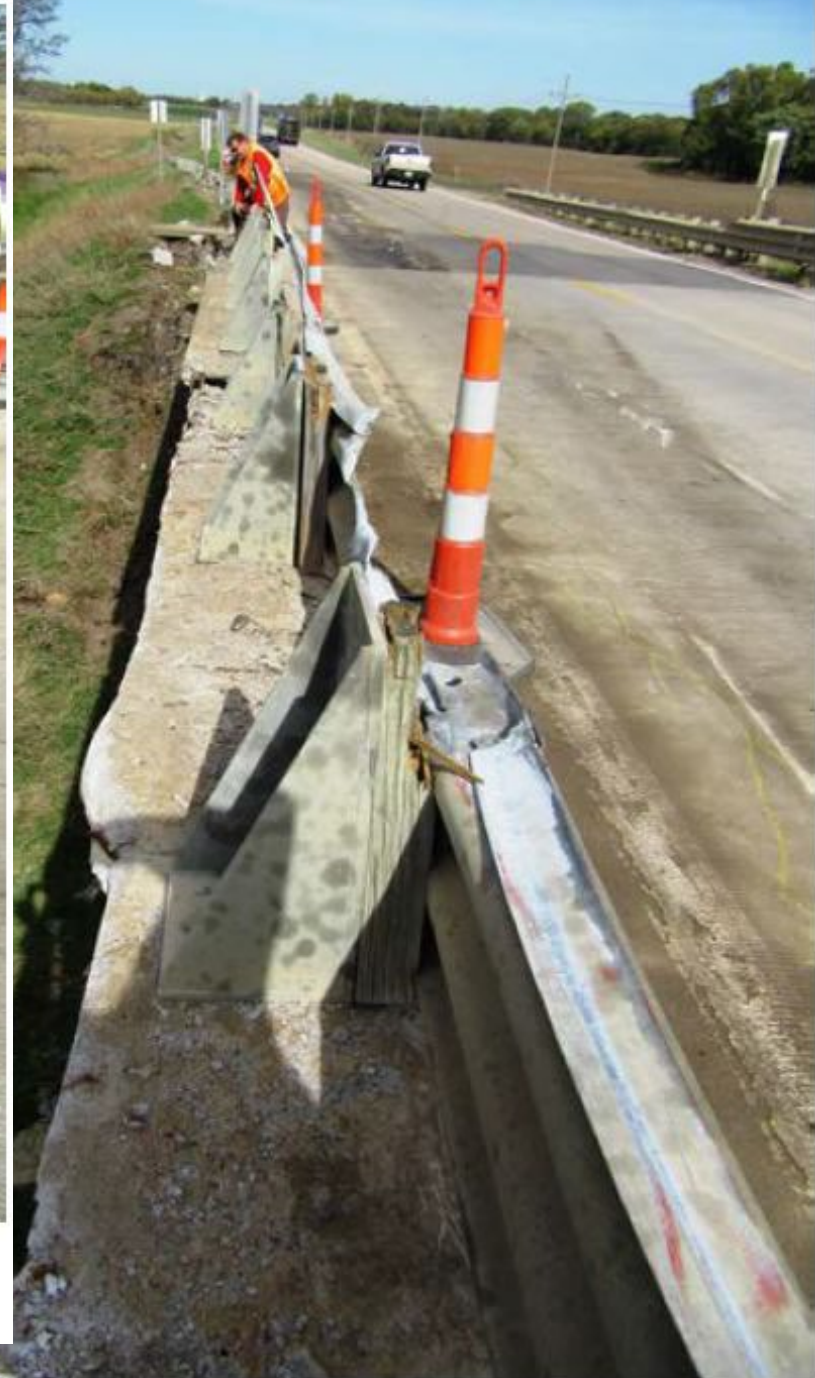
Br. No. 15-101-237.05 (023)

Parapet damage in Span 3 left side of bridge

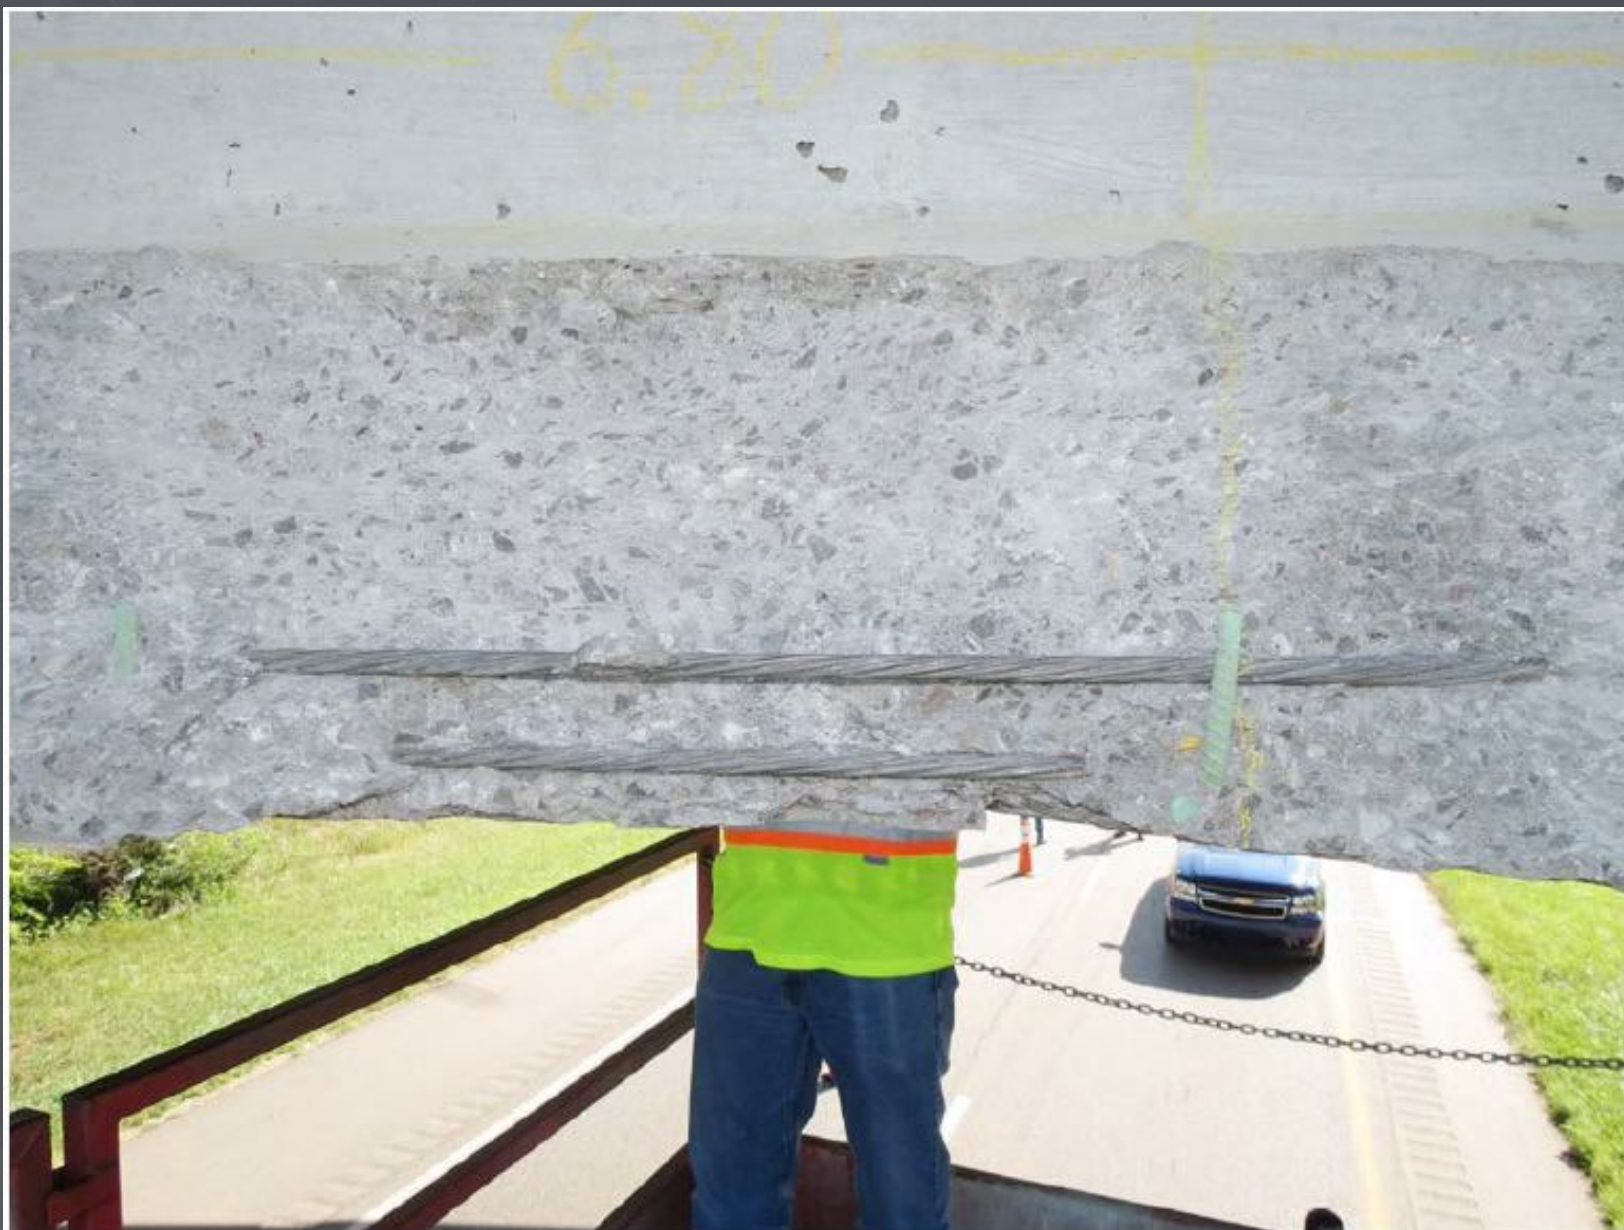
Br. No. 196-8-28.38 (160)

Girder A, left side, 8-16-17 impact, 2 exposed strands, (none were severed).

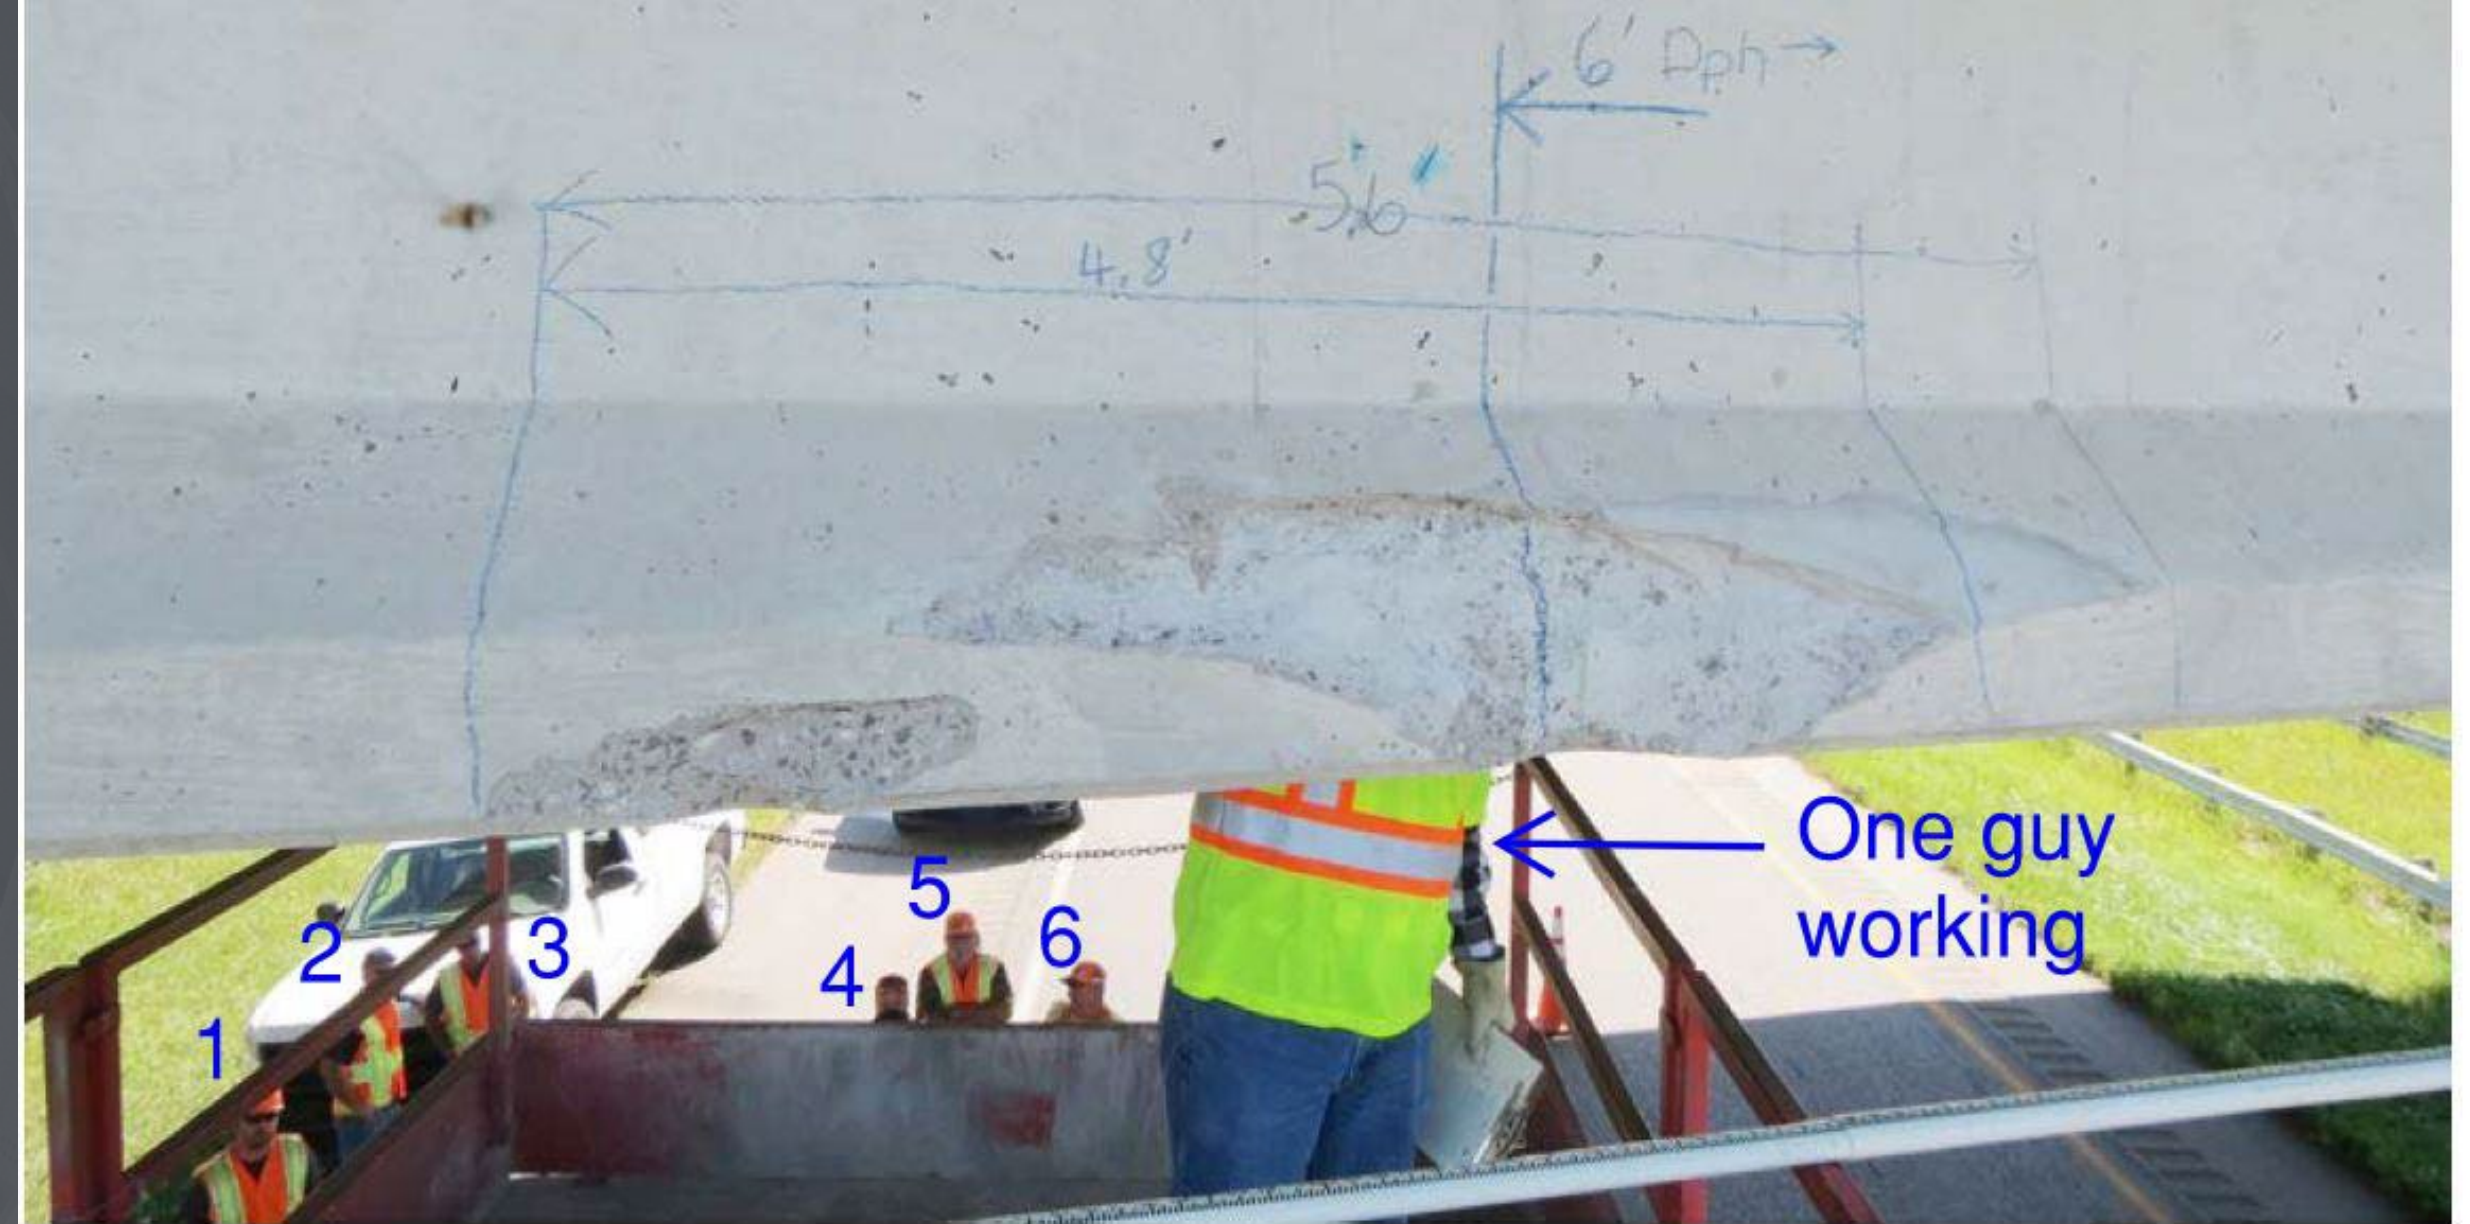
Br. No. 196-8-28.38 (160)

Girder A, left side, 2015 impact, (hit again in 2017).

CFRP REINFORCED POLYMER WRAP: The wrap shall be the bi-directional MasterBrace FIB600/50 per wet layup system or approved equivalent. The surfaces shall be prepared according to the Manufacturer's instructions. A UV resistant, concrete colored coating shall be applied to the surface of the CFRP after installation. Specifications for the coating system shall be sent to the State Bridge Office for review 3 weeks prior to installation.

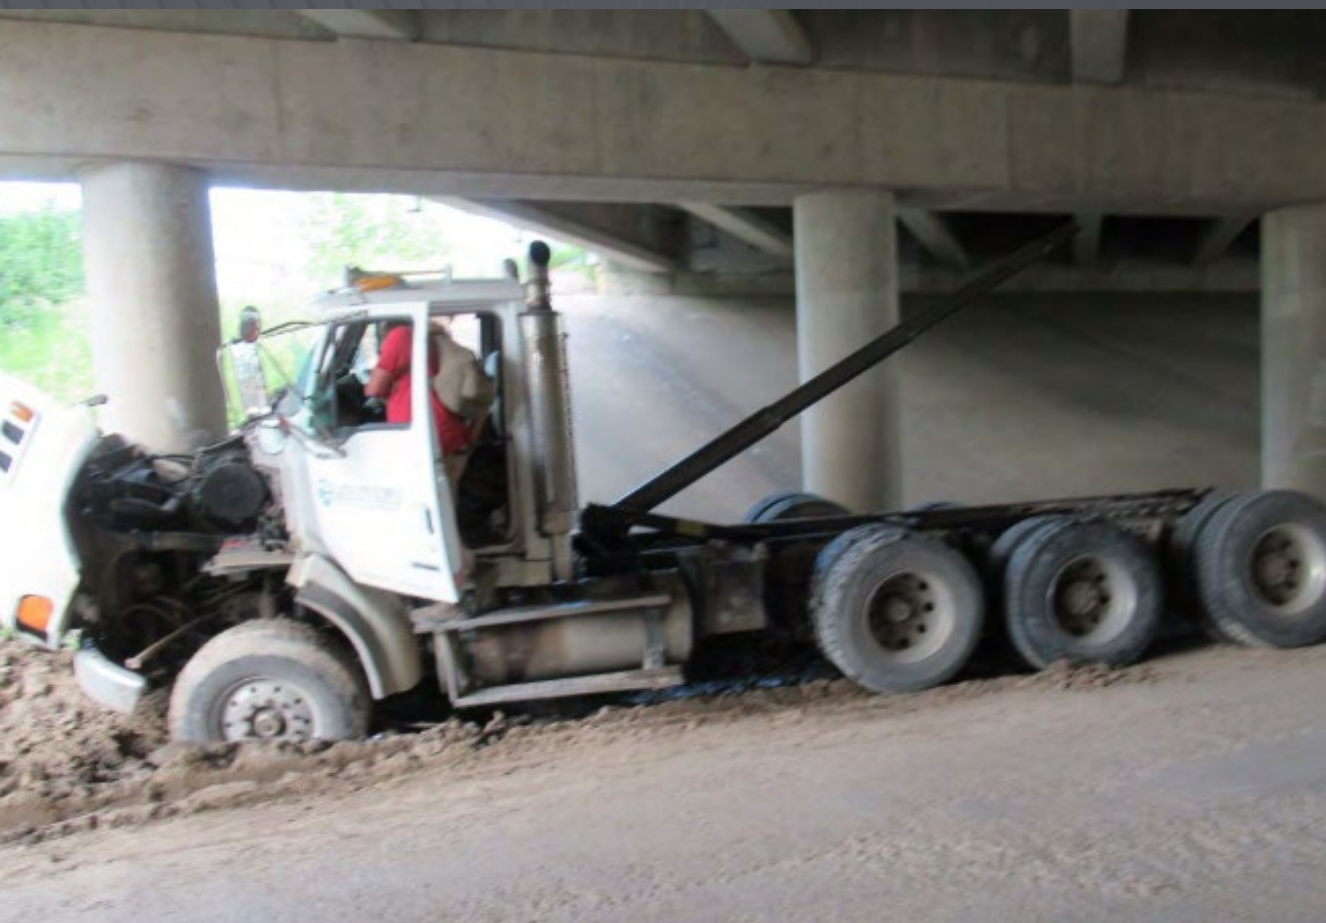
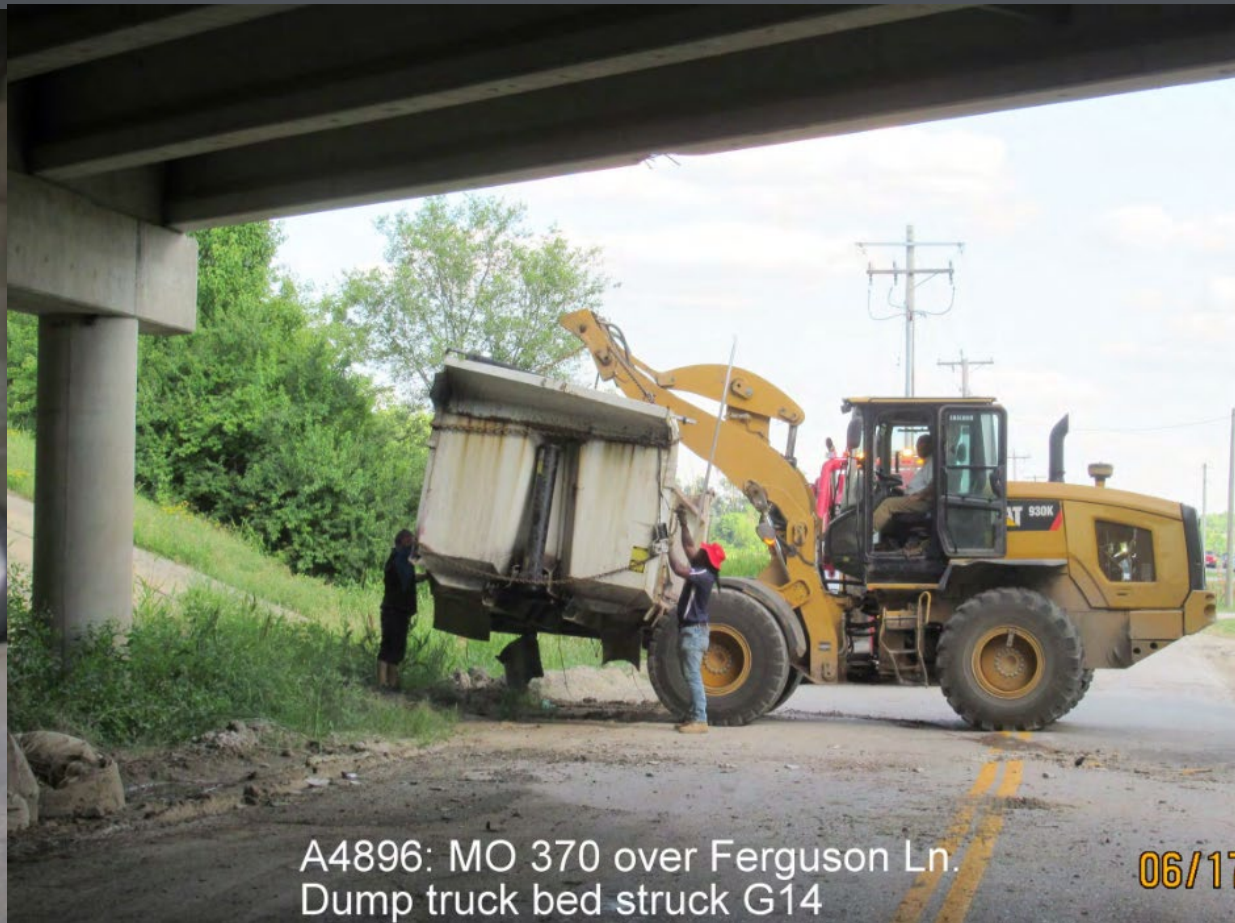
A4896: MO 370 over Ferguson Ln.
Dump truck bed struck G14

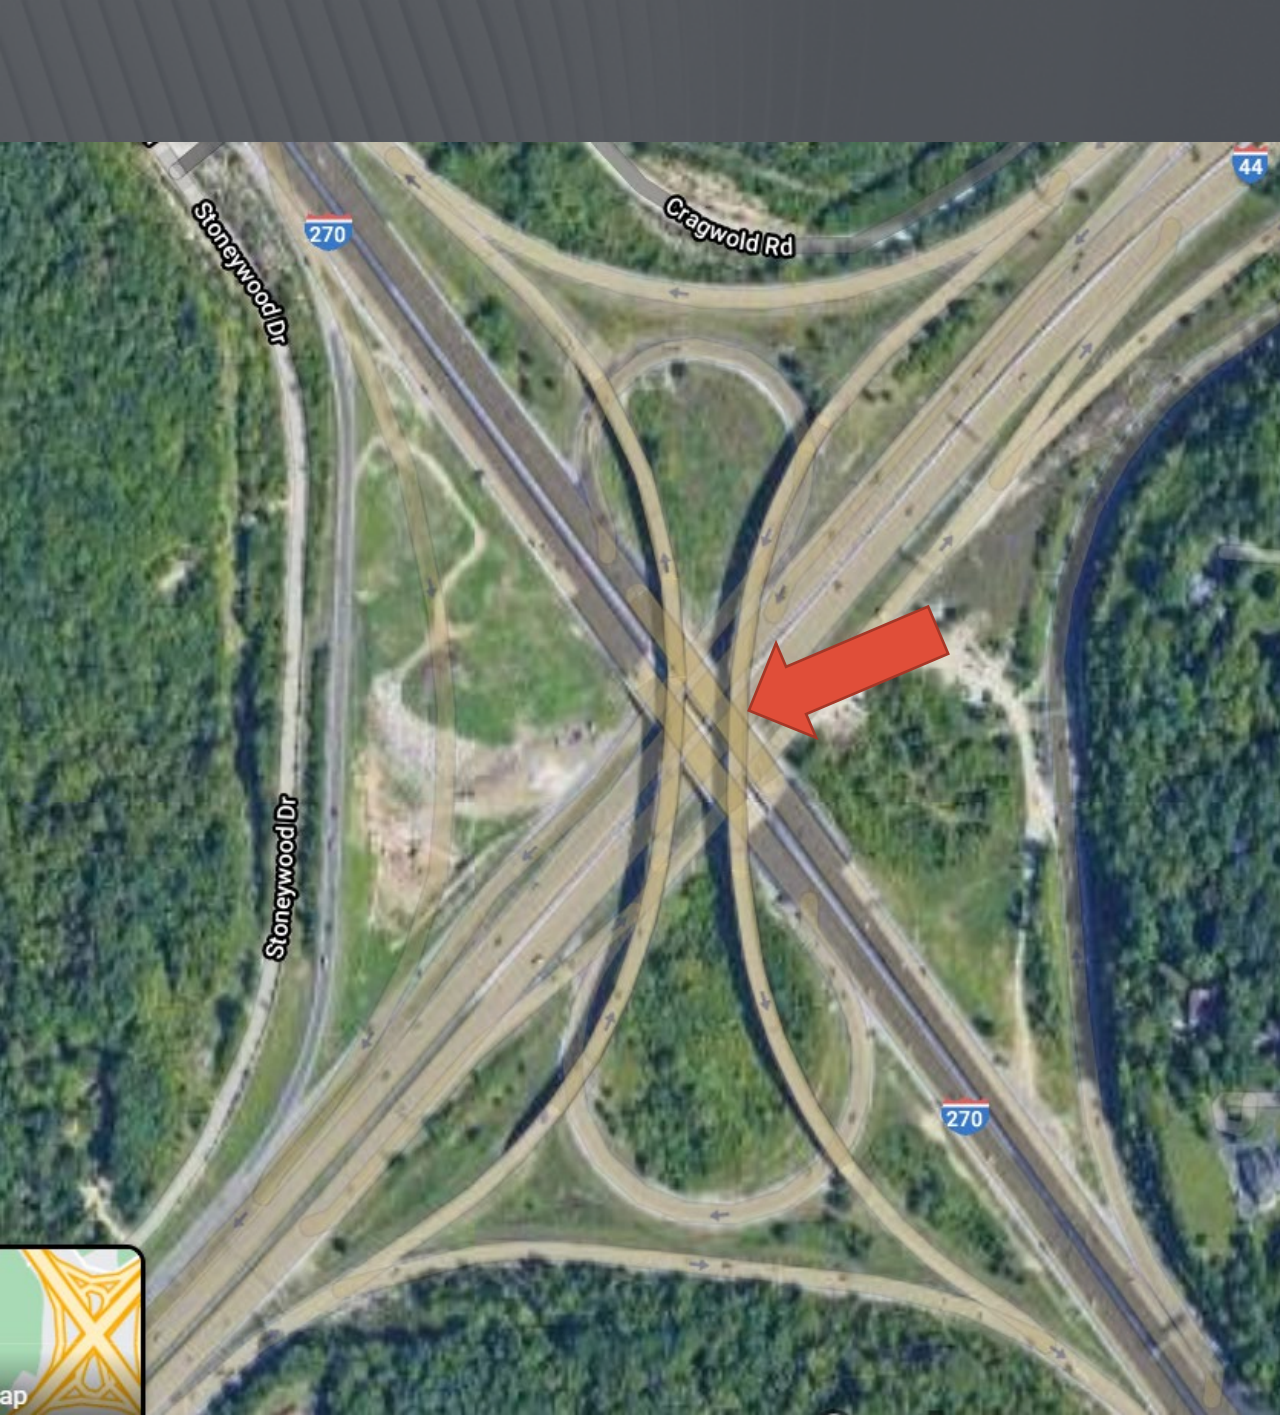
A1006: I-270 over I-44
G1 Span 3 Collision Damage
Looking West

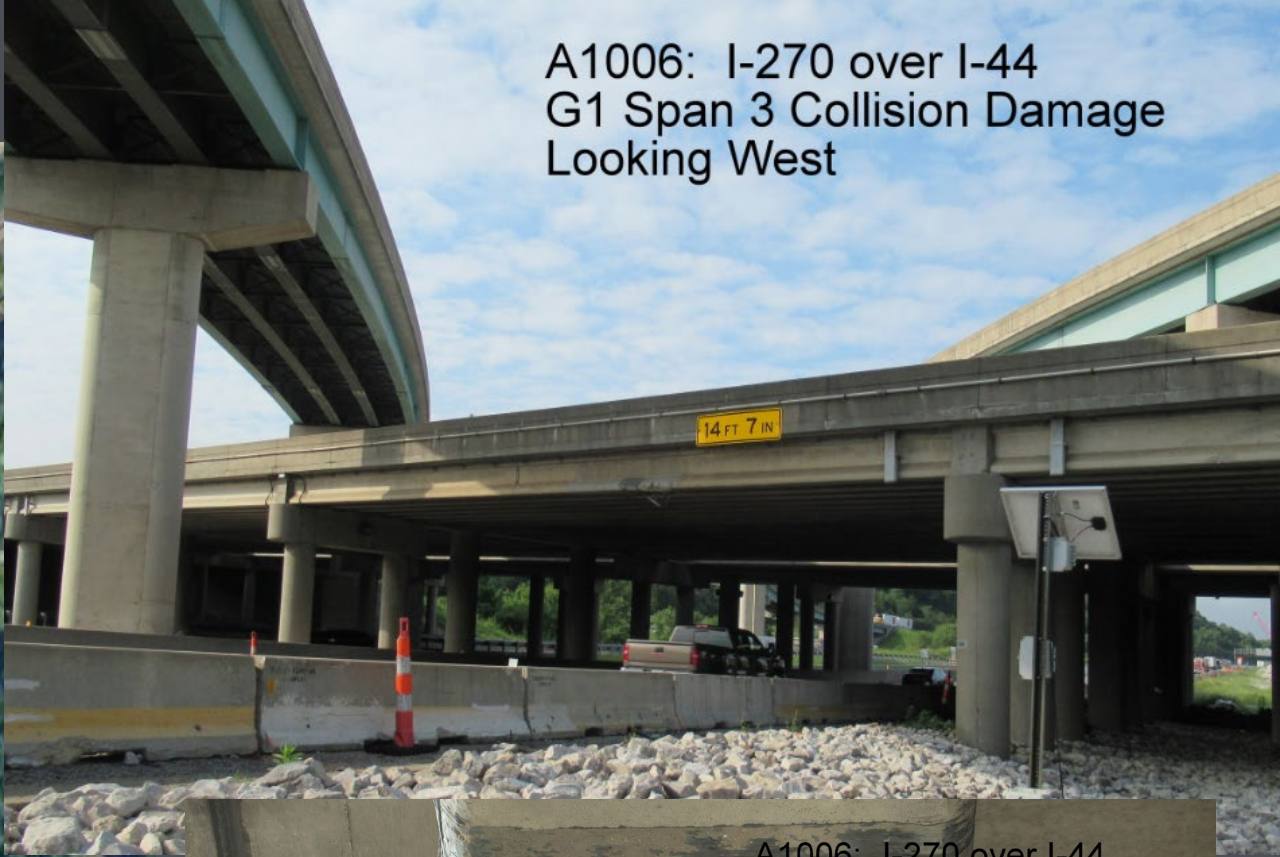
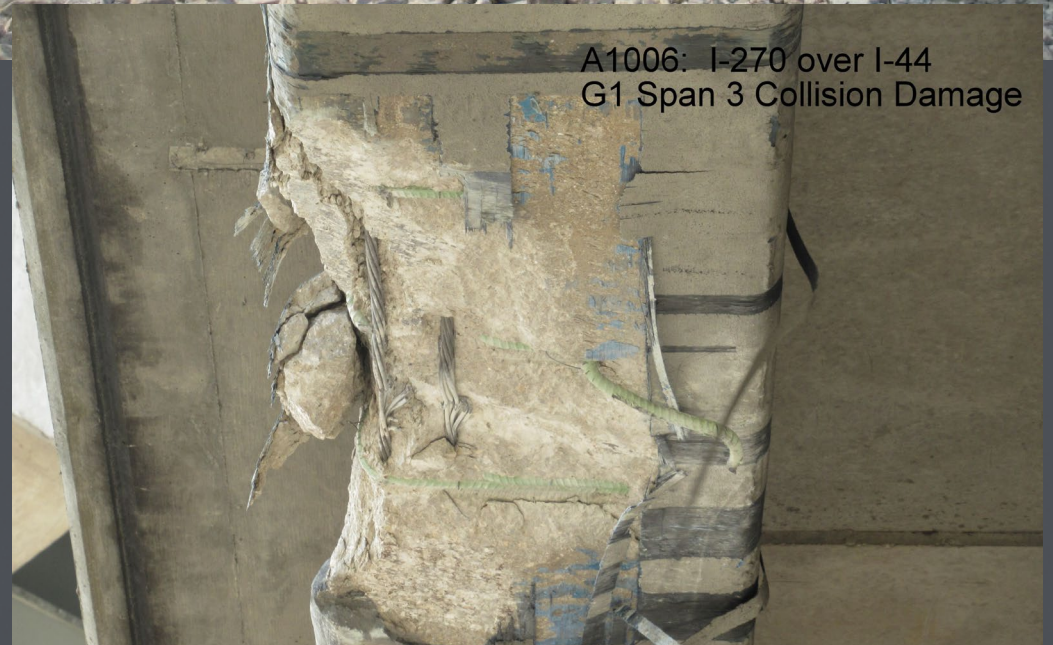
A1006: I-270 over I-44
G1 Span 3 Collision Damage

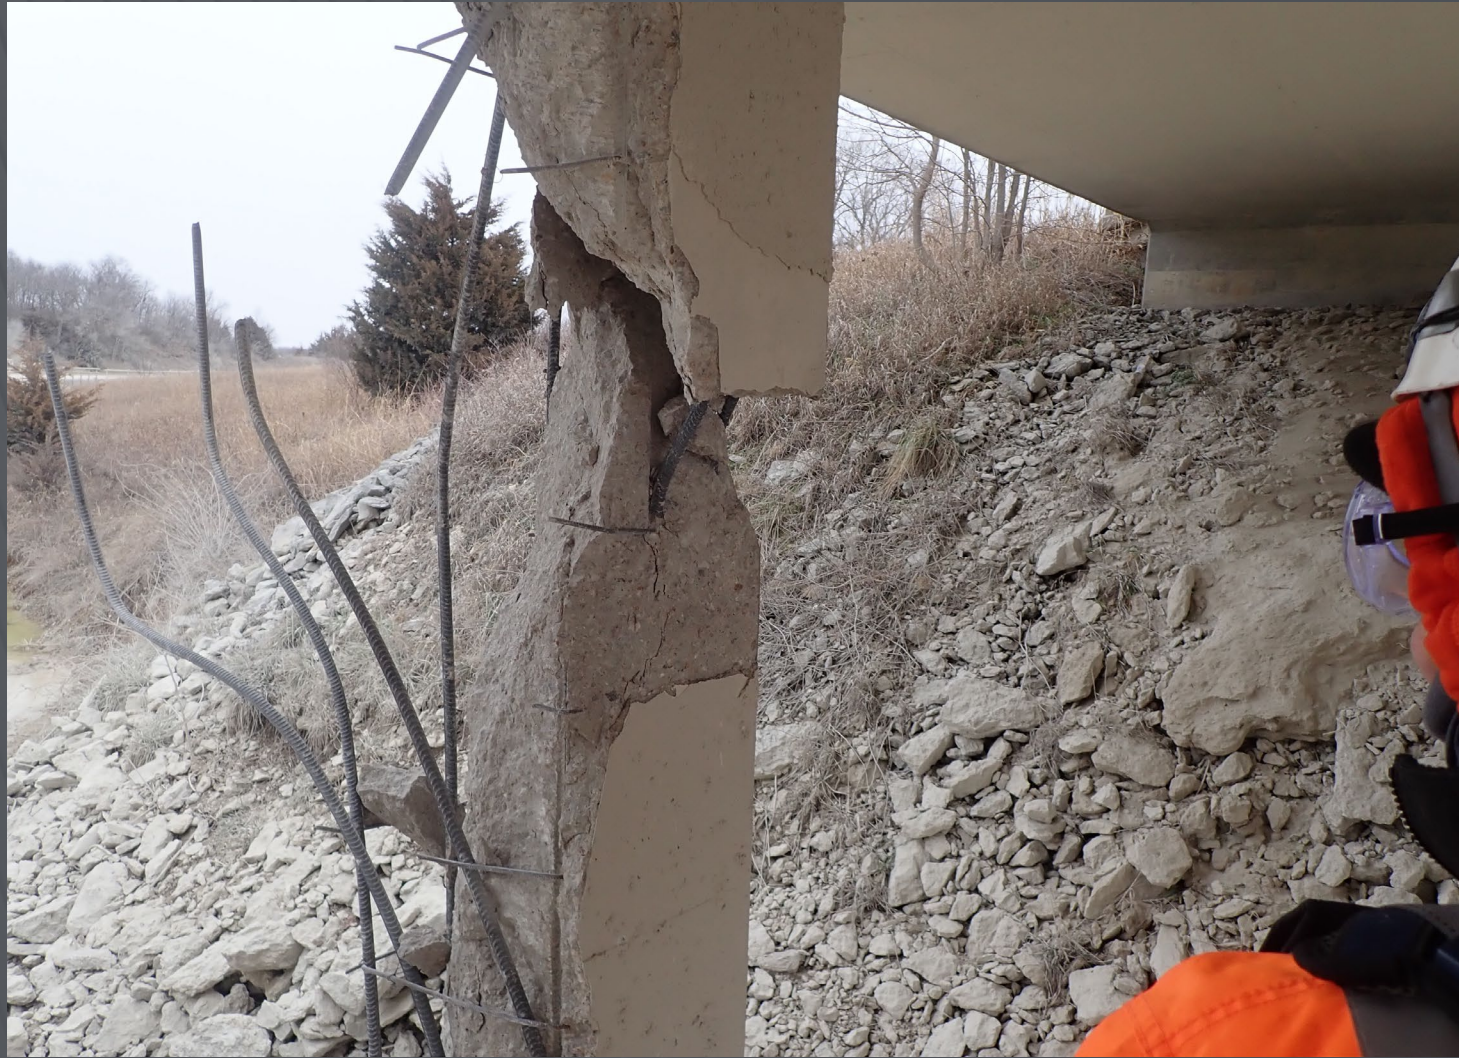
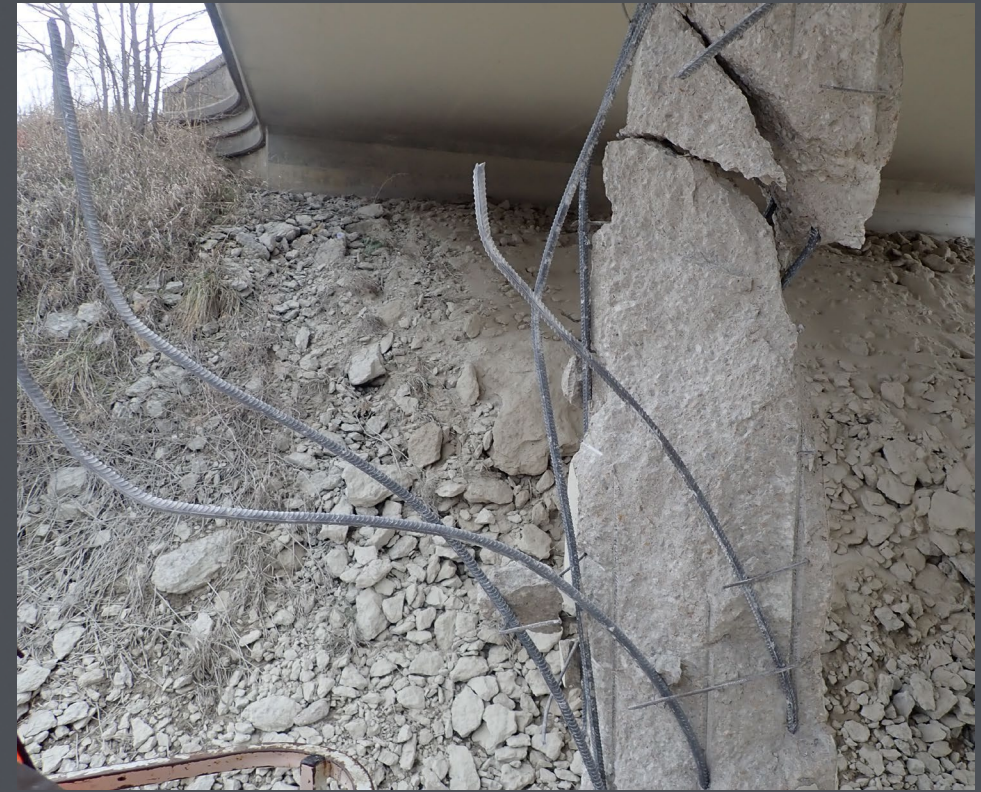
- Column concrete completely broken
- More than half of column steel broken

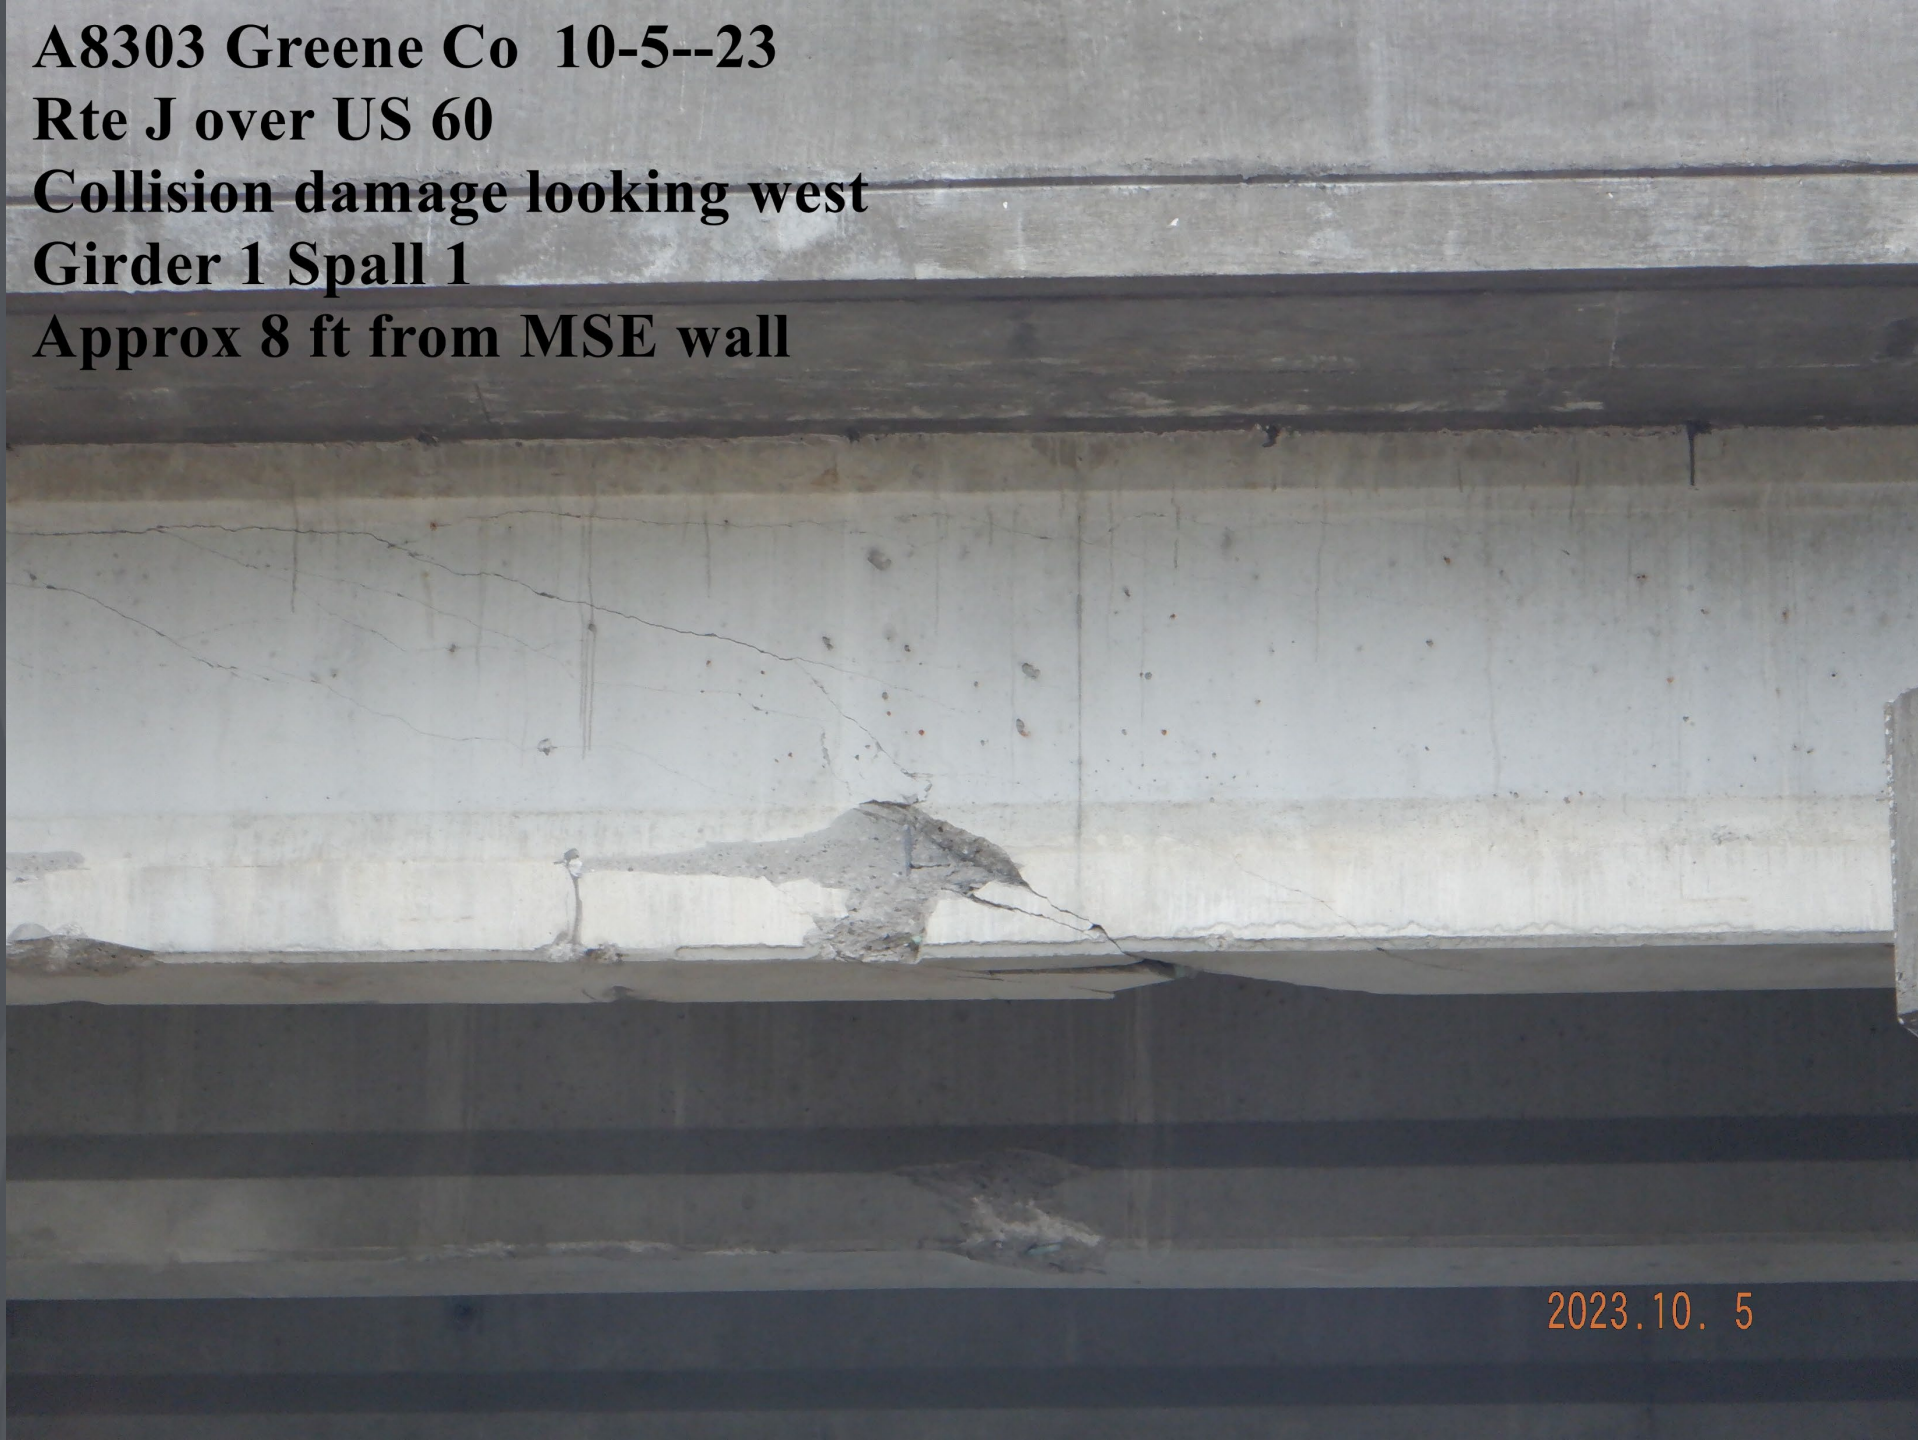
A8303 Greene Co 10-5--23

Collision damage looking west

Girder 1 Spall 1

Approx 8 ft from MSE wall
