INNOVATING SOLUTIONS

Innovating Solutions

Gateway Mine Remediation

New Jersey Turnpike Authority Pavement Management System

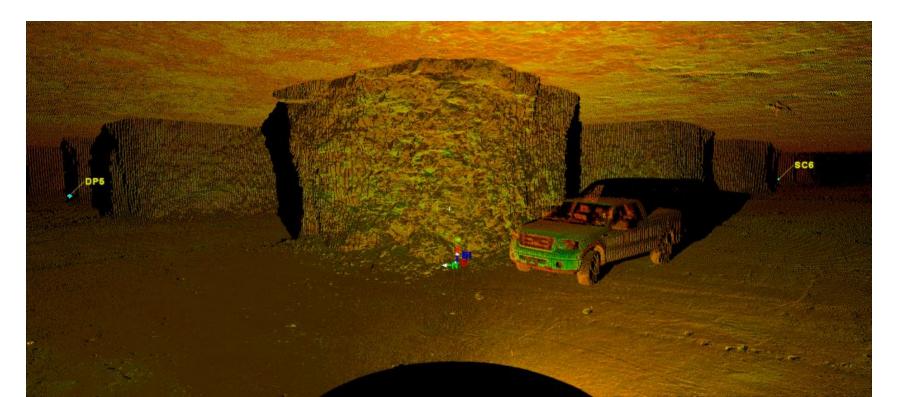
Gateway - General Mine Geometry

- Underground limestone mines
- Preliminary design included mine structure evaluation and recommendations

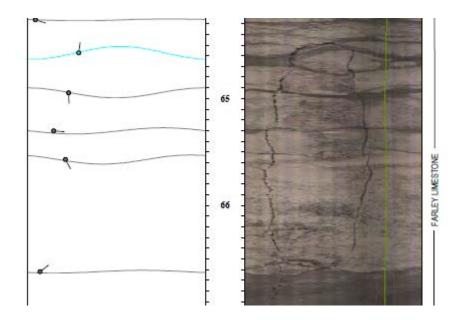
Gateway - Optical Corehole Survey

Vertical Joint from 65.0' - 67.0'

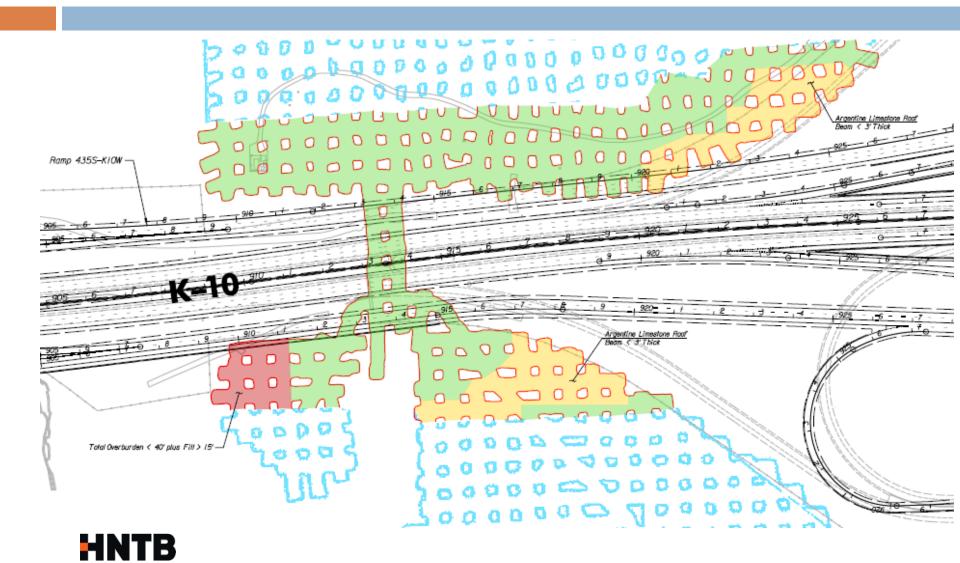
Gateway - Stability/Risk Map

- Mine evaluation study and remediation design completed during preliminary design
- Geotechnical engineers did not have background to evaluate the geospatial data.
- Technology group helped Geotechnical section identify locations of necessary remediation.
- Roadway alignment "fixed" in the area of the mines
- □ Mine remediation complete 2013

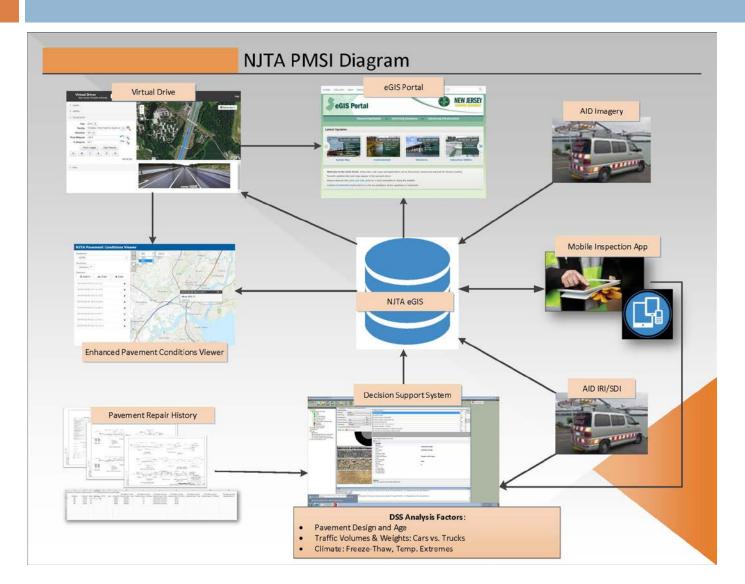
Enterprise Pavement Management System

- An interactive Pavement Viewer Module
- A mobile application for annual inspection rating collection
- A Virtual Drive created from photo images

- Pavement repair data base from as-built records
- Decision Support System

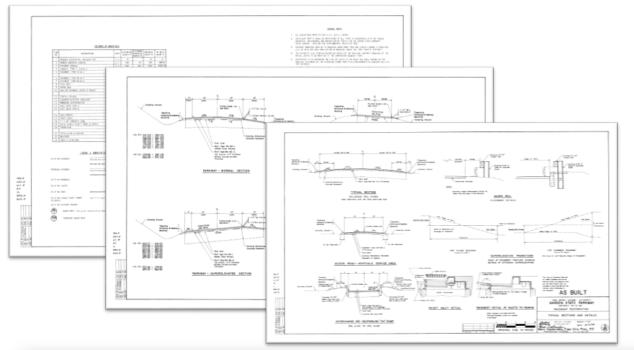
Pavement Repair History

ude toll plaza/no	on-roadway p	aving. Fr	om bridge a	approache	es (exclud	ing bridges							
							Plan Data or Coring	Plan Data or Coring	Plan Data or Coring	Plan Data or Coring	Plan Data or Coring	Plan Data or Coring	Plan Data or Coring
Roadway	Route_ID	Section	MP From	MP To	Lane	ontract No	Pavement Layer 1 Type	Pavement Layer 1 Thickness	Pavement Layer 2 Type	Pavement Layer 2 Thickness	Pavement Layer 3 Type	Pavement Layer 3 Thickness	Subbase Material
GSP	Int156	14				C0601	MA-BC-1	1.5	Bituminous Concrete	Varies			
GSP	Int157	14				C0601	MA-BC-1	1.5	Bituminous Concrete	Varies			
GSP	Int161	14				C0601	MA-BC-1	1.5	Bituminous Concrete	Varies			
GSP	Int163	15				C0601	MA-BC-2	3	Bituminous Concrete	Varies			
	Roadway GSP GSP GSP	Roadway Route_ID GSP Int156 GSP Int157 GSP Int161	Roadway Route_ID Section GSP Int156 14 GSP Int157 14 GSP Int161 14	Roadway Route_ID Section MP From GSP Int156 14	Roadway Route_JD Section MP From MP To GSP Int156 14	Roadway Route_JD Section MP From MP To Lane GSP Int156 14	Roadway Route_JD Section MP From MP To Lane Contract Nc GSP Int156 14 C0601 C0601	GSP Int156 14 C0601 MA-8C-1 GSP Int157 14 C0601 MA-8C-1 GSP Int157 14 C0601 MA-8C-1 GSP Int151 14 C0601 MA-8C-1	Roadway Route_10 Section MP From MP To Lae Plan Data or Coring Plan Data or Coring	Plan Data or Coring Plan Data or Coring	Roadway Route_ID Section MP From MP To Lane Plan Data or Coring Plan Data or Coring	Plan Data or Coring Plan Data or Coring	Plan Data or Coring Plan Data or Coring

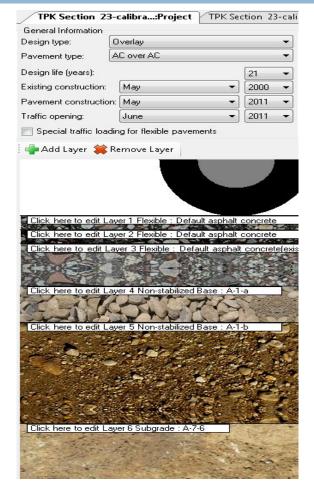
Decision Support System

PvD	AASHTOWare Pavement ME Design
 Climate Station Elevation (ft) Climate station Latitude (decimals degree Longitude (decimal degree) 	
Depth of water table (ft)	Annual(10)

4	AADTT		
	Two-way AADTT	1	14435
	Number of lanes	1	6
	Percent trucks in design di	re 🗹	51
	Percent trucks in design la	n 🗹	65
	Operational speed (mph)	1	65
4	Traffic Capacity		
	Traffic Capacity Cap	1	Not enforced
4	Axle Configuration		
	Average axle width (ft)	1	8.5
	Tandem axle spacing (in)	1	51.6
	Dual tire spacing (in)	1	12
	Quad axle spacing (in)		49.2
	Tire pressure (psi)		120
	Tridem axle spacing (in)	1	49.2
4	Lateral Wander		
	Design lane width (ft)		12
	Mean wheel location (in)		18
	Traffic wander standard de	• 🔽	10
4	Wheelbase		2010-E
	Average spacing of long as	a 🗹	18
	Average spacing of mediu		15
	Percent trucks with long as		61
	Percent trucks with mediur		22
	Percent trucks with short a		17
	Average spacing of short a		12
	An anage spacing of shore		
Gre	owth Function		
Line	ear 🔻		
Line	aar 💌		Γ Γ

Vehicle Class	Distribution (%)	Growth Rate (%)	Growth Function		
Class 4	2	2.3	Linear	-	
Class 5	25	2.3	Linear	-	L, F,
Class 6	8	2.3	Linear	-	L
Class 7	4	2.3	Linear	-	
Class 8	4	2.3	Linear	-	
Class 9	55	2.3	Linear	-	
Class 10	2	2.3	Linear	-	
Class 11	0	0	Linear	-	
Class 12	0	0	Linear	•

- Surface Conditions Analyzed with respect to various rating systems
- ME Design software develop pavement performance predictions
 - Traffic (Number of Trucks, truck type and distribution, growth, number of lanes, traffic speed)
 - Last Mill and Overlay
 - Existing Pavement Condition
 - Existing Pavement Thickness and Material Types

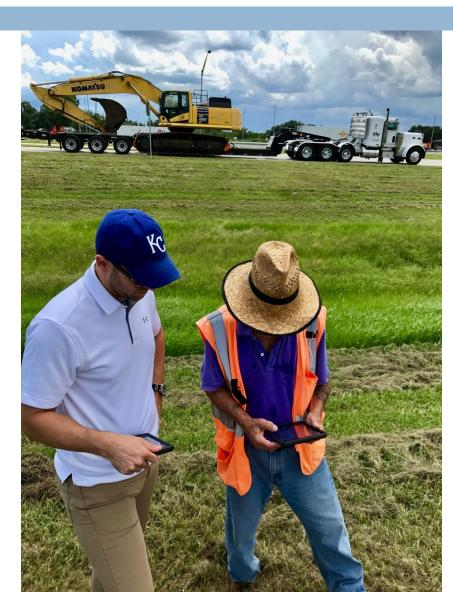
MCSAW- Condition Assessment Training

- HNTB Trained Subconsultant in iPAD use
- Assets rated on a 5-point scale:
 - Excellent
 - Good
 - 🗖 Fair
 - Poor
 - Critical/Failed

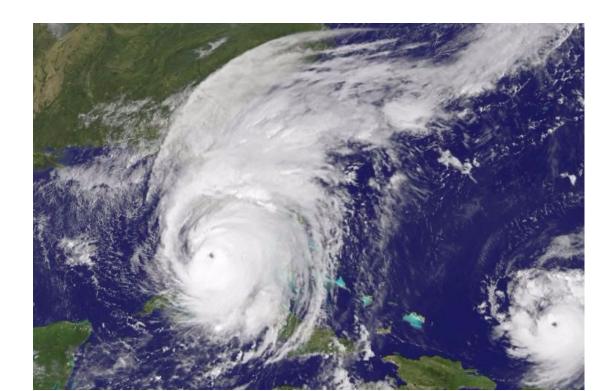
MCSAW Asset Collection

- Training the Client
- Multiple office, people, geographical locations involved
- Hurricane Irma
- □ Size of ramps

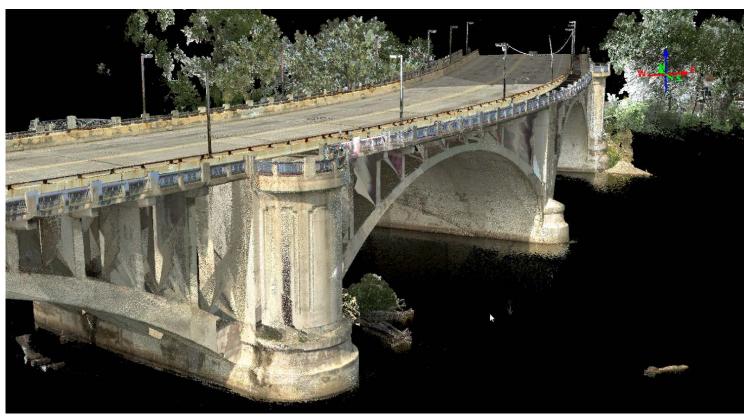
Advanced Data Acquisition Approach

- Land
- Sea
- Air
