JOHNSON DRIVE EMERGENCY BRIDGE REPAIRS

Samantha Kevern, P.E., S.E.
Sr. Project Engineer
HNTB Corporation

JOHNSON DRIVE BRIDGE OVER I-435

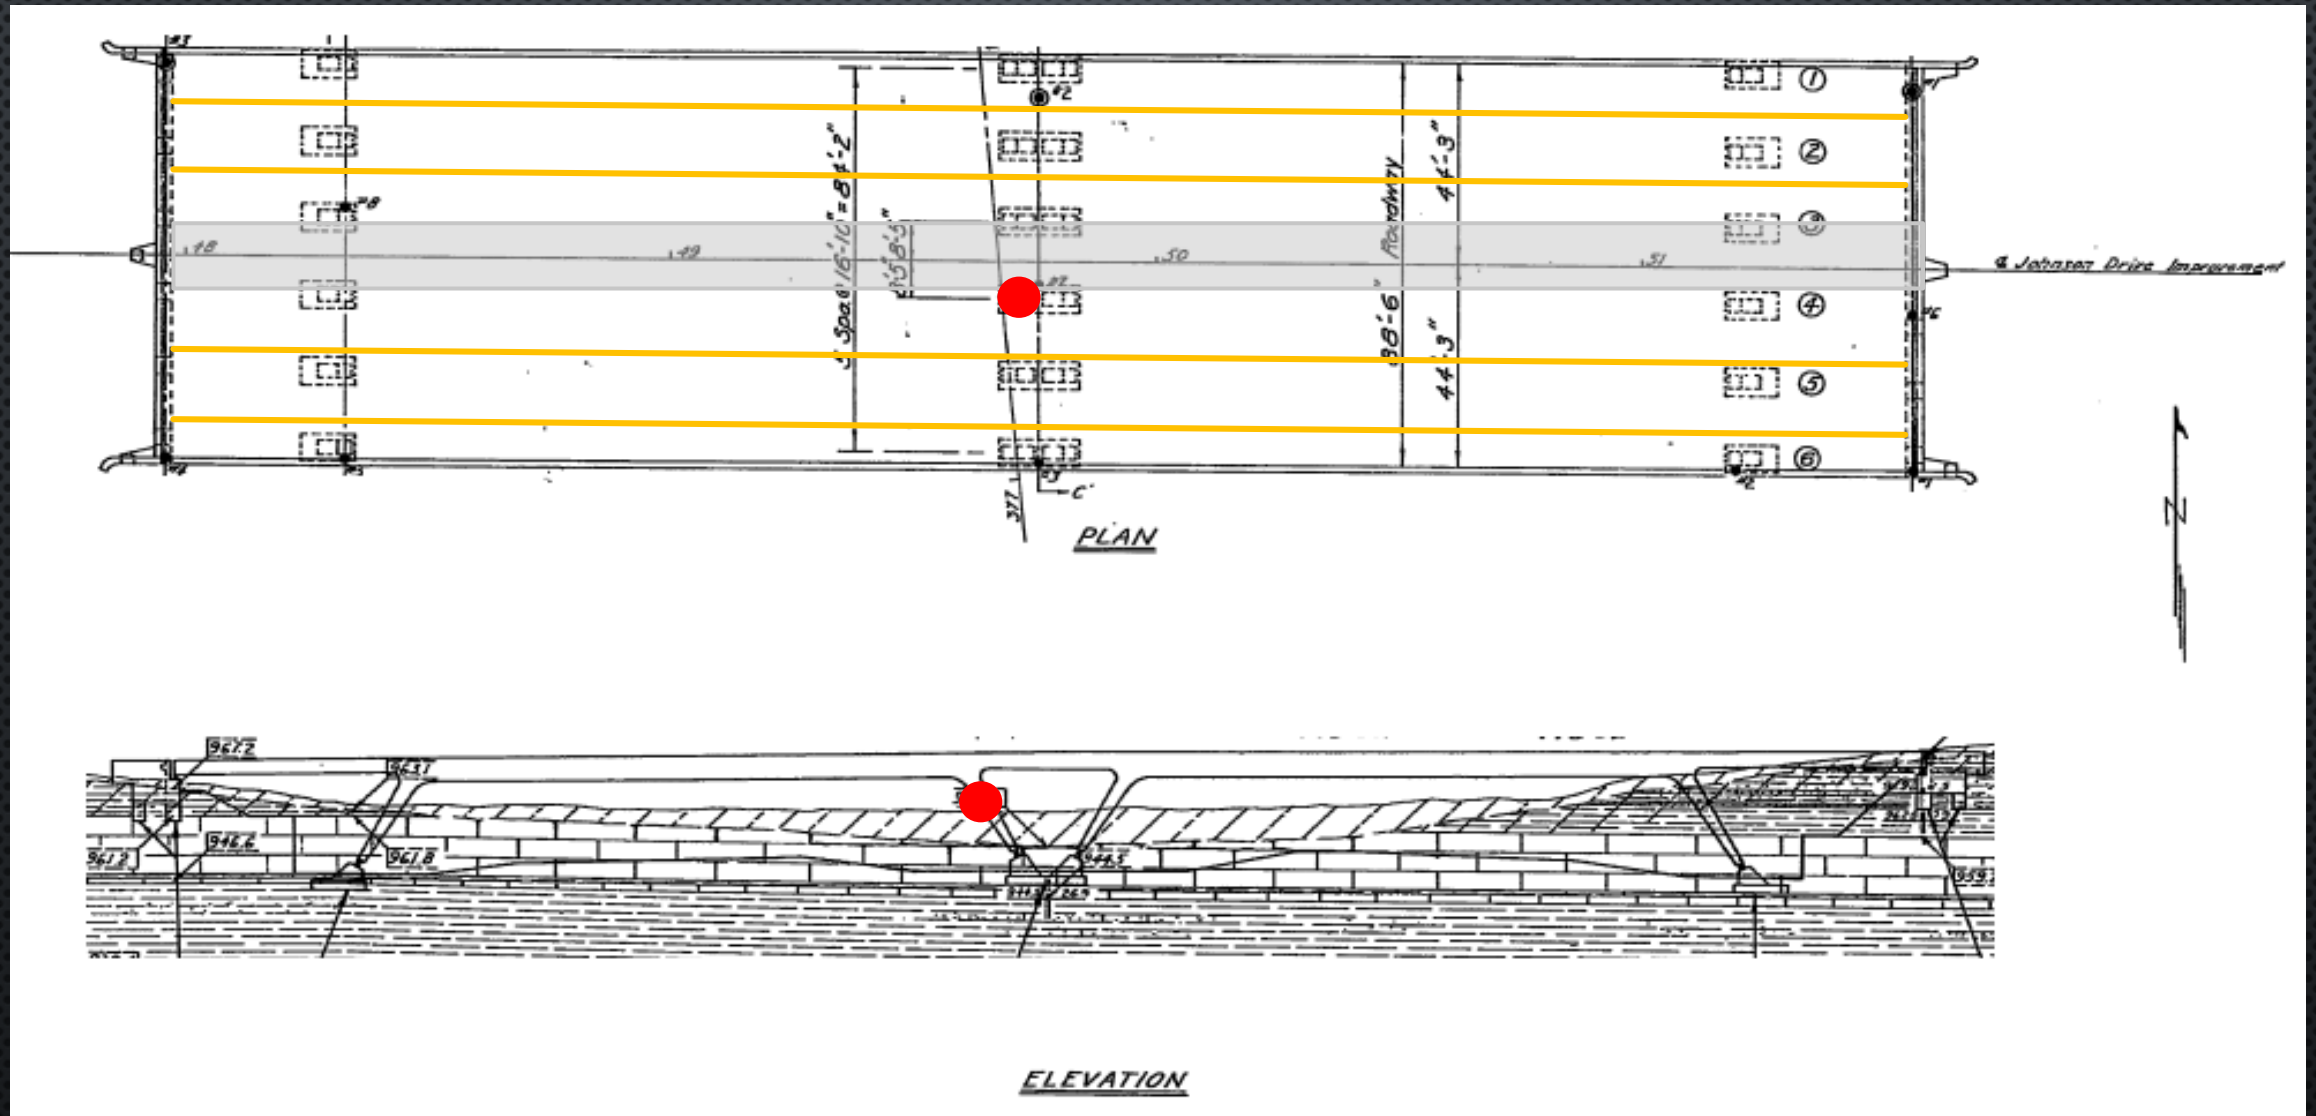
LOCATION OF IMPACT

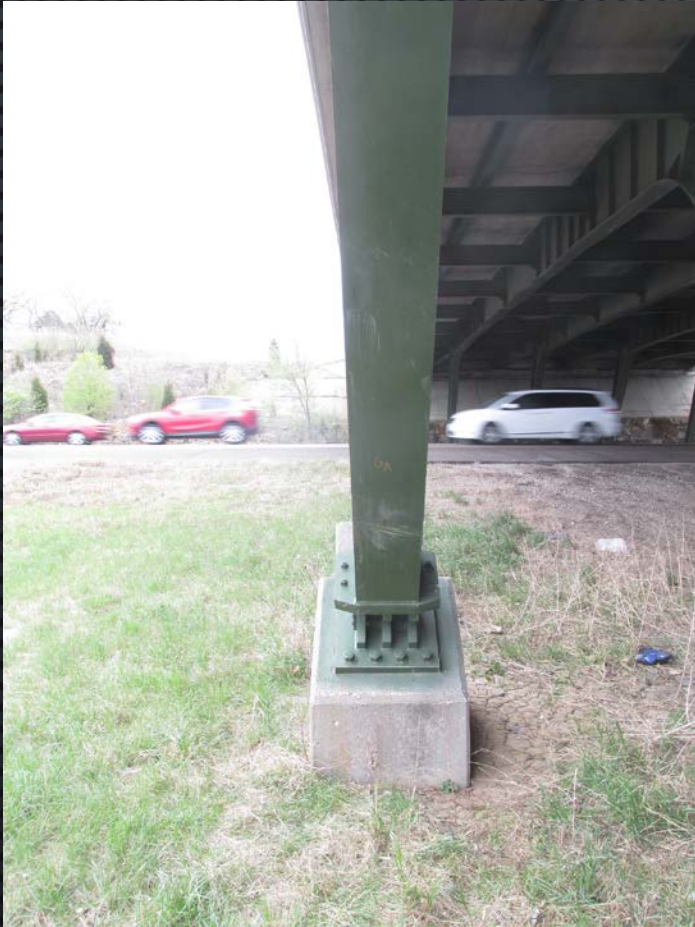
Frame 1

BRIDGE DAMAGE

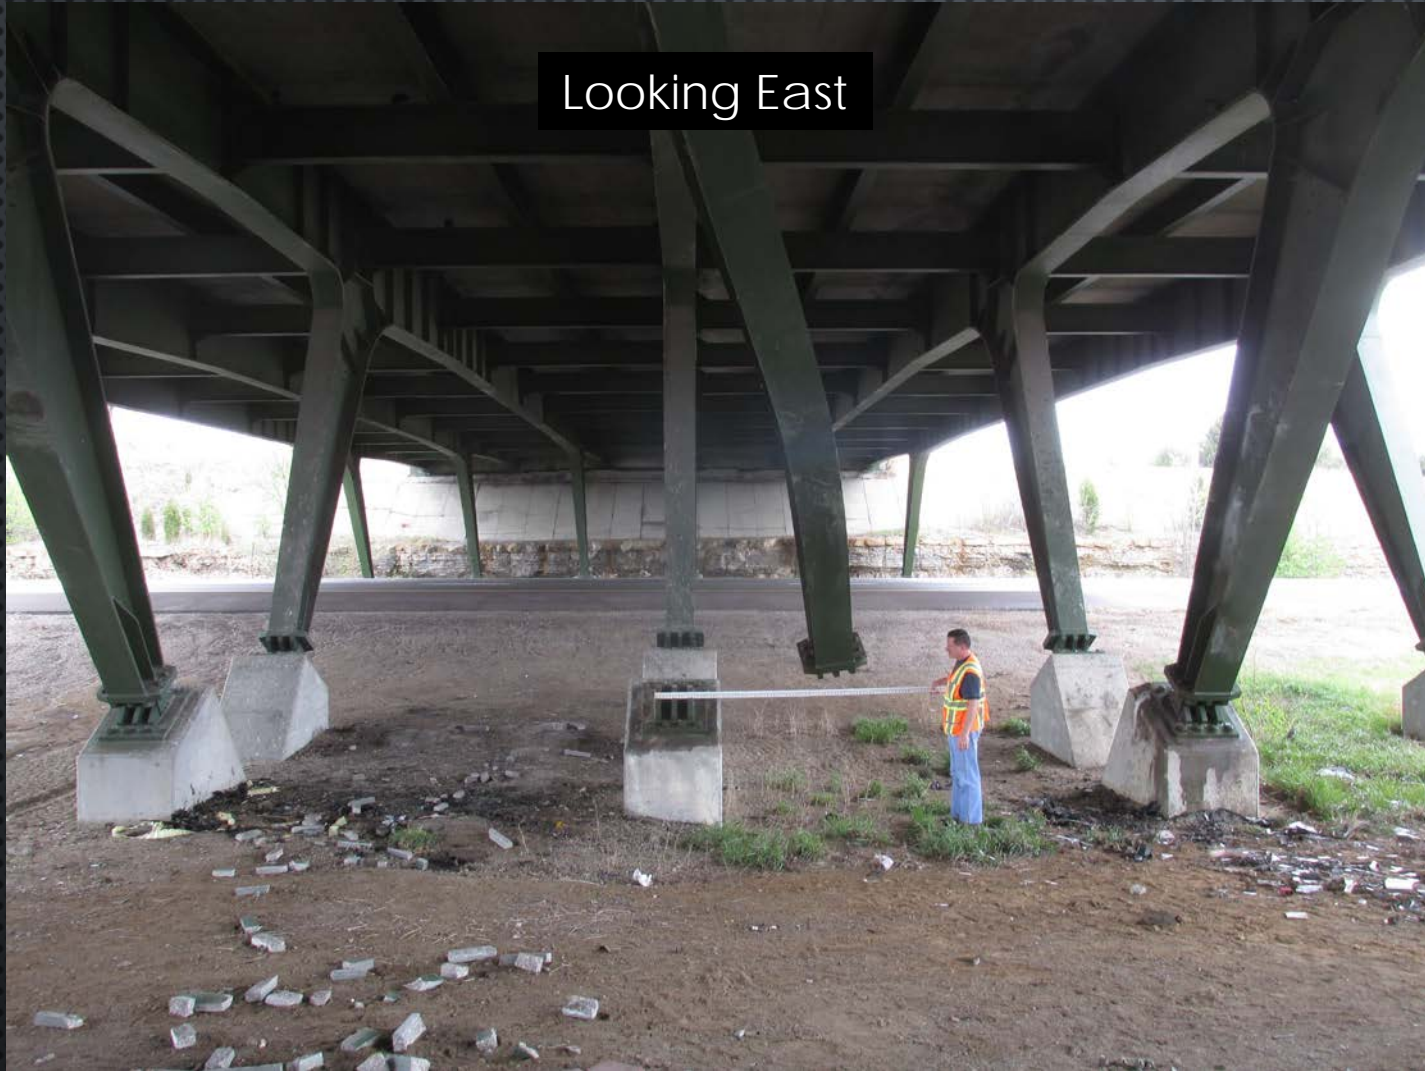
Frame 4

BRIDGE DAMAGE

Looking East

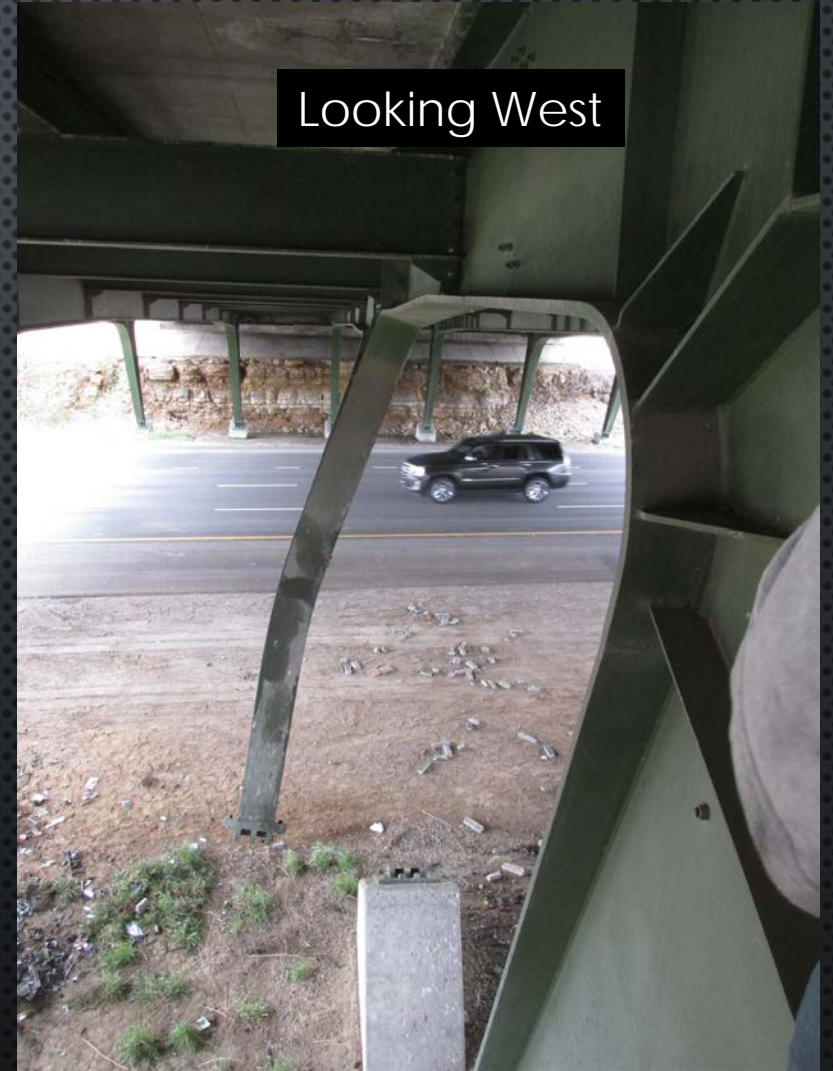
Frame 4

Looking West

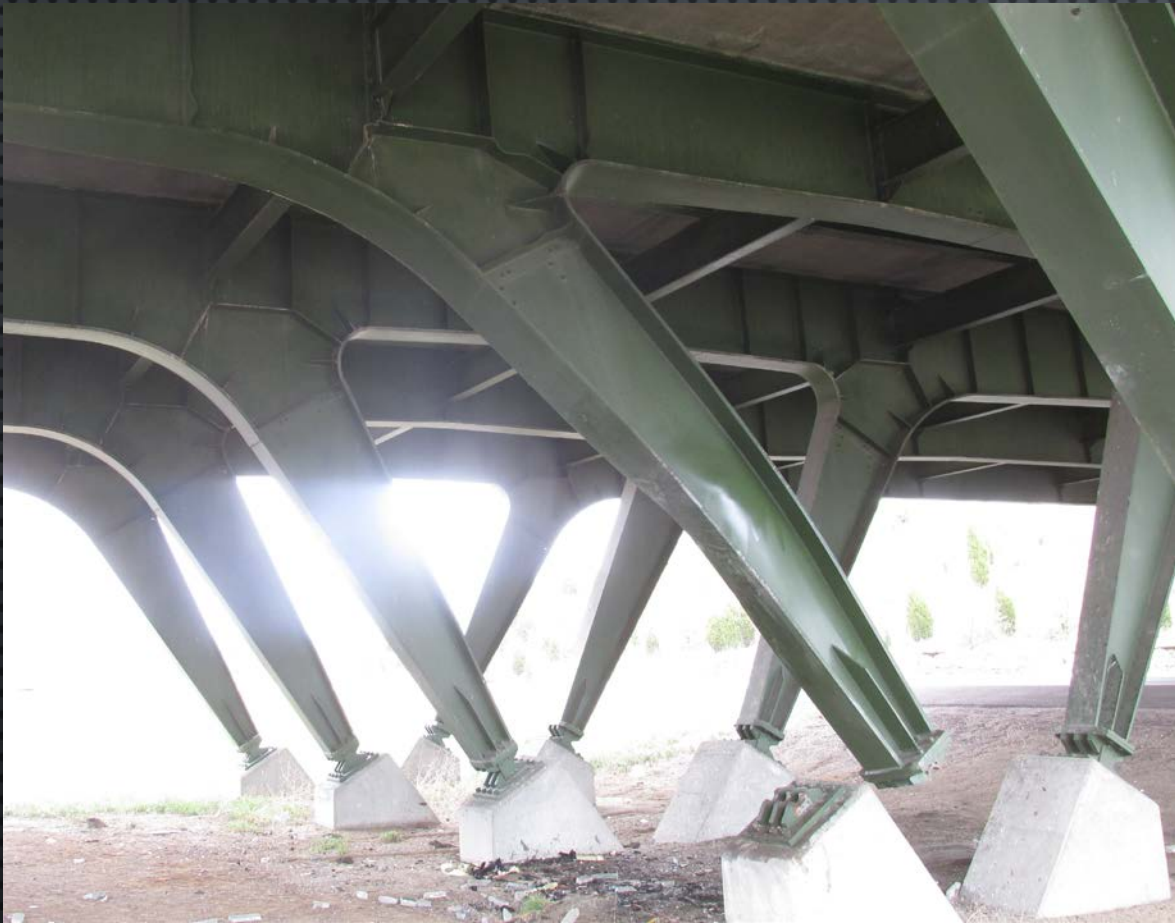
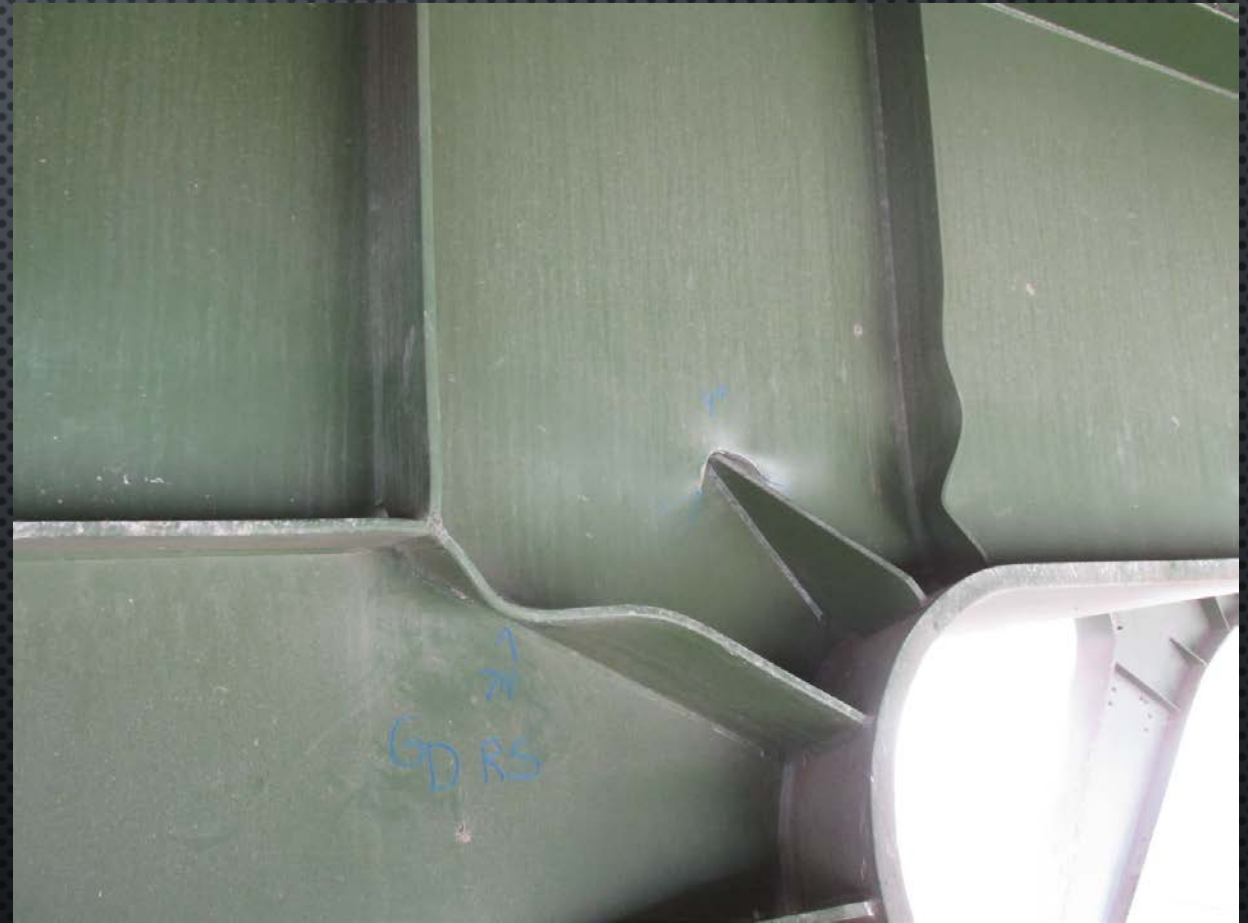
BRIDGE DAMAGE

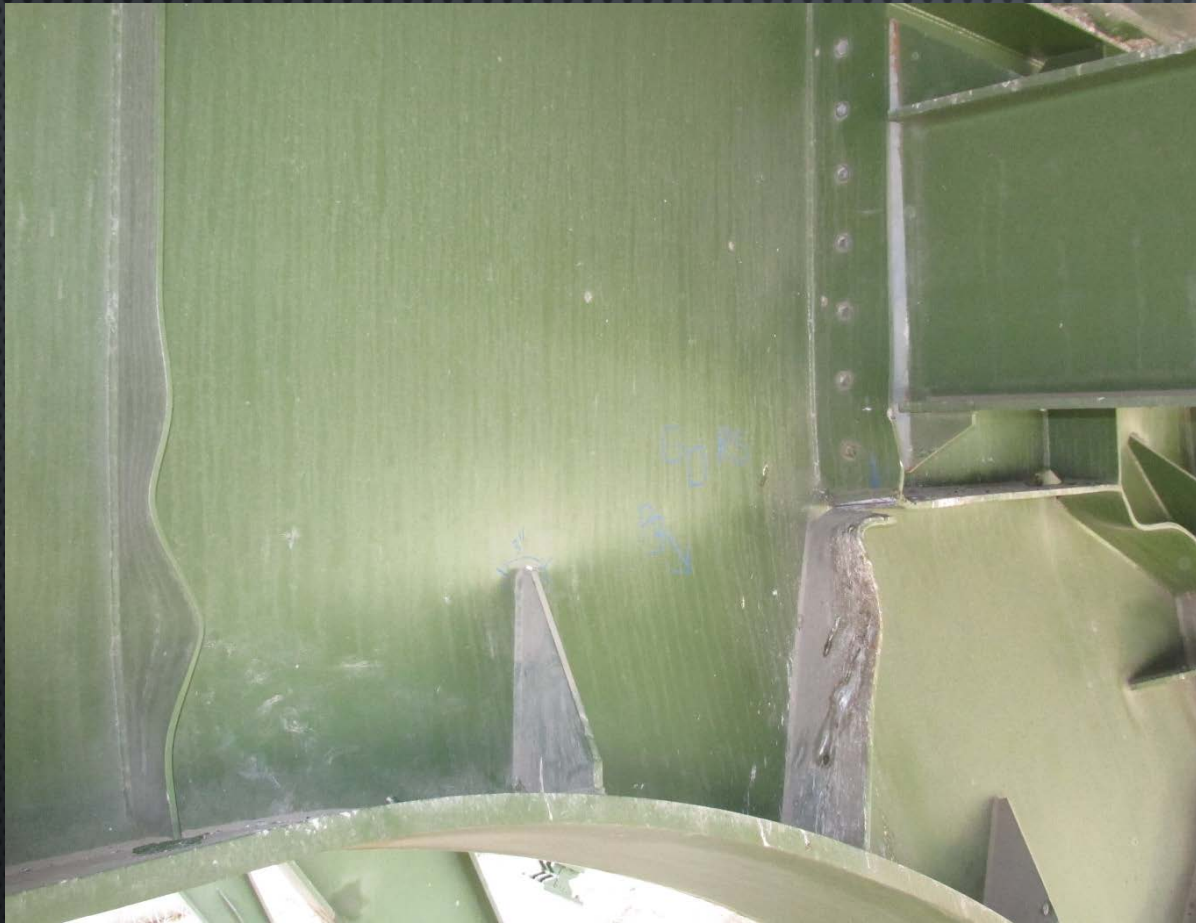
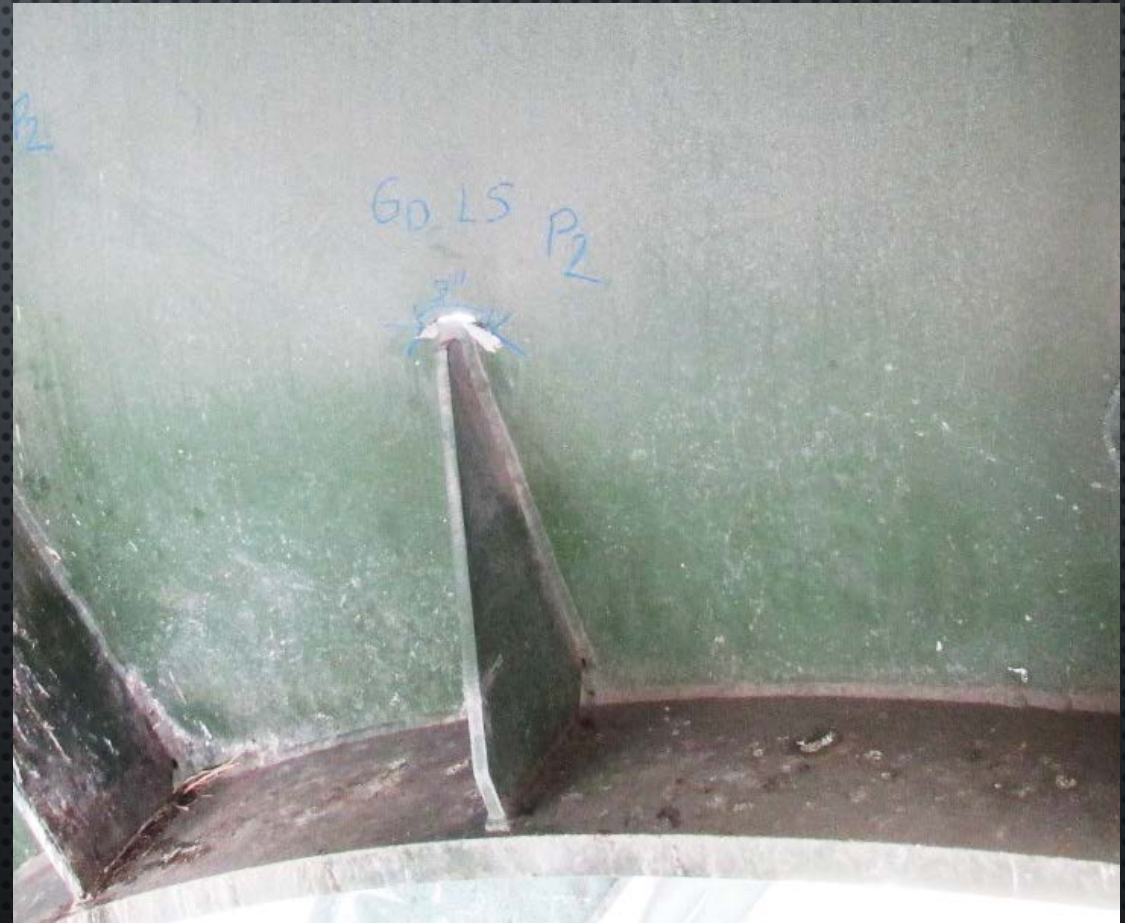
BRIDGE DAMAGE

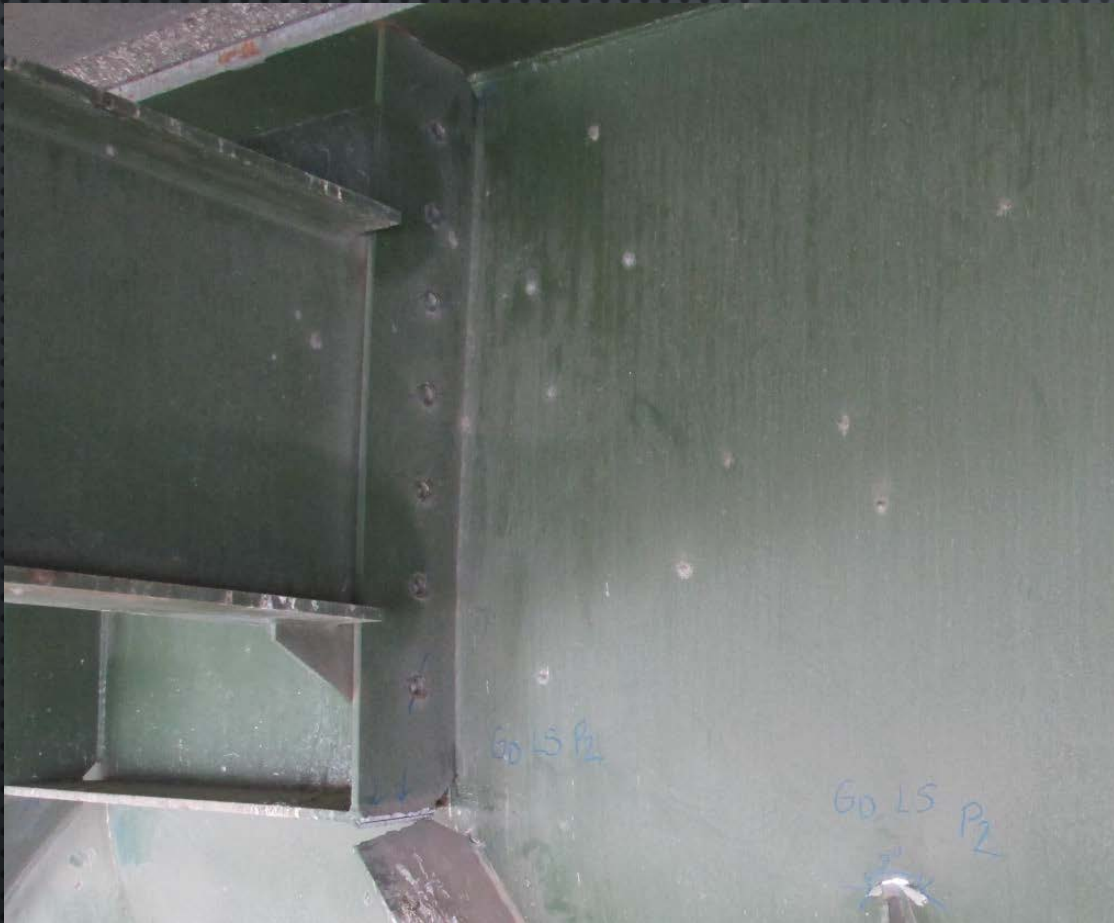
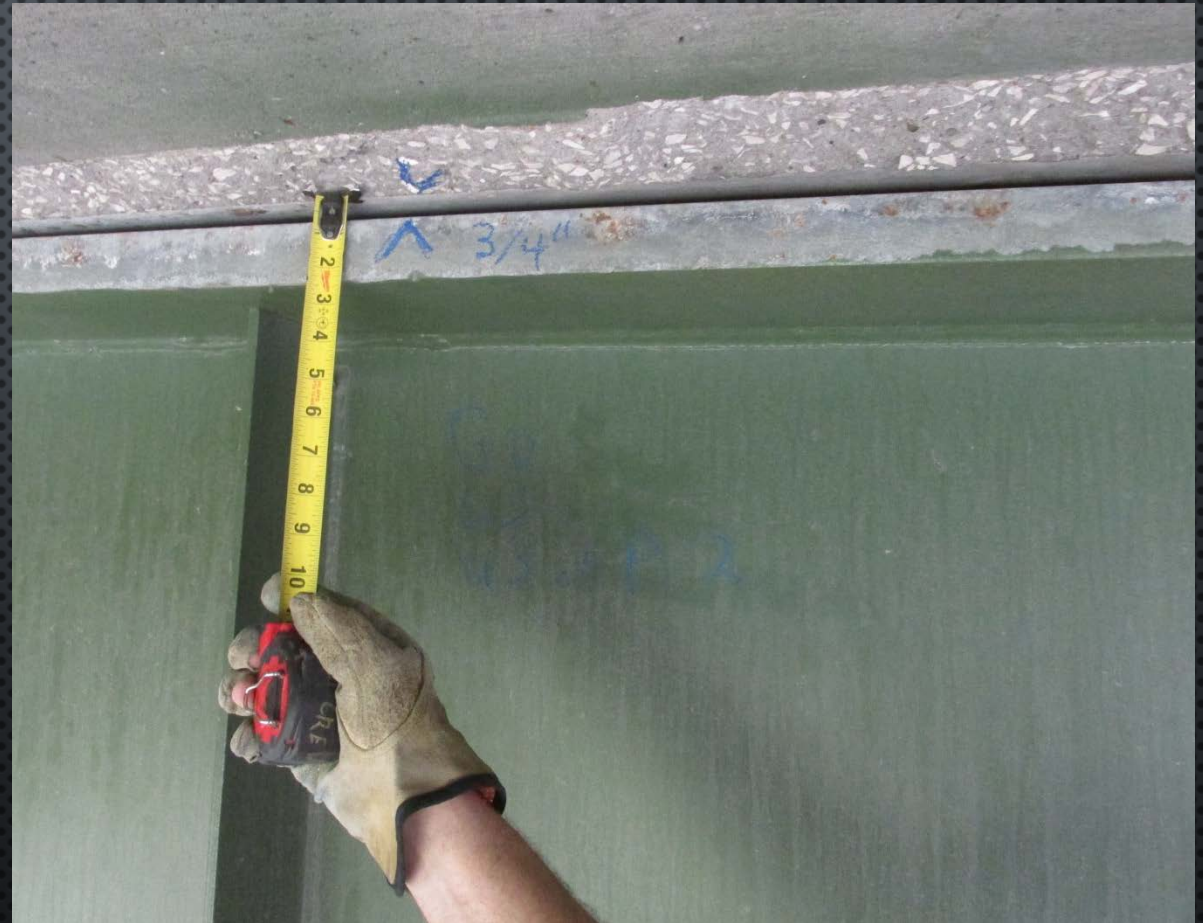
BRIDGE DAMAGE

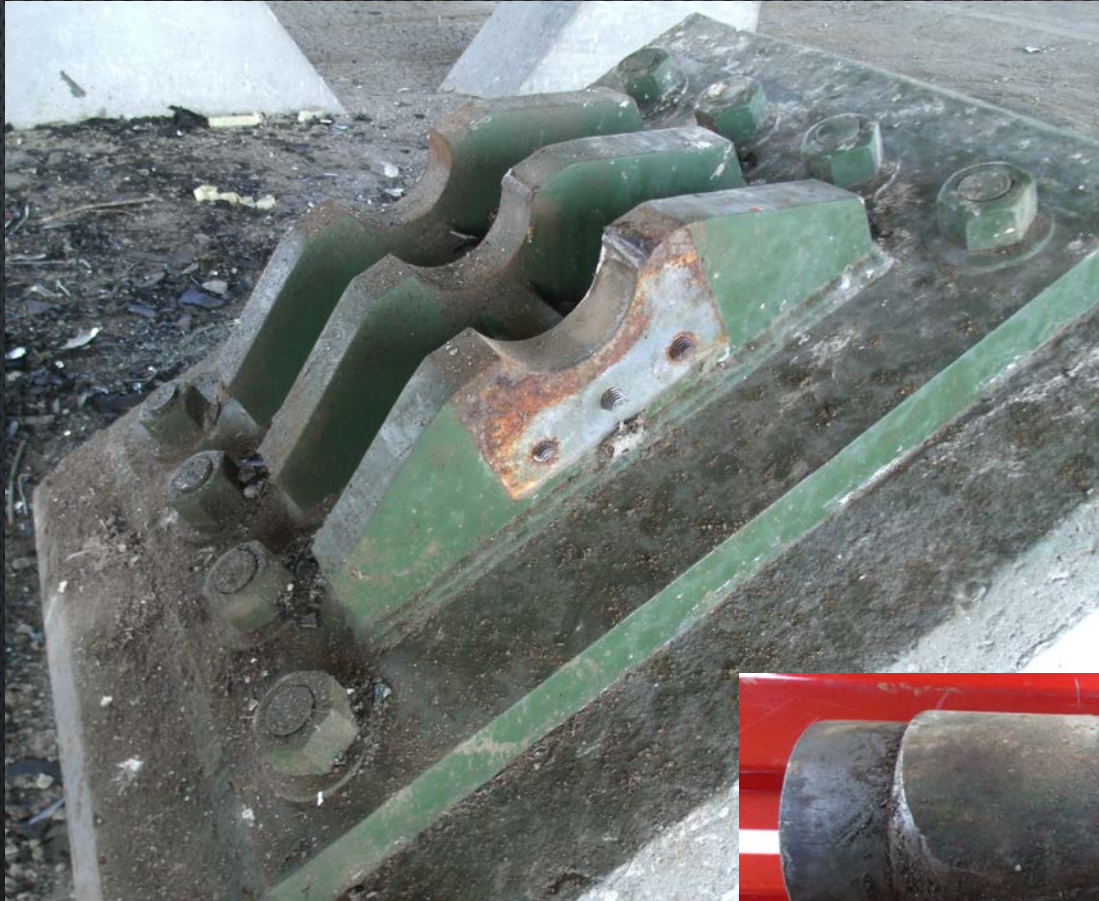
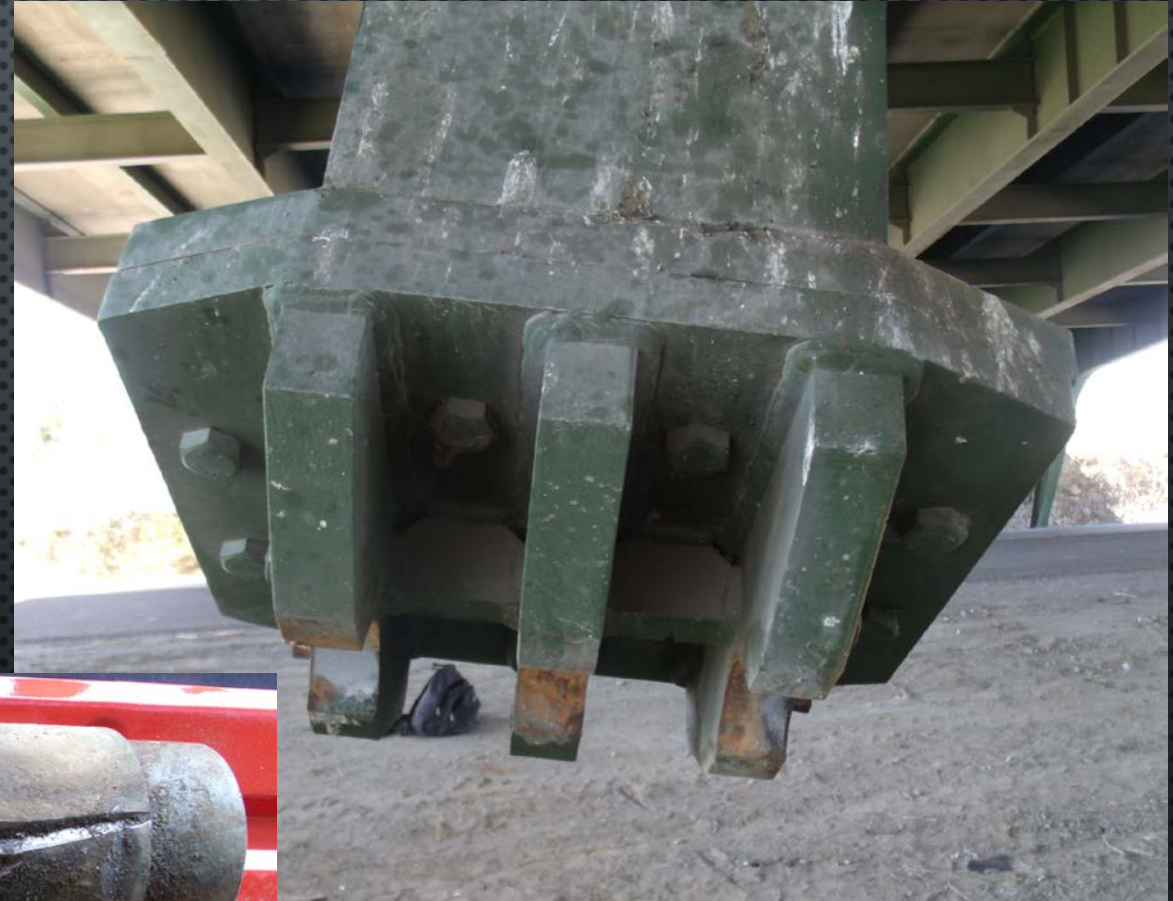
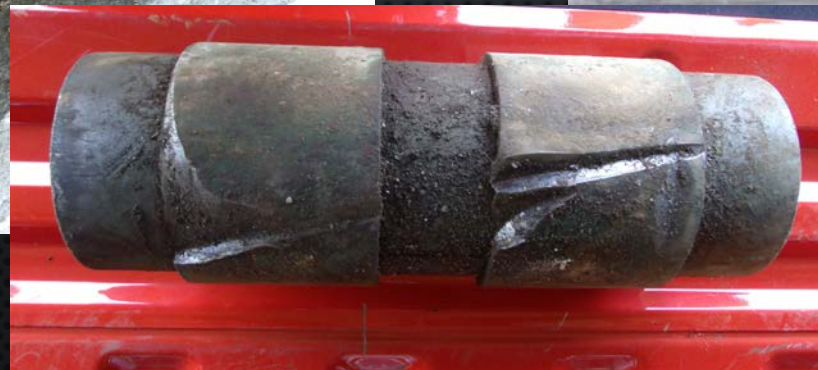
BRIDGE DAMAGE

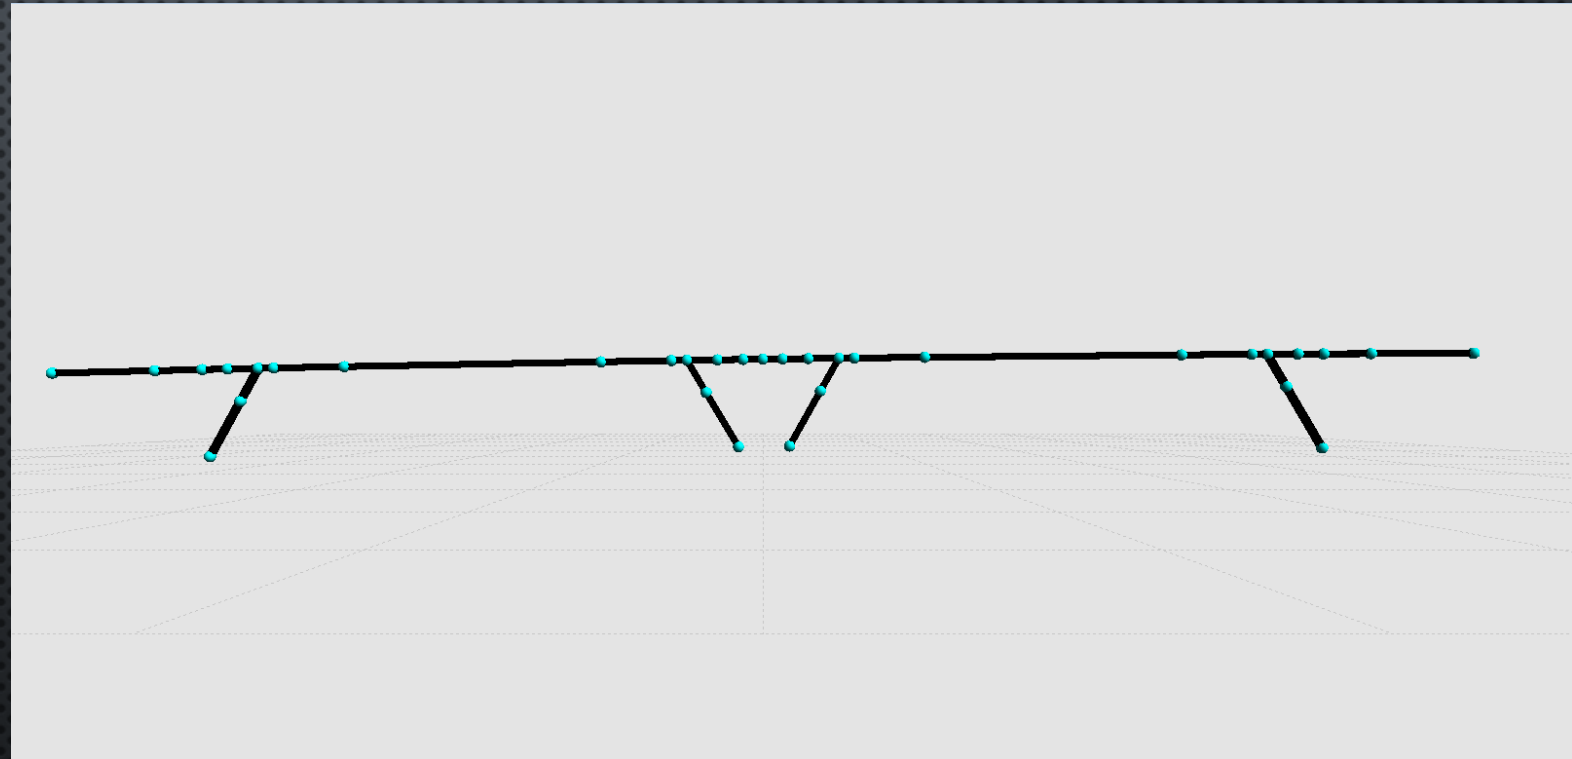
BRIDGE ANALYSIS

- 2-D FRAME MODEL
- STEEL MEMBERS ONLY
- ANALYSIS USED TO DETERMINE JACKING LOAD REQUIRED TO RE-LOAD THE DAMAGED LEG

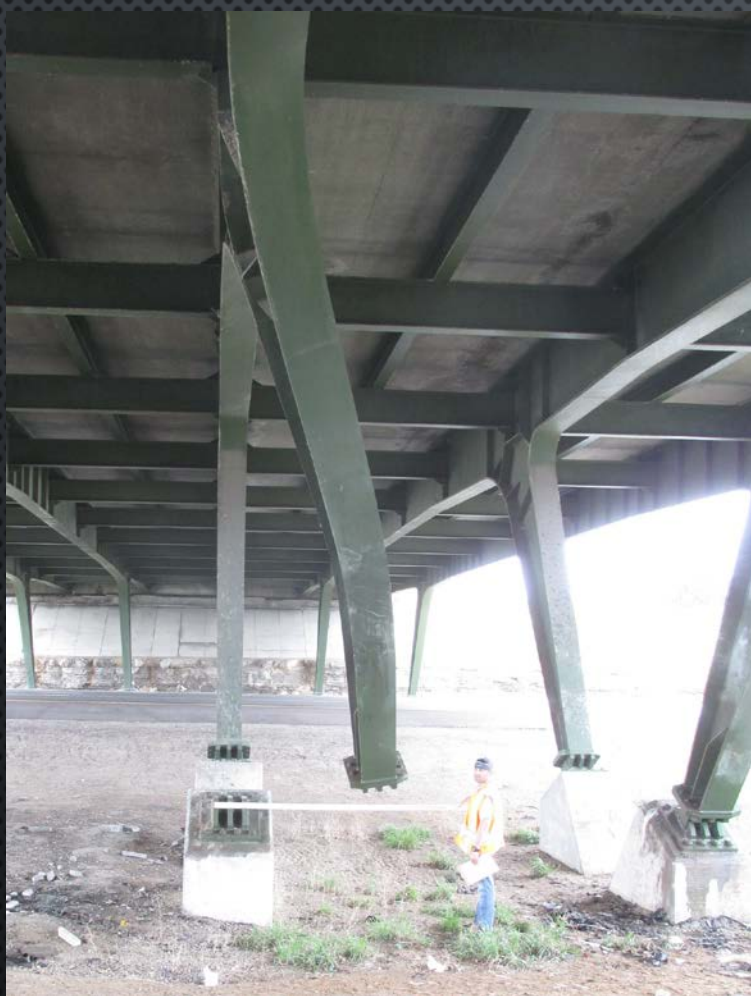
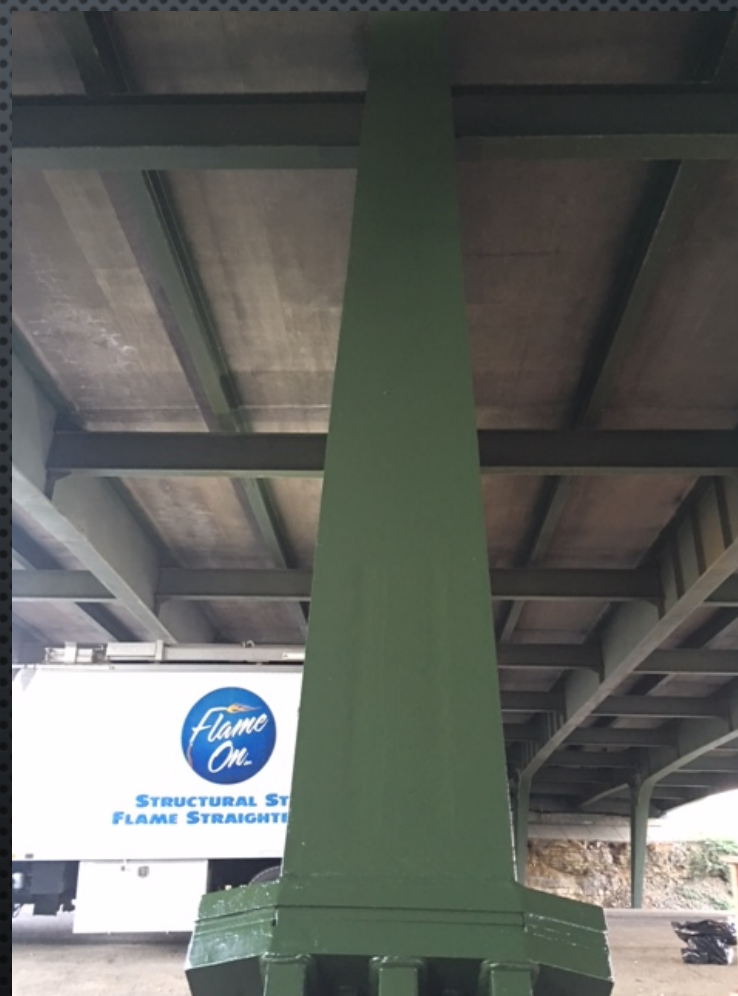
BEFORE AND AFTER
