T Terracon Consultants, Inc.
CANEY FORK RIVER BRIDGE

THERMAL INTEGRITY PROFILING

AS DIAGNOSTIC TOOL

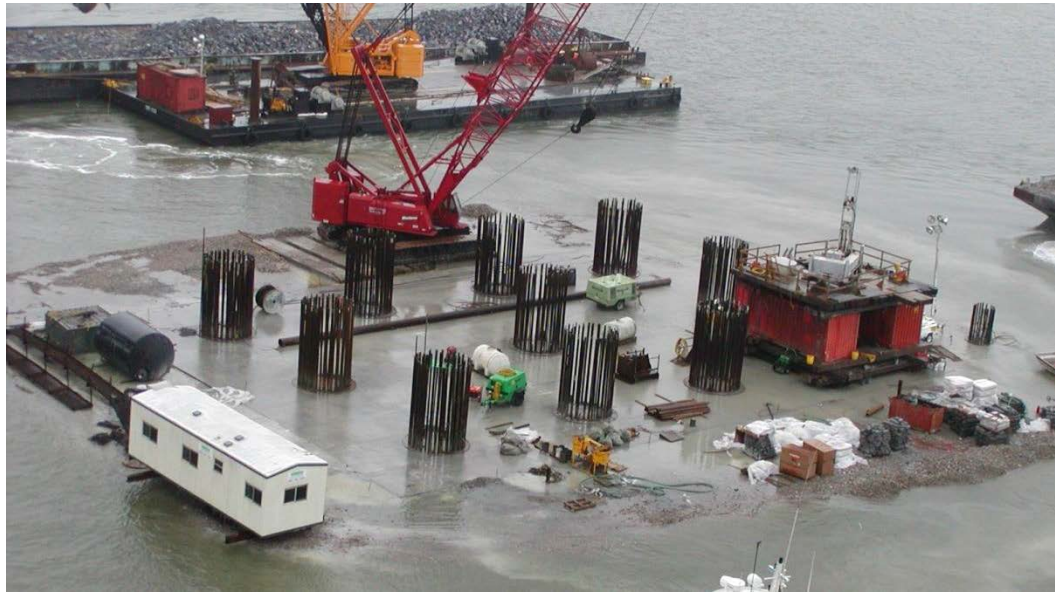
West Tower Drilled Shaft Foundations
Arthur Ravenel Jr. Bridge, Charleston SC

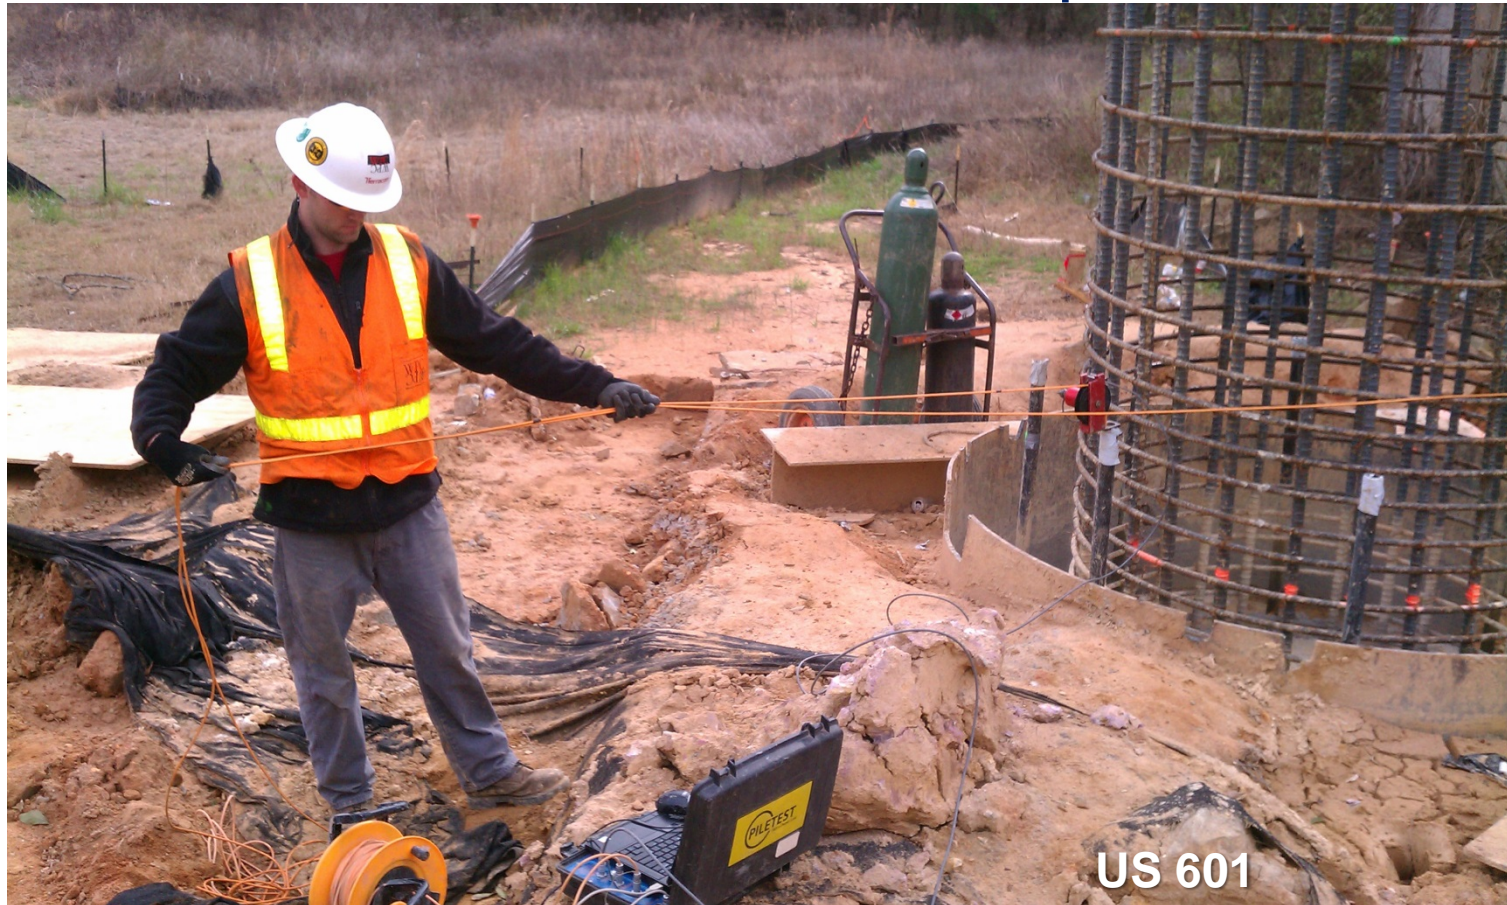
CSL ANALYSIS

FAT = First Arrival Time

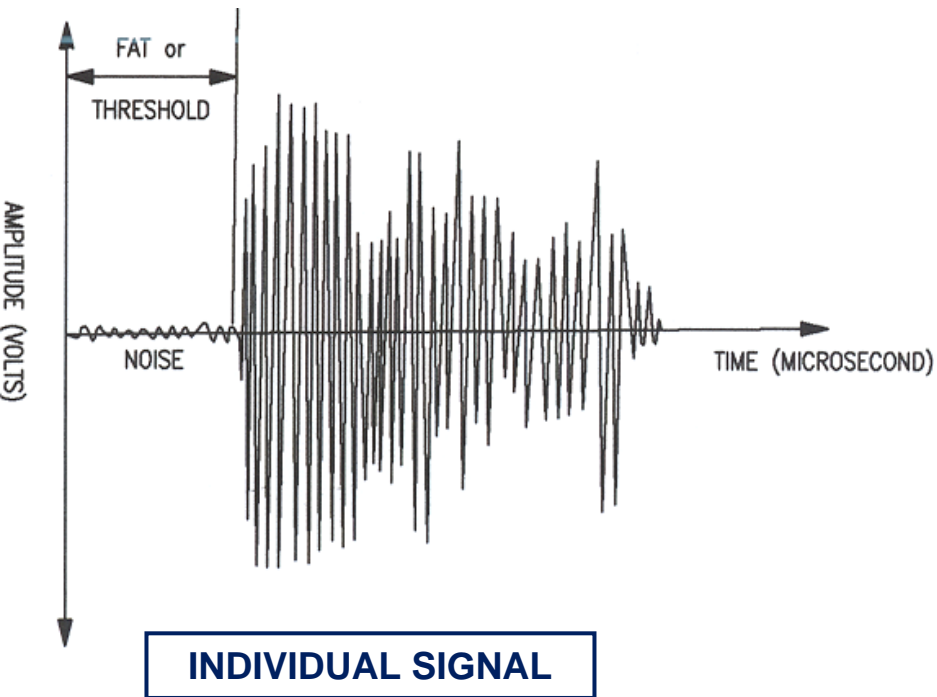
WHAT AFFECTS SIGNAL?

- Low density concrete
- Voids
- Soil Intrusions

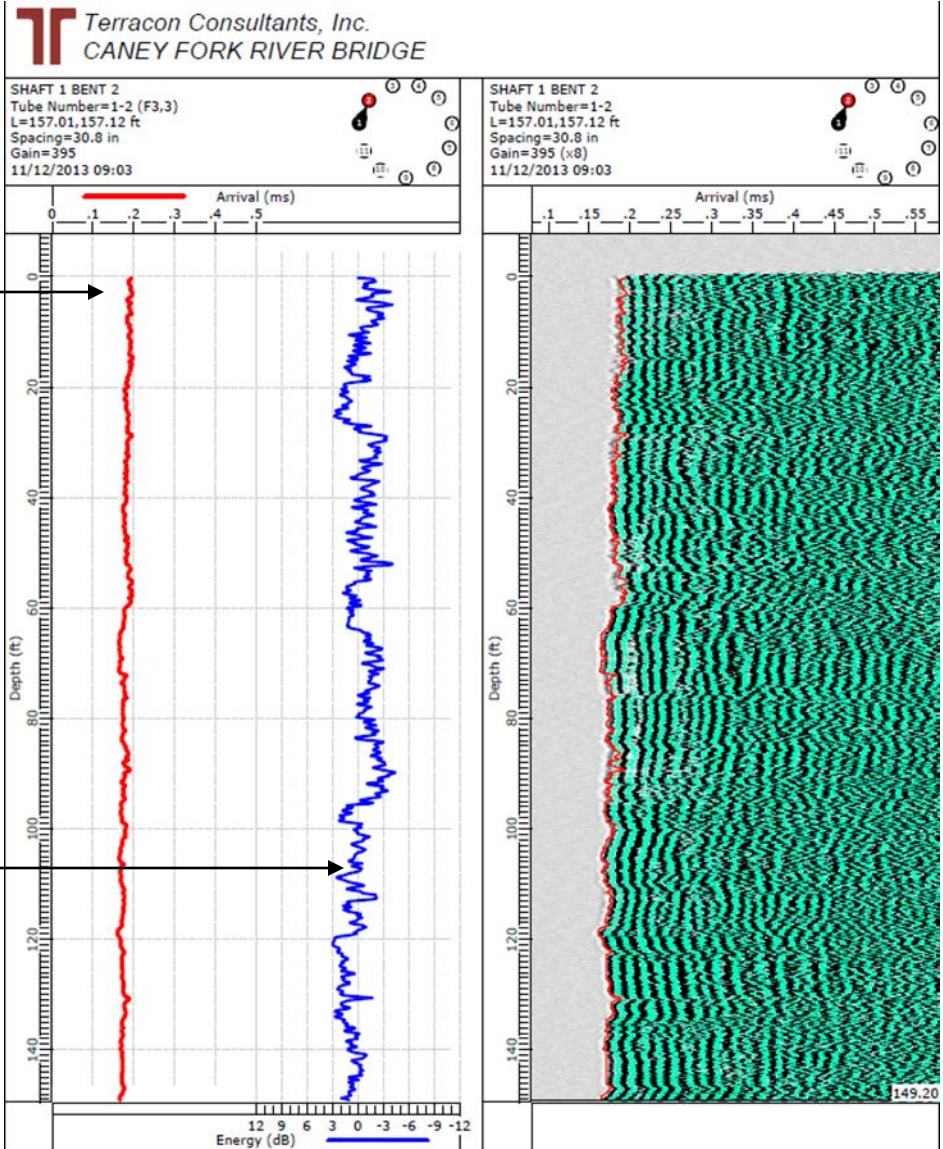
Arrival Time

Energy

Waterfall

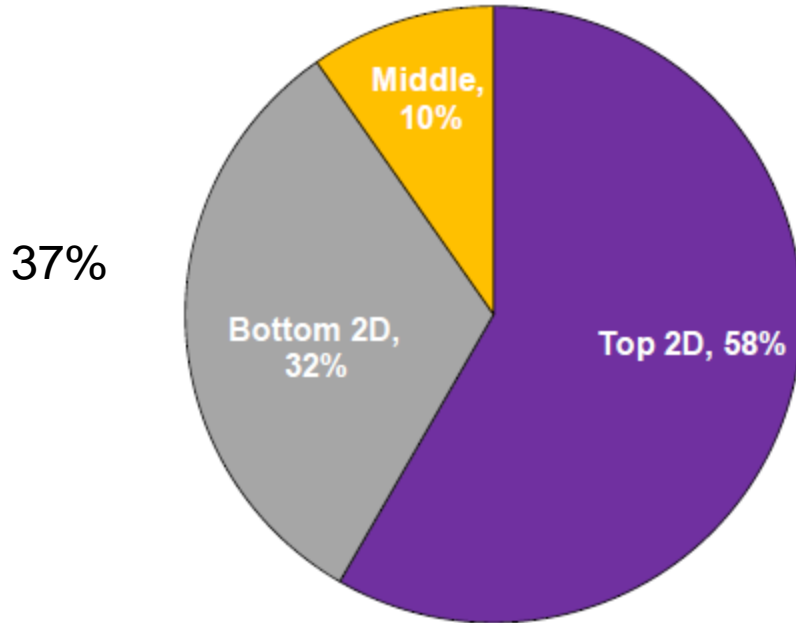
Bill Camp, S&ME Inc
“CSL of SC Drilled Shafts:
A Ten Year Summary”
ADSC Expo 2012,
San Antonio, March 2012

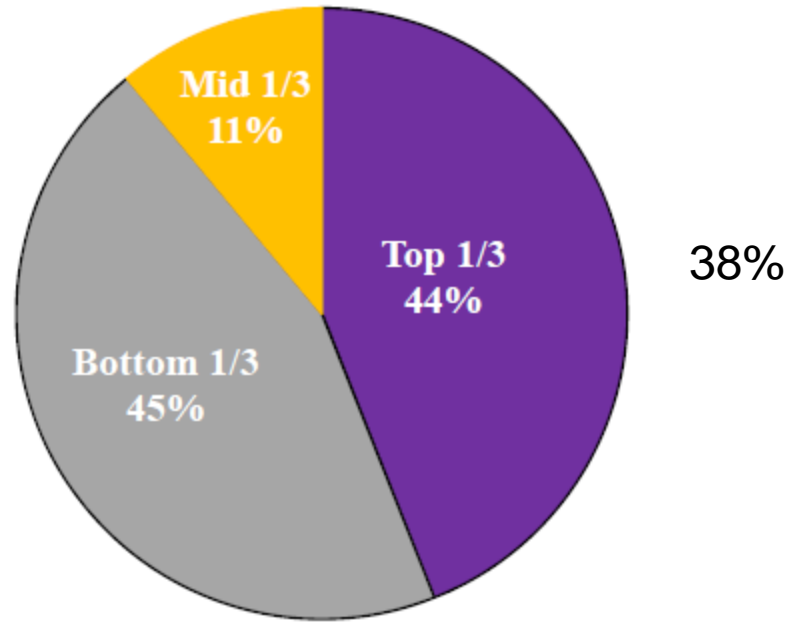
Jones & Wu, Geotechnology, Inc
“Experiences with CSL and Concrete
Coring for Verification of Drilled Shaft
Integrity”
ADSC GEO3
Construction QA/QC Technical Conference,
Dallas November 2005

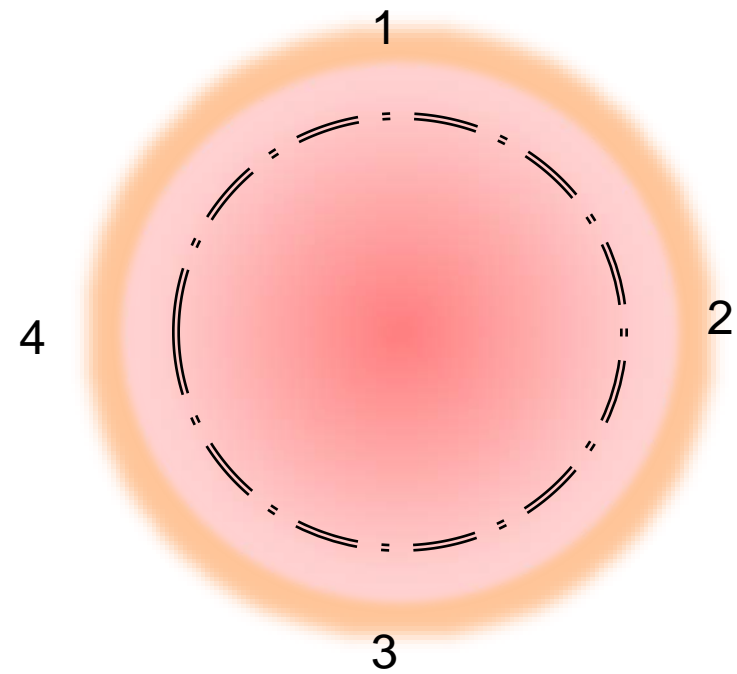
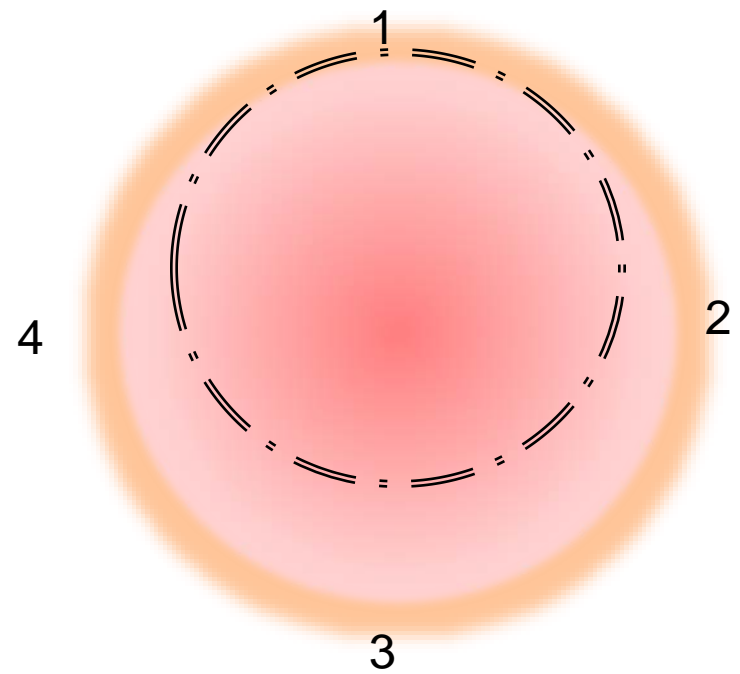
CAGE SHIFT

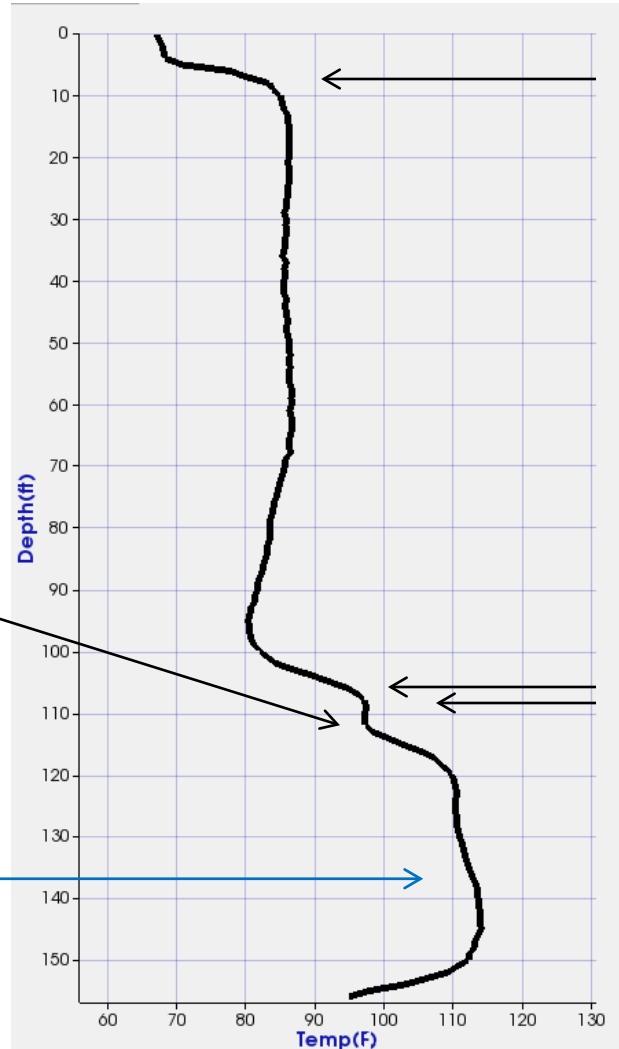
Top of river &
Top of shaft

Bottom of river

Shaley Limestone

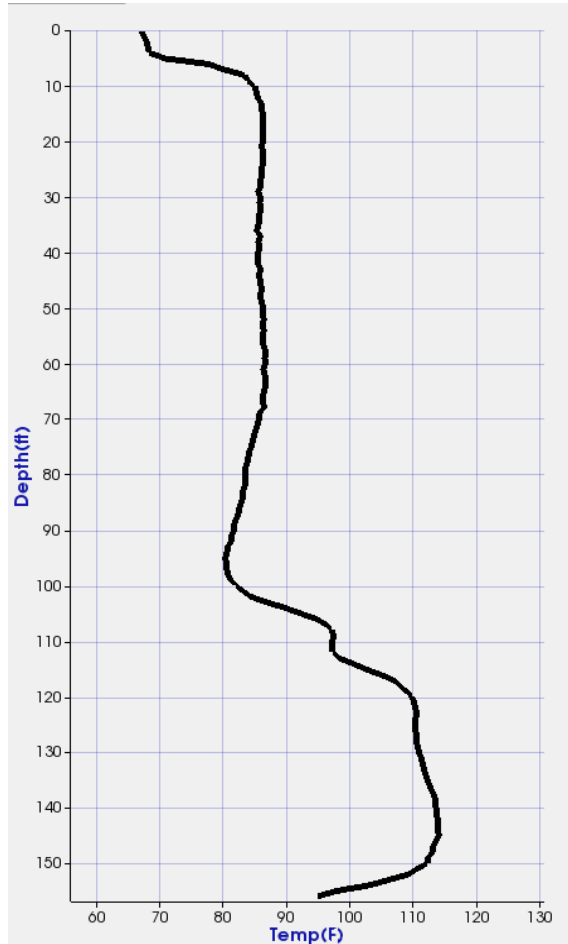
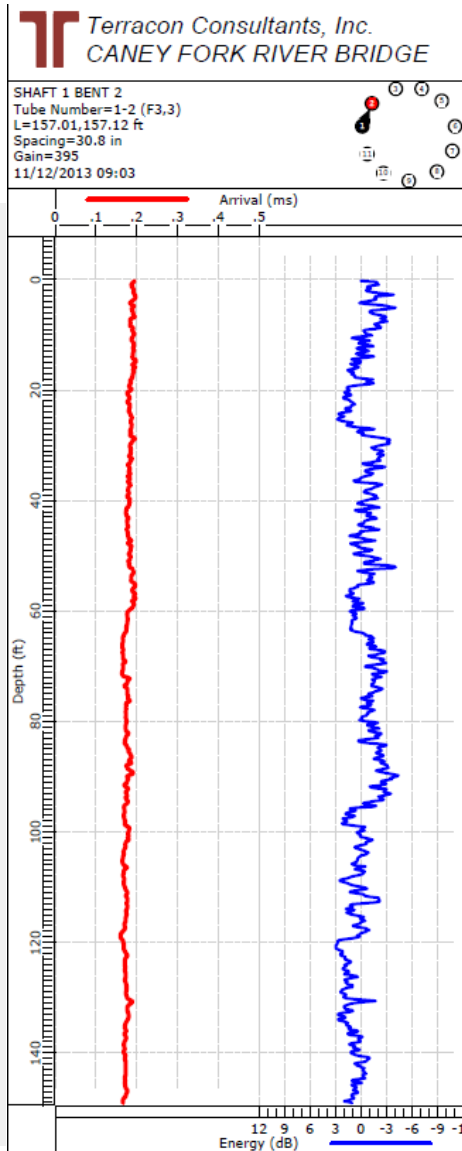
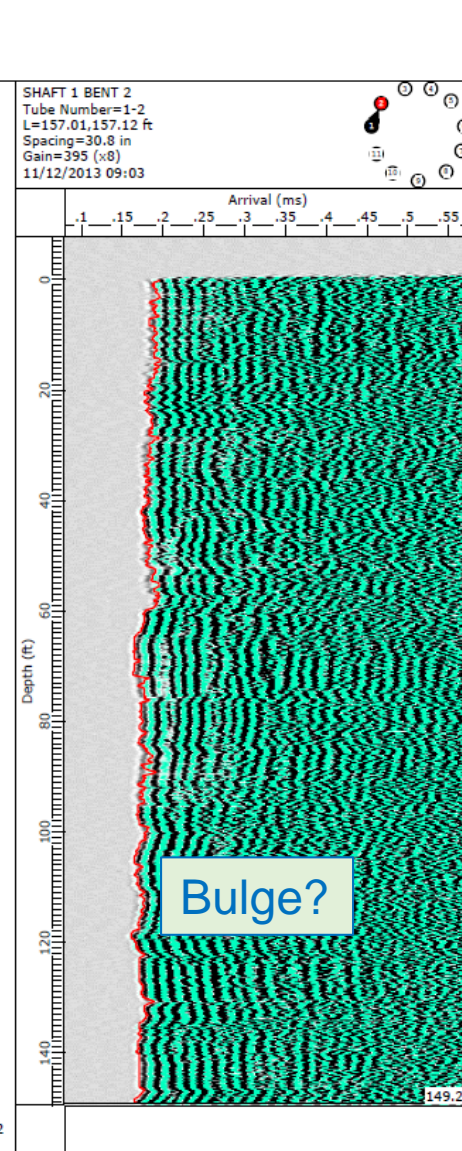
CSL Vs THERMAL

Can evaluate bulges for
increased capacity

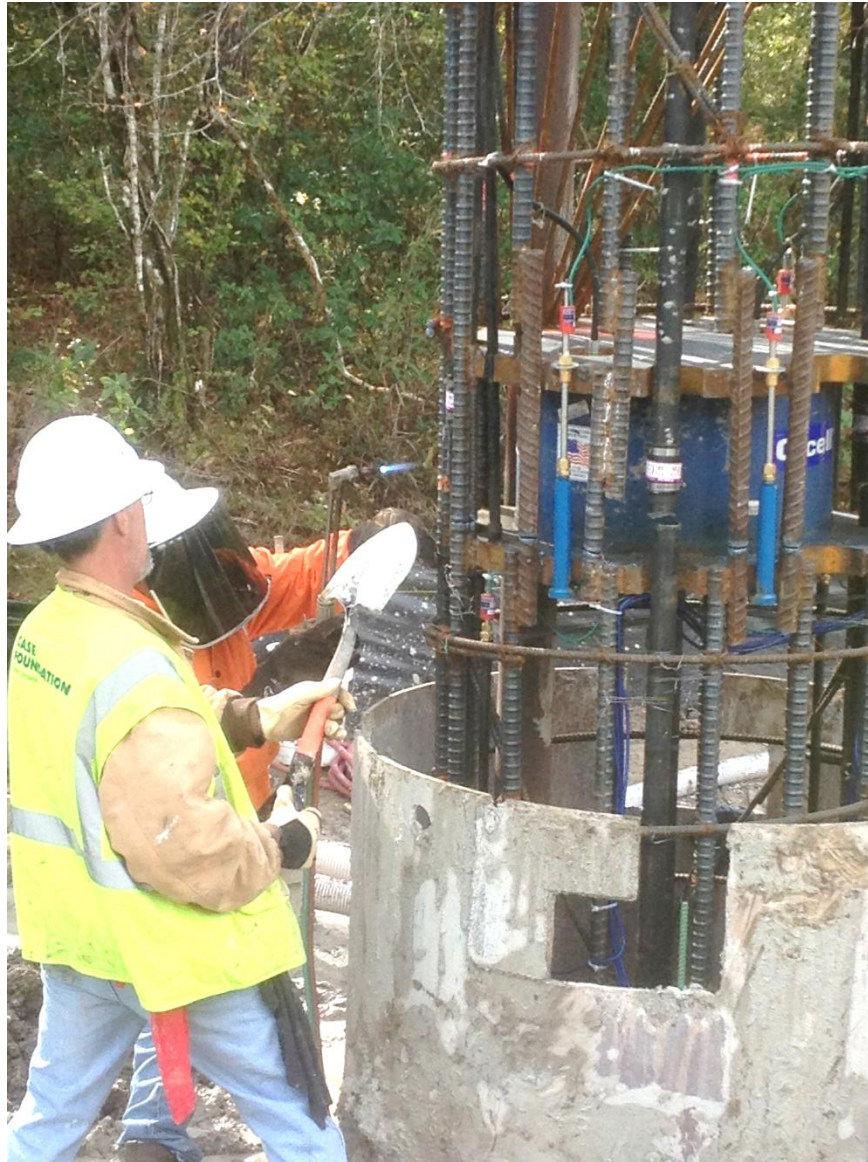
← ANOMALY

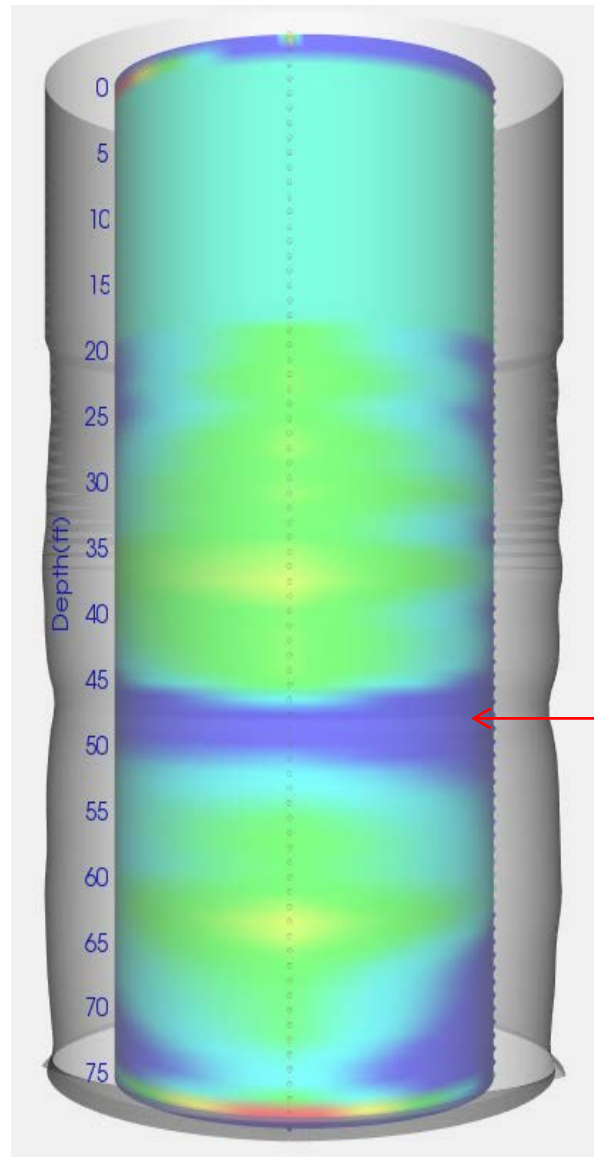
THERMAL MODEL OF SHAFT

Osterberg Cell

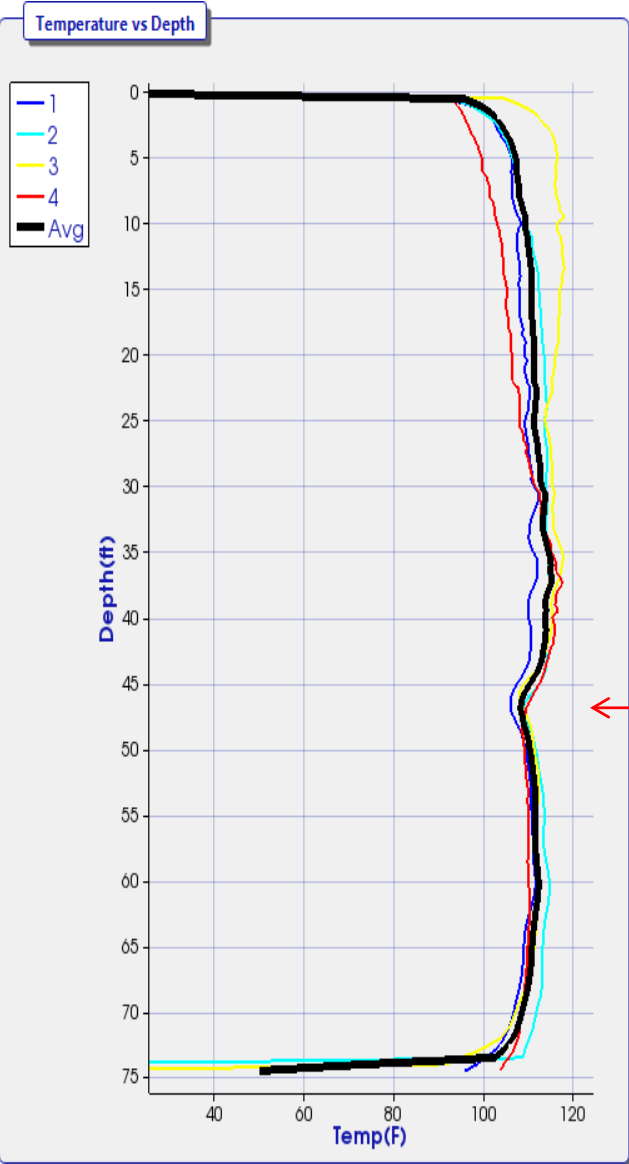
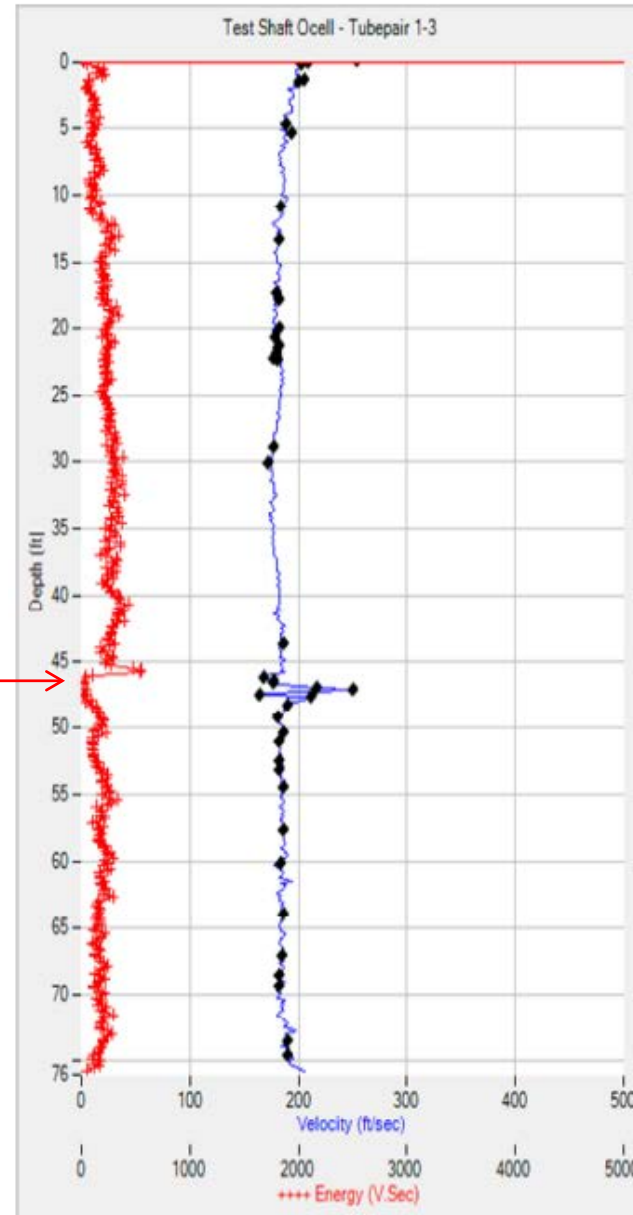
CSL vs THERMAL

Shaft Name - Test Shaft Ocell
Test Date - 1/13/2013
Tube Spacing - 30
Tubepair Depth - 75.71 ft
Gain - 500

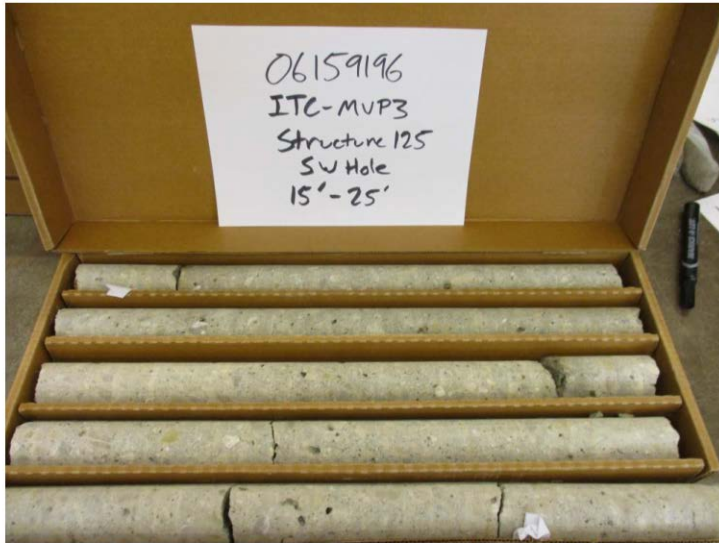
Structure 125 – Southwest Core. Concrete cores from 15 to 25 feet.

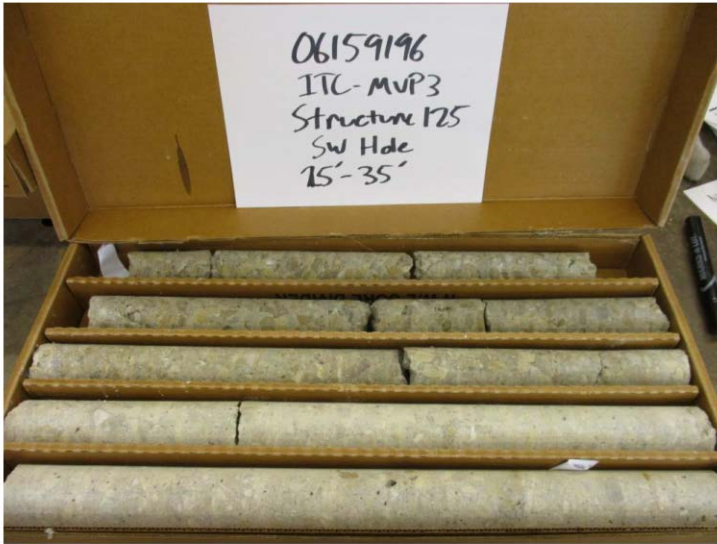
Structure 125 – Southwest Core. Concrete cores from 25 to 35 feet.

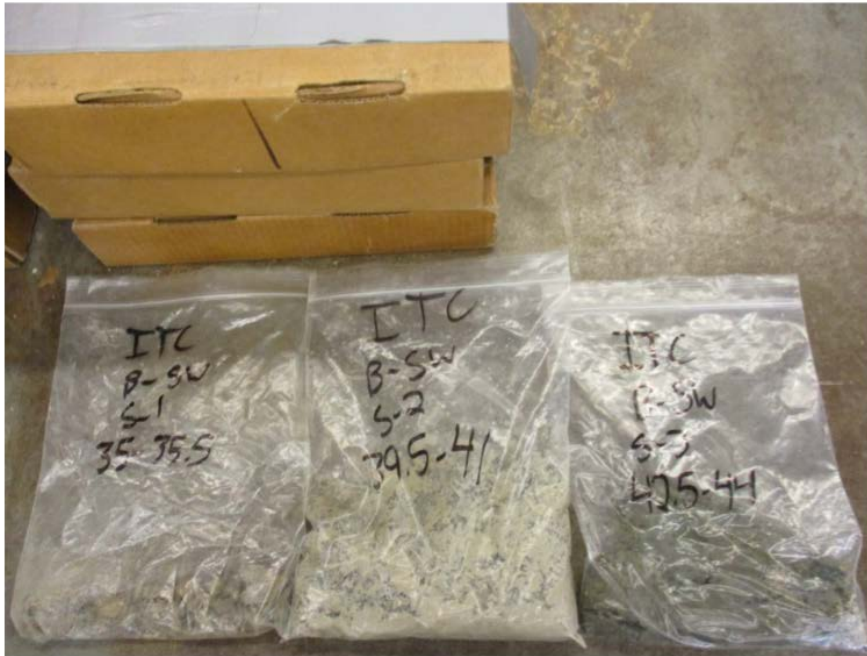
Structure 125 – Southwest Core. Concrete cores from 35 to 44 feet.
