# THE OLD CHAIN OF ROCKS BRIDGE INSPECTION & LOAD RATING

**TOM LOHMAN, PE, SE**  
**HORNER & SHIFRIN**  
**MARCH 8, 2018**

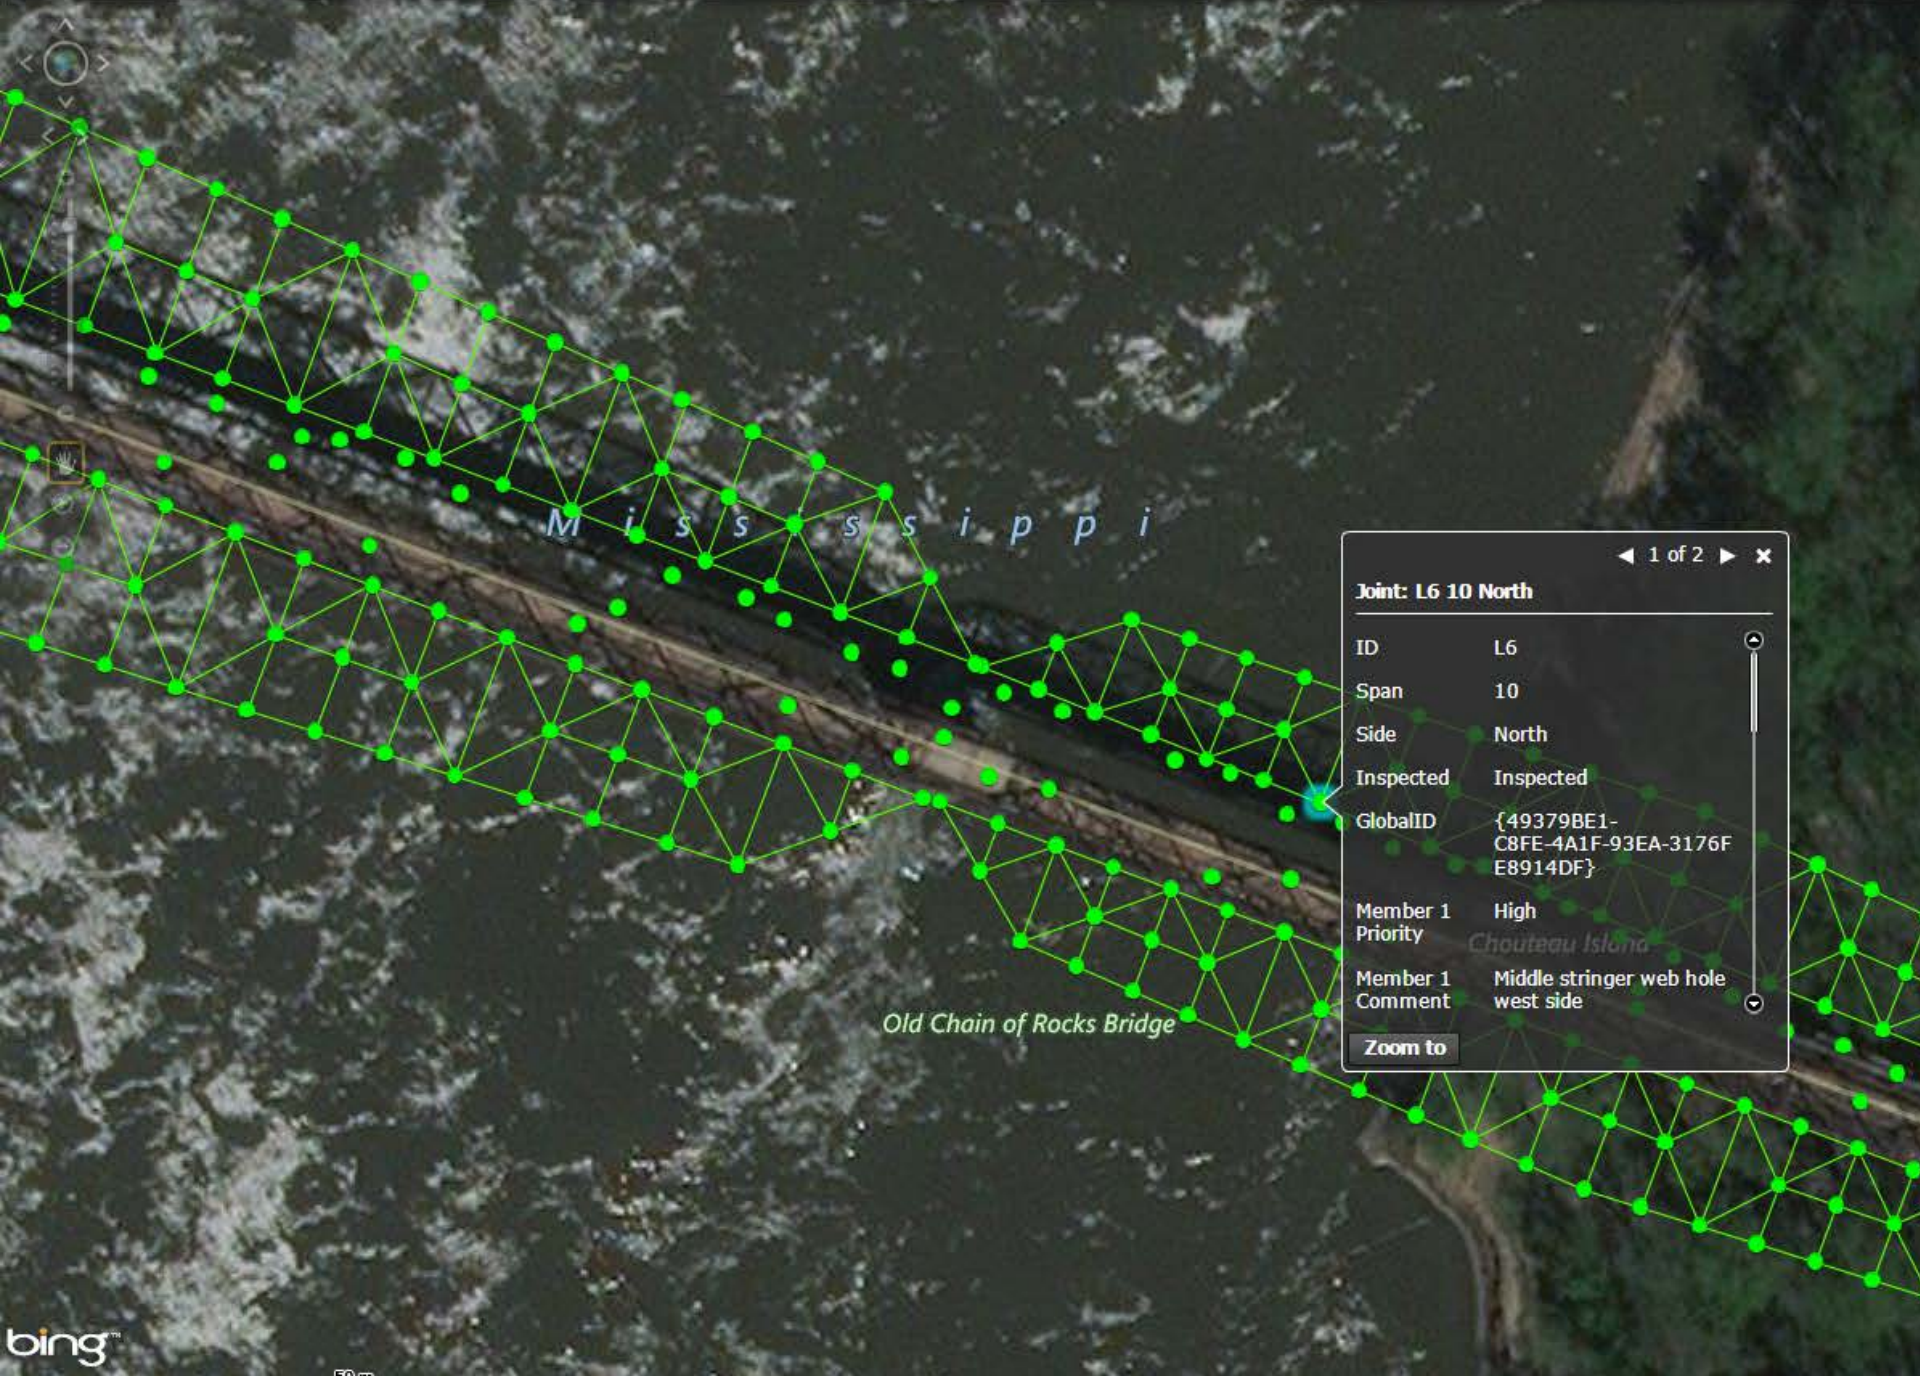
**Joint: L6 10 North**

ID	L6
Span	10
Side	North
Inspected	Inspected
GlobalID	{49379BE1-C8FE-4A1F-93EA-3176FE8914DF}
Member 1 Priority	High
Member 1 Comment	Middle stringer web hole west side

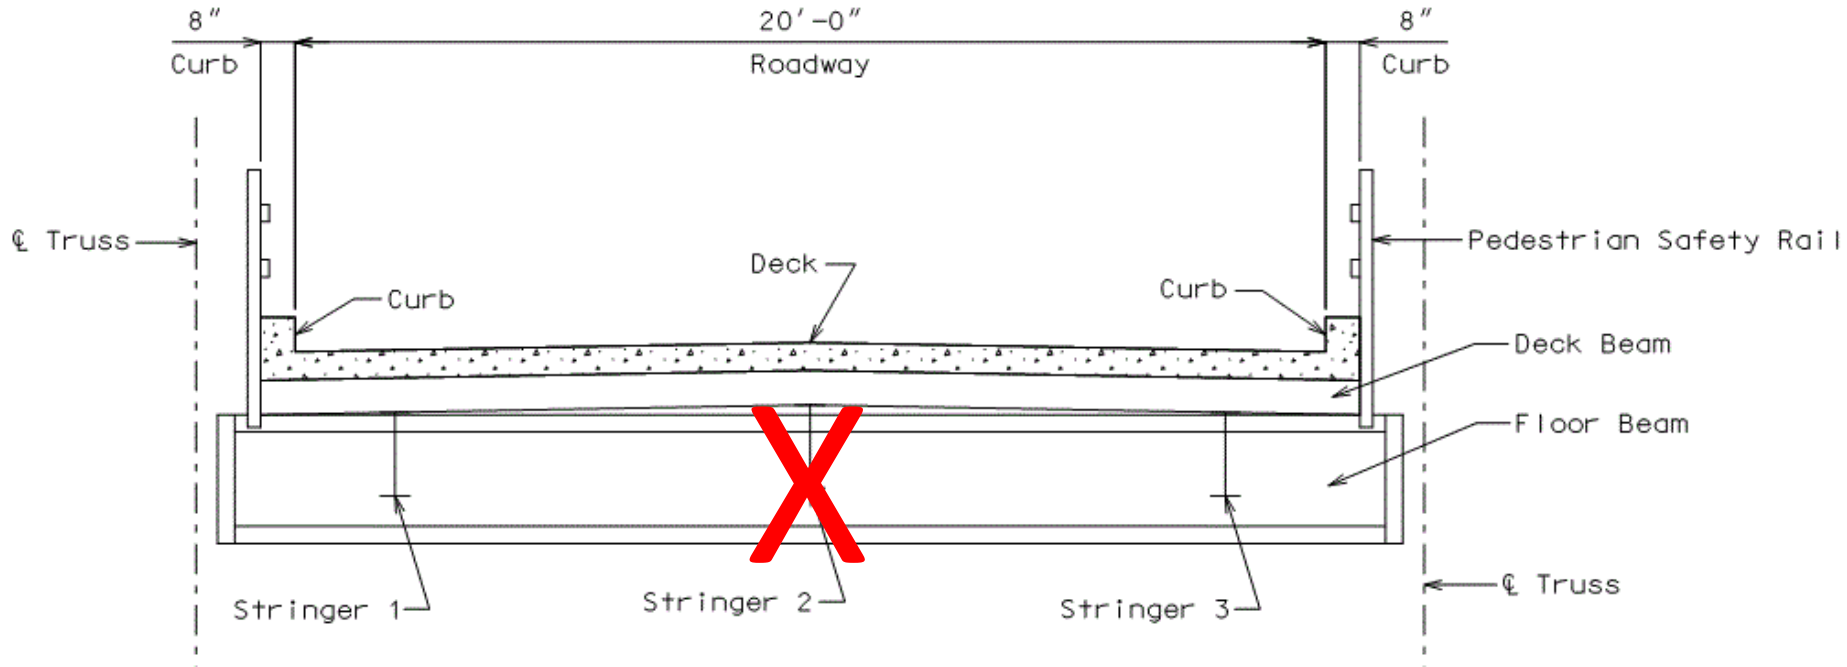
TYPICAL CROSS SECTION

- **As-found = 7500 pound personal vehicle**
- **After repairs = nearly H20 at 15 mph**
- **Pedestrian = 750 people/span after repairs**
