Inspection and Non-Destructive Testing and Load Rating of Hernando De Soto Bridge

2023 TEAM Conference,
Branson, MO
March 16th, 2023

Hernando De Soto Bridge-Main Span Unit

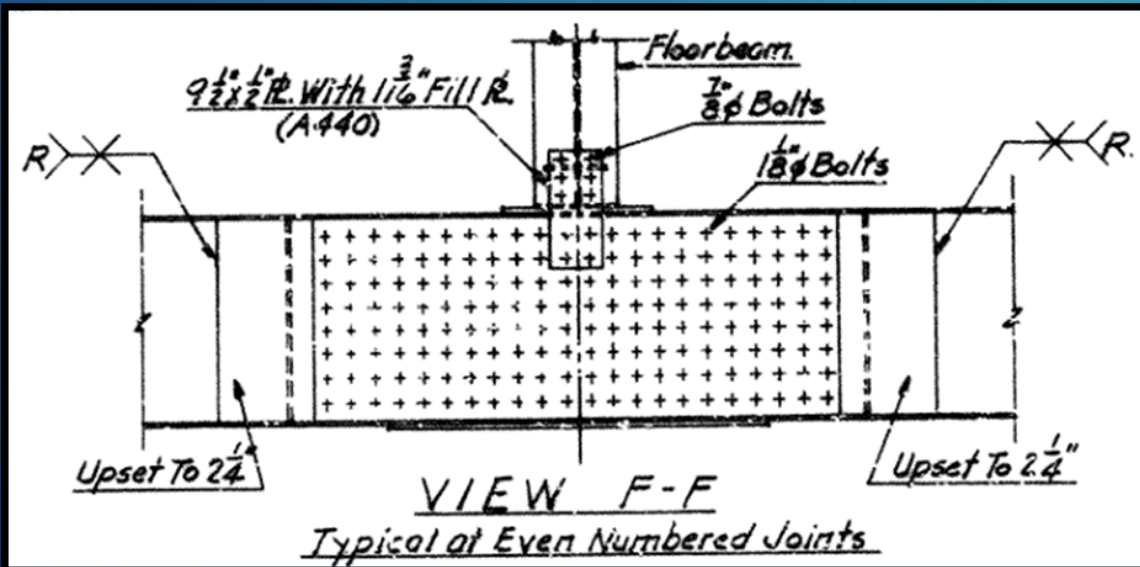
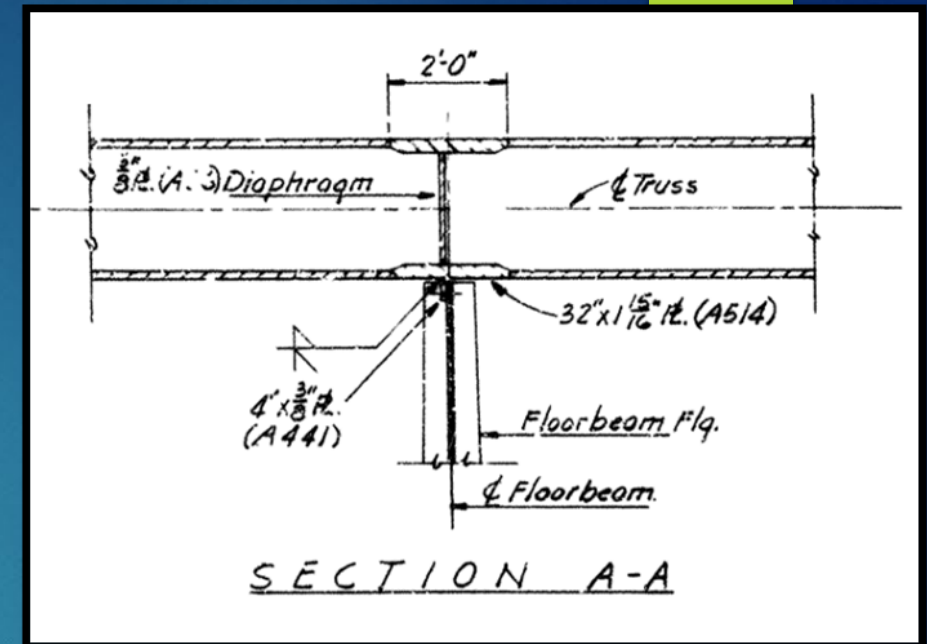
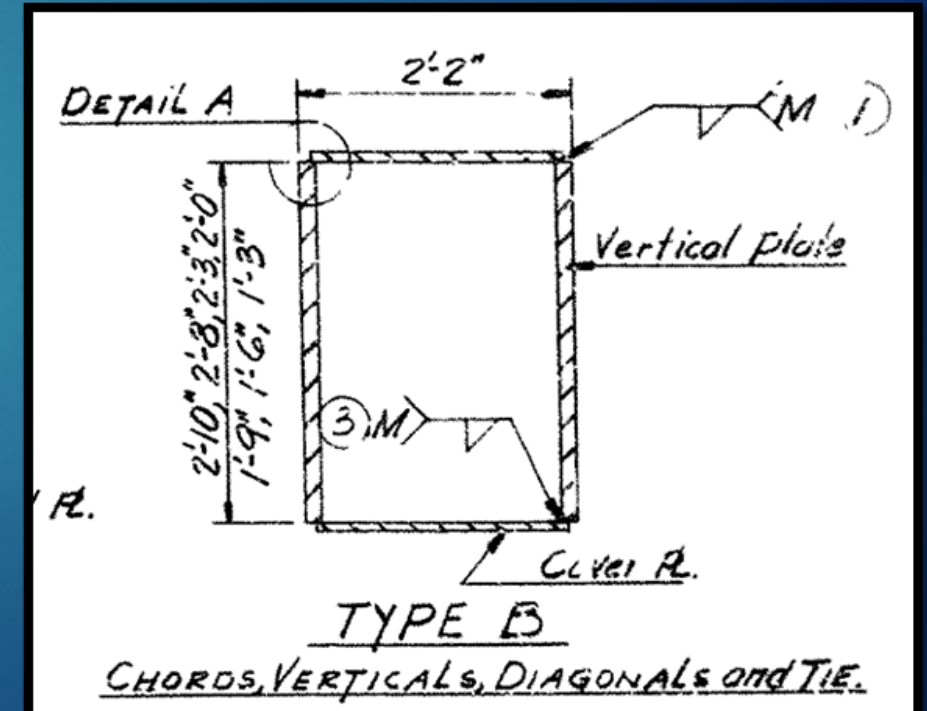
Tie Girder Details

- ▶ Welded built-up box
 - Full penetration butt welds at web transitions
 - Fillet Welds in corners
- ▶ 32" x 26" box with 1/2" top cover plates and 1-3/8" web plates
- ▶ Thickened to 1-15/16" and 2-1/4"

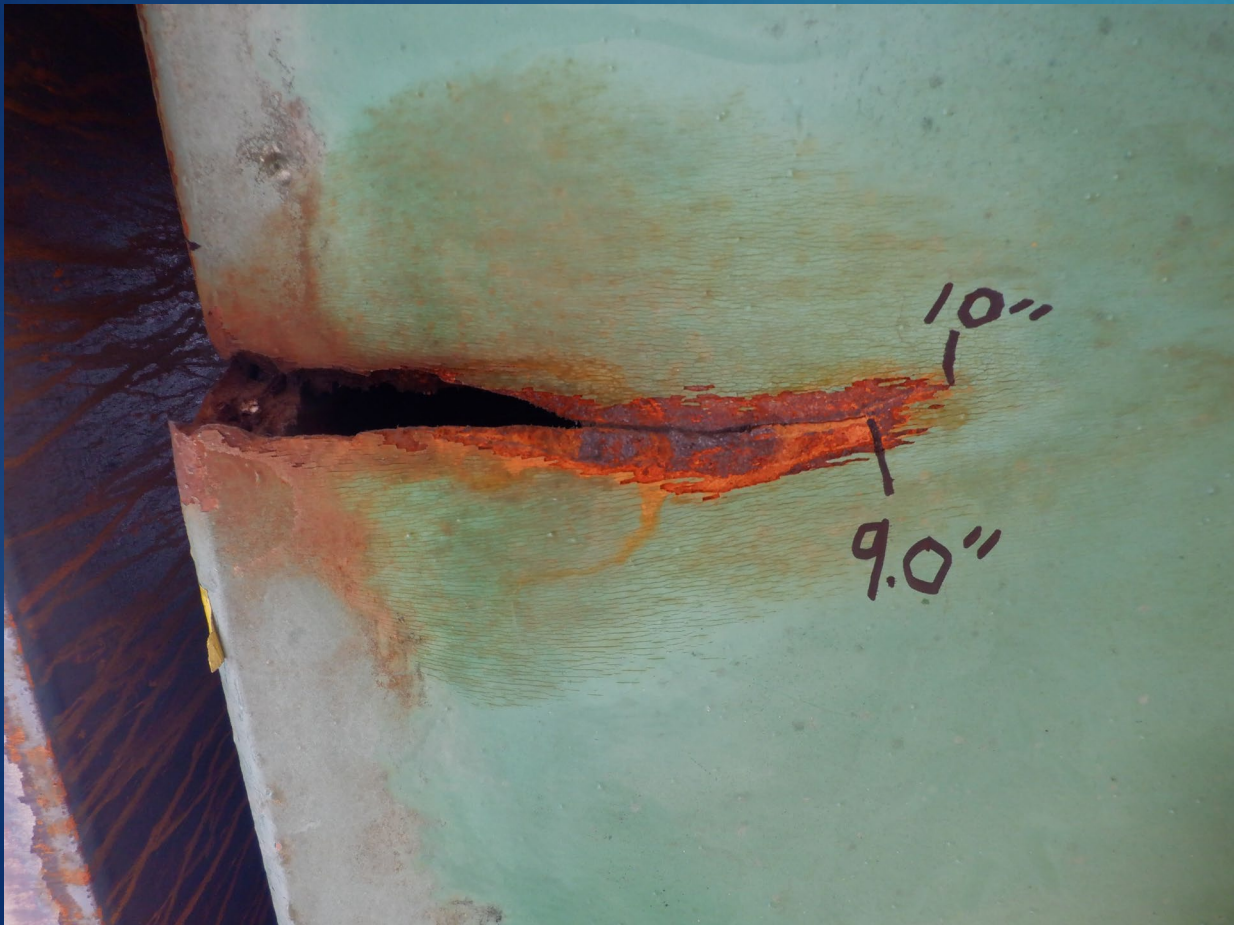
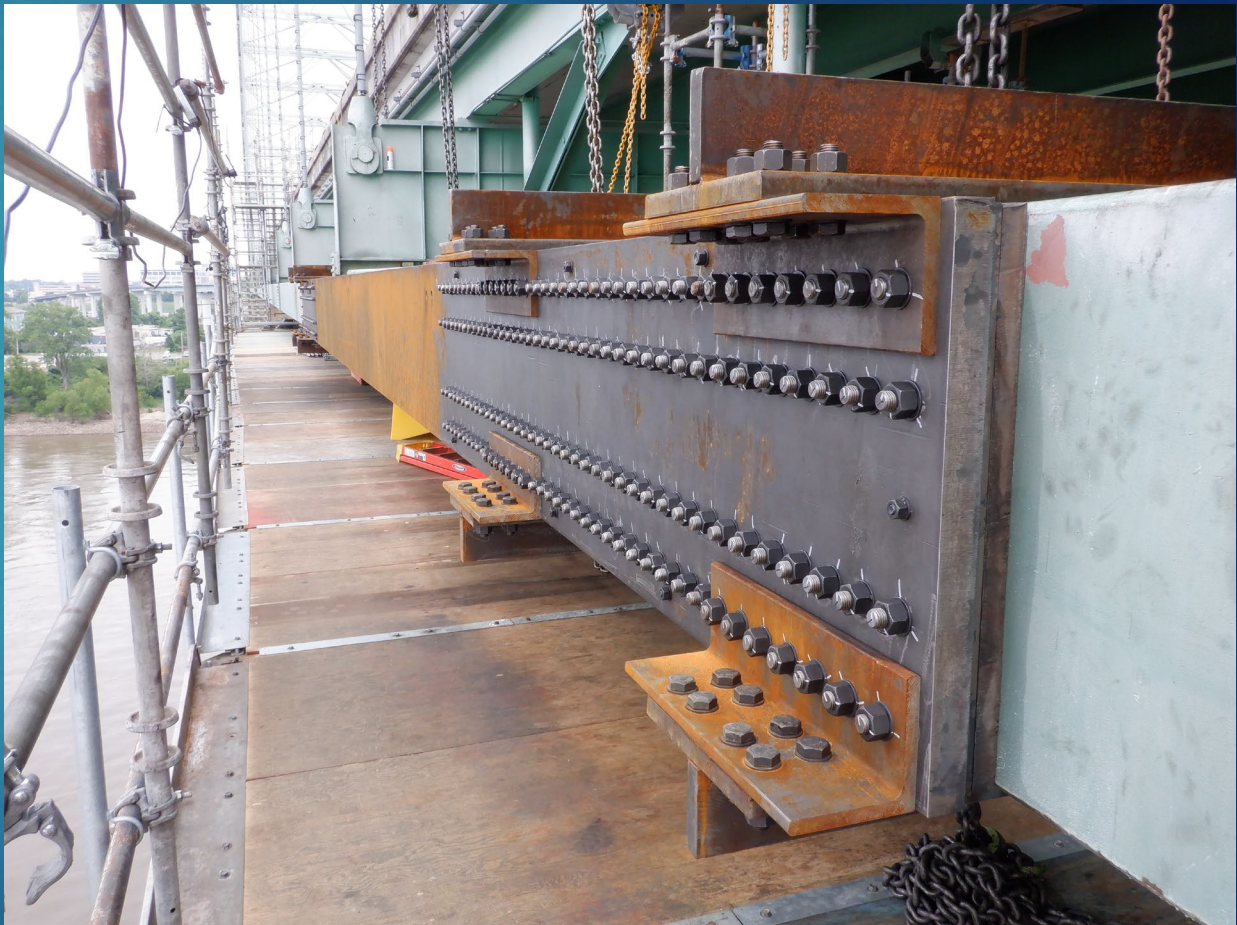
The Fracture

- ▶ Estimated Stress in Tie Girder After Fracture
 - DL = 87 ksi
 - DL + LL = 95 ksi (95% of Yield Strength of Steel)

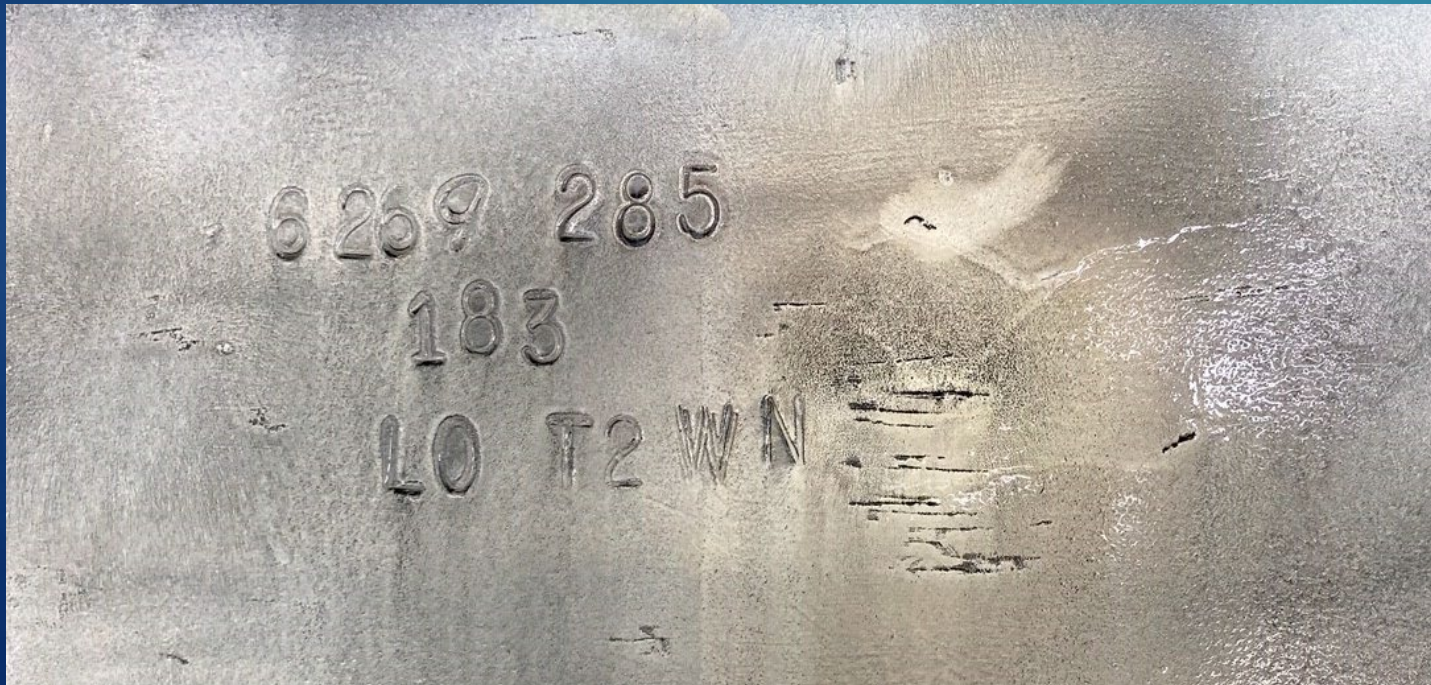
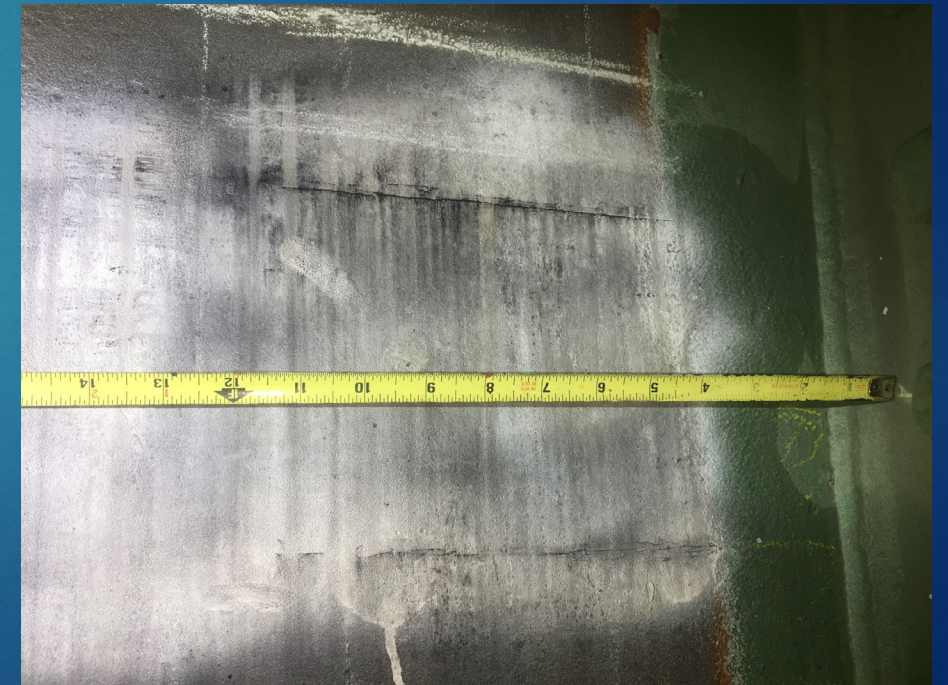
Eddy Current

- ▶ Scanned all 484 welds
- ▶ Three passes to cover Heat Affected Zone
- ▶ No paint removal required
- ▶ Findings confirmed with Magnetic Particle Testing (MPT)
- ▶ Discovered indications 0.05" deep and shallower-Even piece mark stamps!

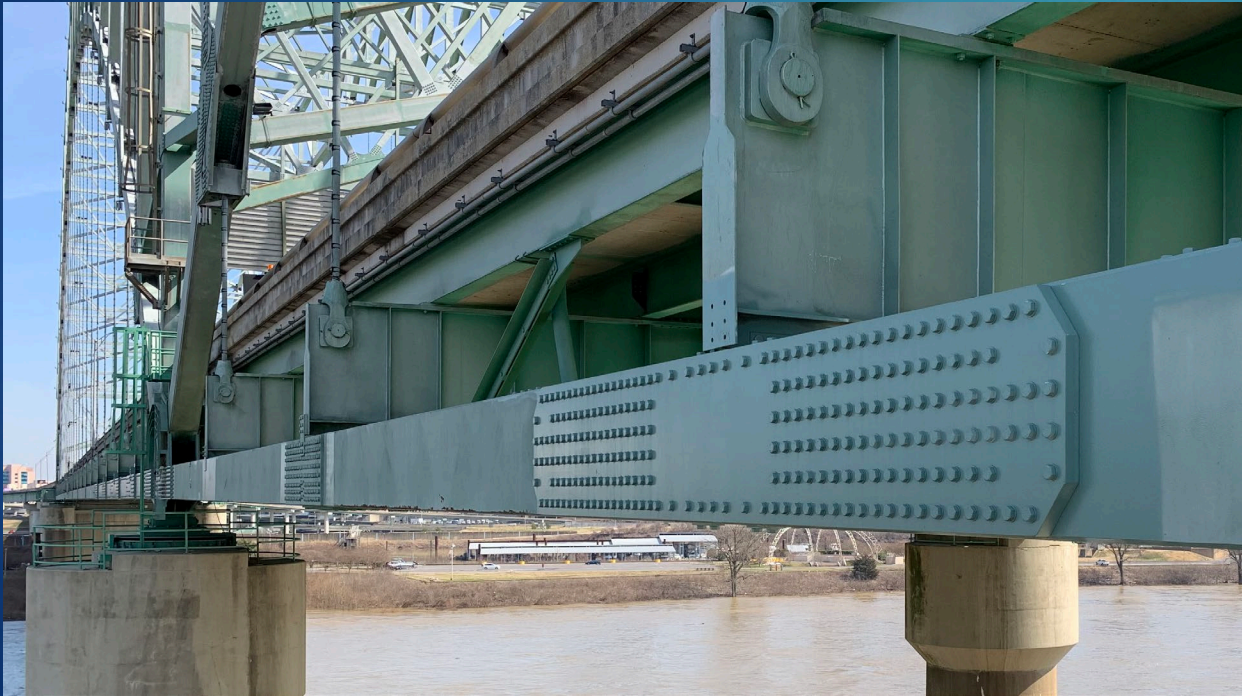
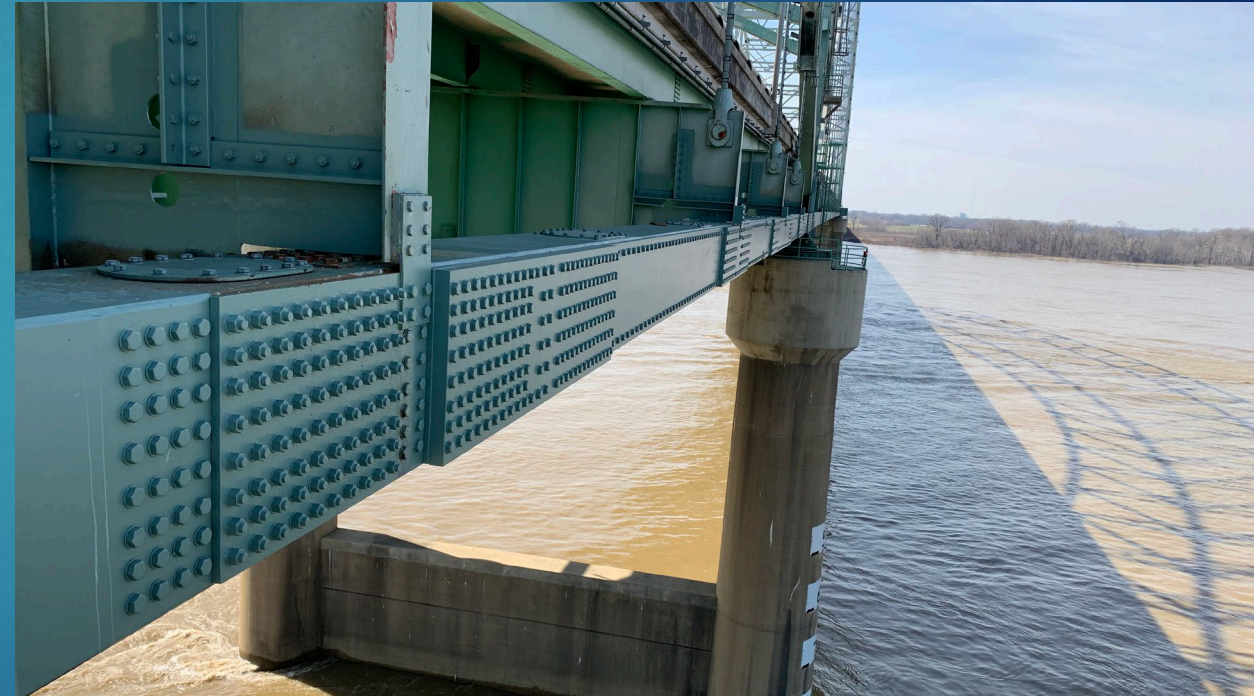
Repairs and Results

- Destructive Evaluation
- 17 additional repair locations
- FHWA Memorandum

- ▶ Requires DOTs
 - ▶ Review inspection records to identify FCMs fabricated with T-1 steel
 - ▶ Document the members identified
 - ▶ Ensure they have been **appropriately** inspected including:
 - ▶ Adequate hands-on inspections and NDT
 - ▶ Any rejectable indications using AASHTO/AWS considered critical findings
 - ▶ Report to FHWA structure information and NDT findings
 - ▶ NDT to be complete by March 31, 2024

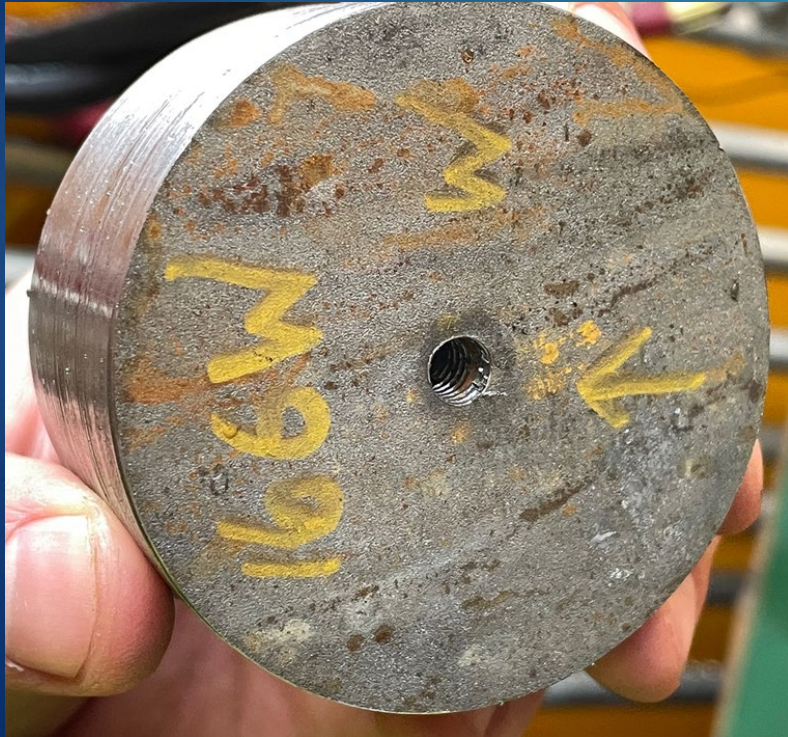
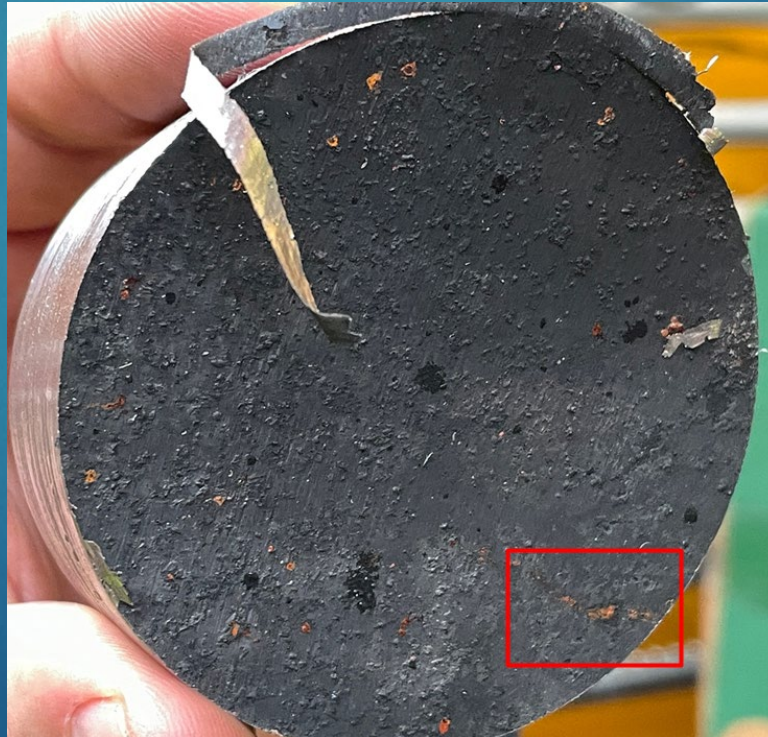
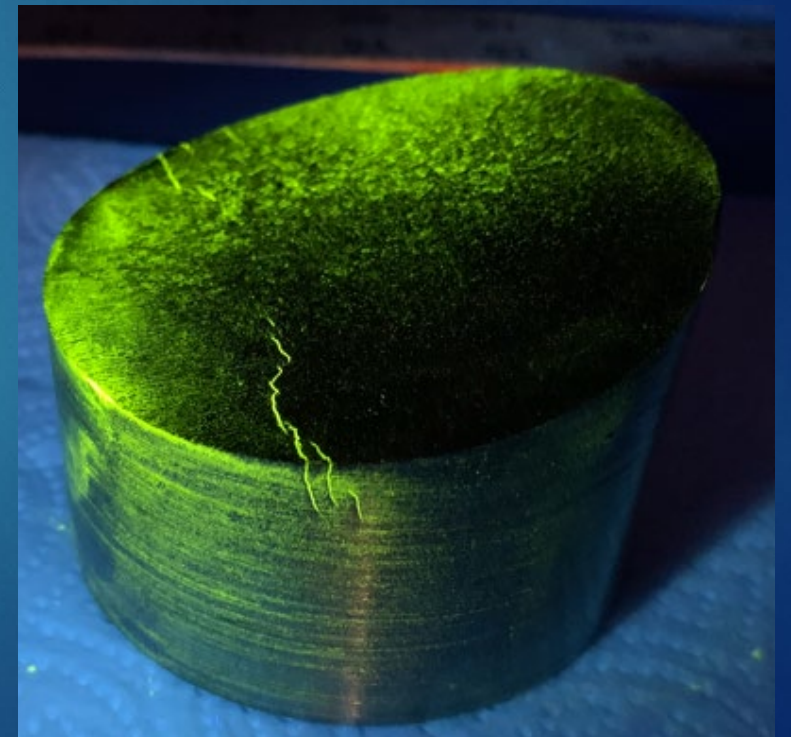
Destructive Evaluation

- ▶ WJE engaged to core butt welds
- ▶ Initial prognosis is hydrogen cracking

- ▶ Fabrication defect-usually at time of welding or shortly thereafter
- ▶ Normally originate in heat affected zone but can extend into weld metal
- ▶ Improper pre-heating
- ▶ Contaminated electrodes
 - ▶ I-40 fracture appears to have originated from repair welds
- ▶ Weld metal hydrogen
 - ▶ Can be as simple as moisture on electrodes or steel
- ▶ Stresses on weld due to external restraint, material thickness, joint geometry and fit-up
 - ▶ Poor fit-up greatly increases risk due to excessive root gap
 - ▶ Restraint due to lack of proper pre-heating likely cause
- ▶ Parent material-higher Carbon Equivalent value increases risk

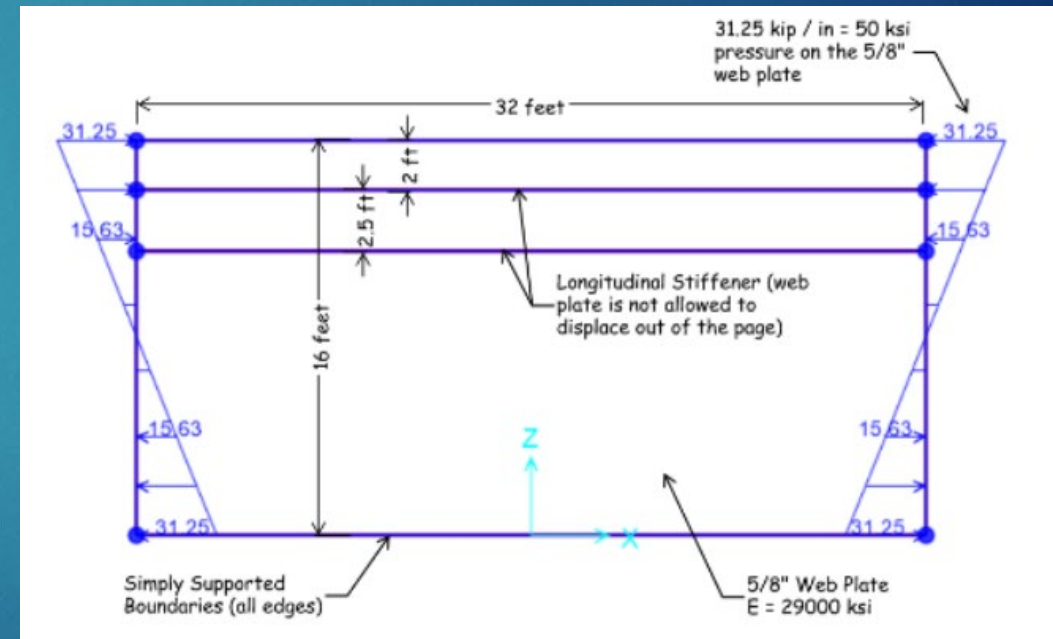
Two Longitudinal Stiffeners

- ▶ Three plate conditions are analyzed.
 - ▶ Without a longitudinal stiffener
 - ▶ Single longitudinal stiffener positioned at the optimal position on the plate
 - ▶ The two longitudinal stiffeners in as-built condition

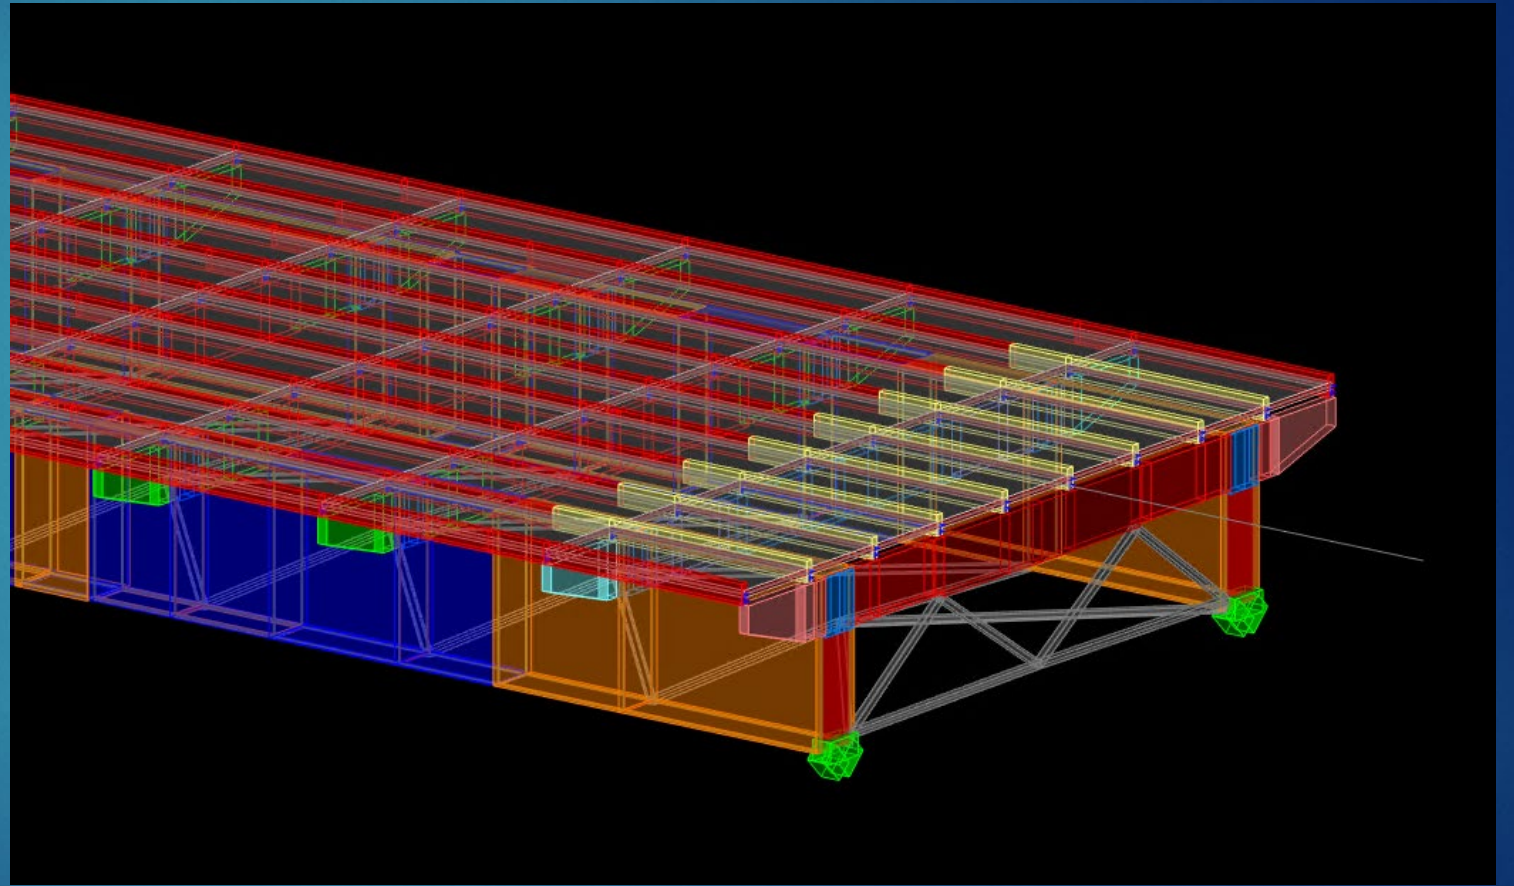
Analysis Model

- ▶ Box member modeled using Shell elements
- ▶ Stringers and Floorbeams Modeled as frame elements
- ▶ Deck modeled Shell elements

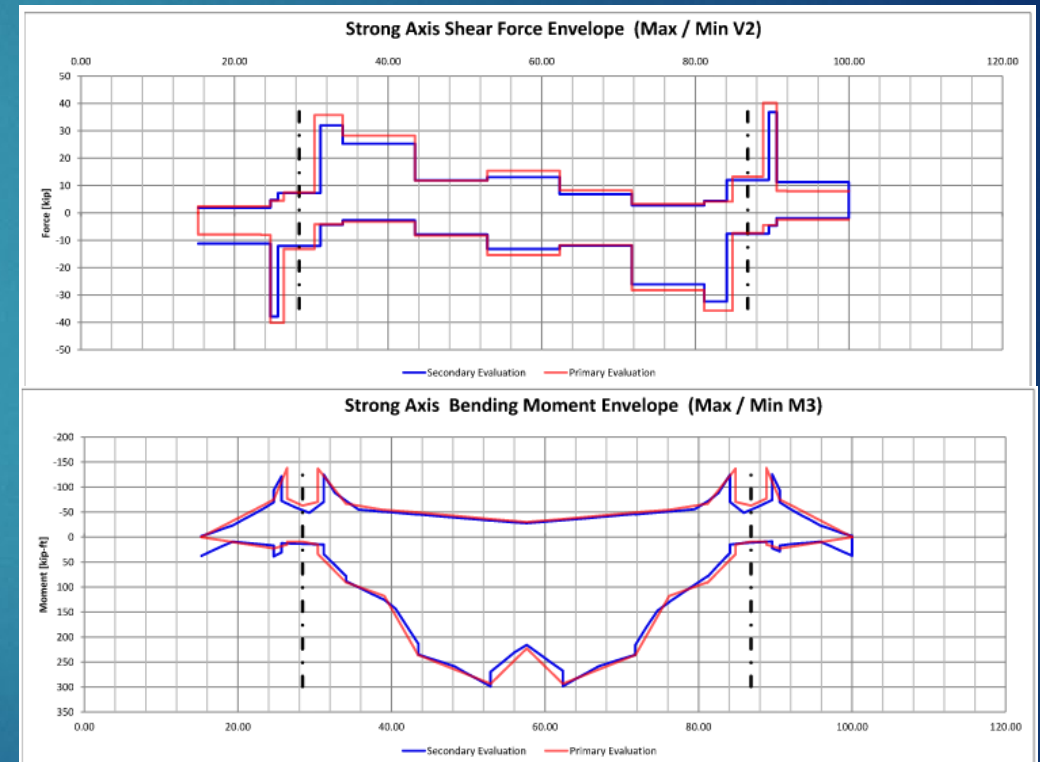
Floorbeam

- ▶ Combination of ECT and PAUT was effective in discovering flaws in various weld types
- ▶ NDT findings validated with destructive testing
- ▶ CSI an effective tool in analyzing the approach unit superstructure system and developing “k” factors for the slender web
- ▶ Controlling Load Ratings elements are Stringers and Floorbeams
