Jefferson Barracks Bridge: A Case for Rehabilitation

March 14, 2024

Wiss, Janney, Elstner Associates, Inc.

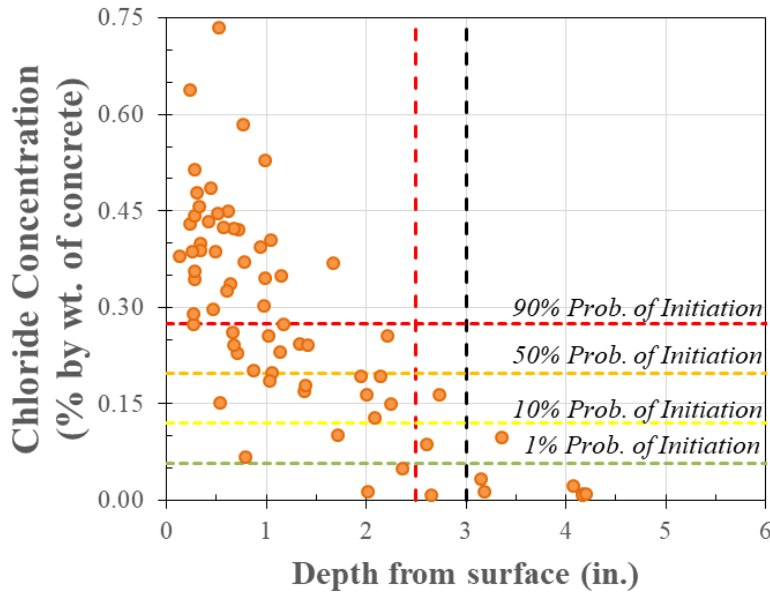
Bridge A4936

Chloride Concentrations

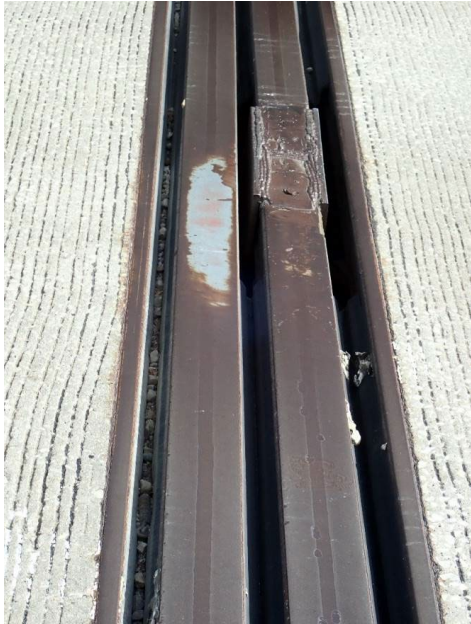
Bridge A4936

Deck Expansion Joints - Modular

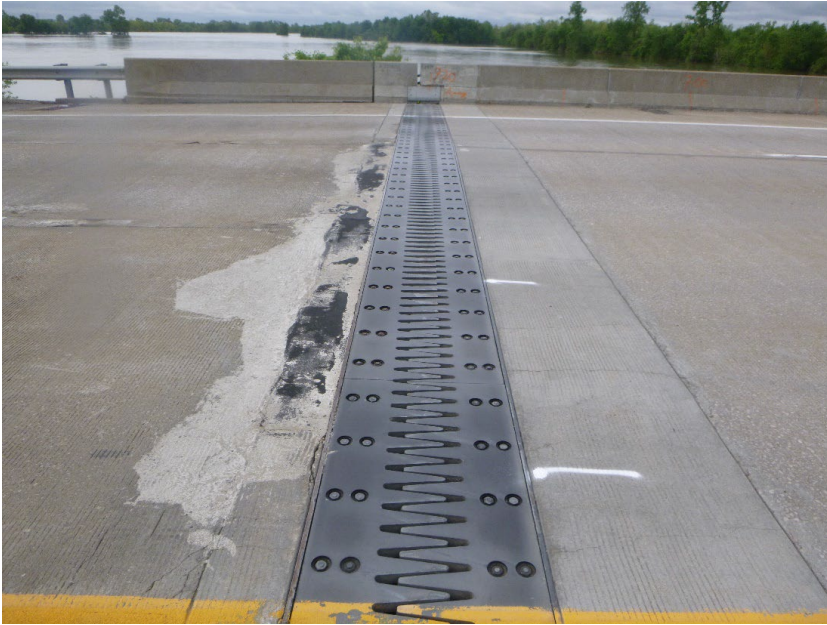
Bridge A4936

Deck Expansion Joints - Finger

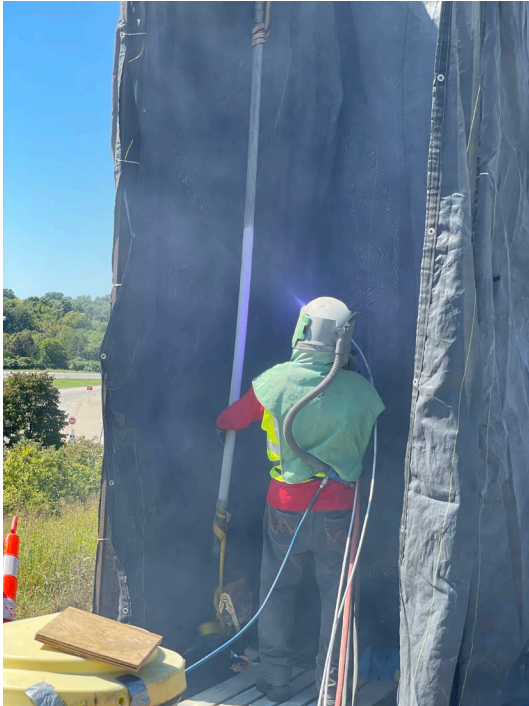
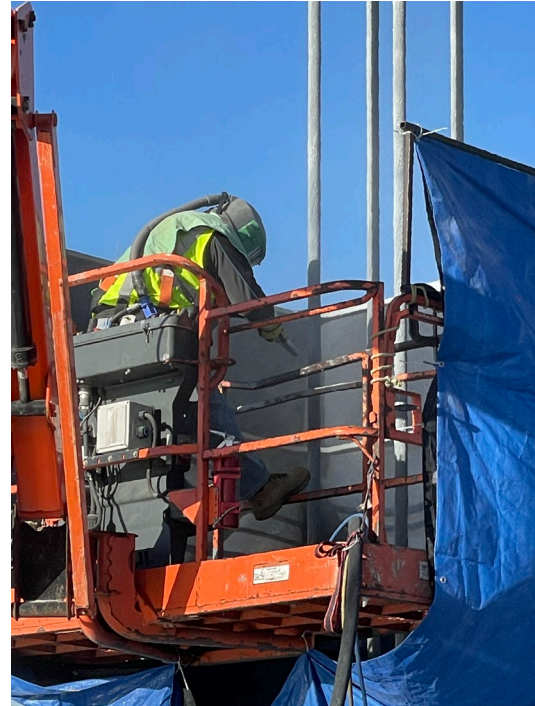
Hanger Cable Metalizing

Hanger Cable Corrosion

- Replace cables
- Coat cables
- Metalize cables
 - Different abrasive media to achieve required bond

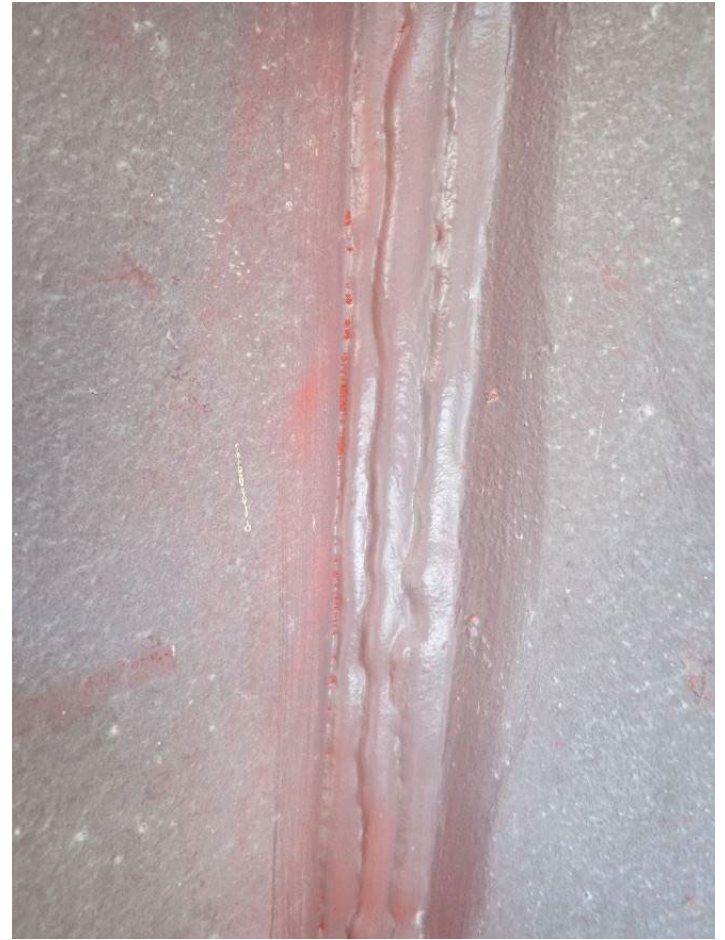
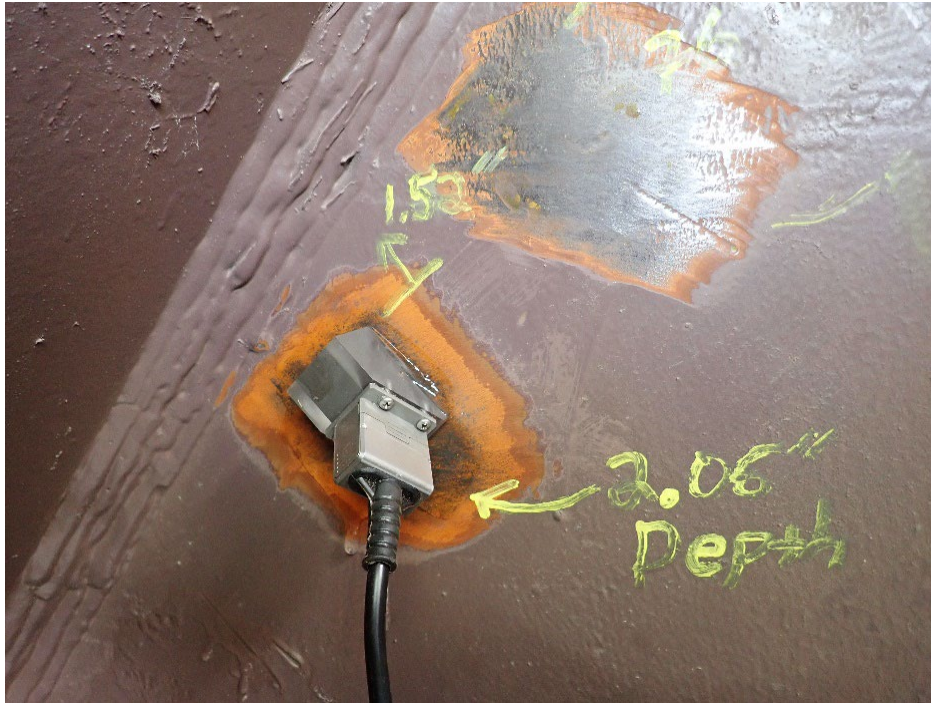
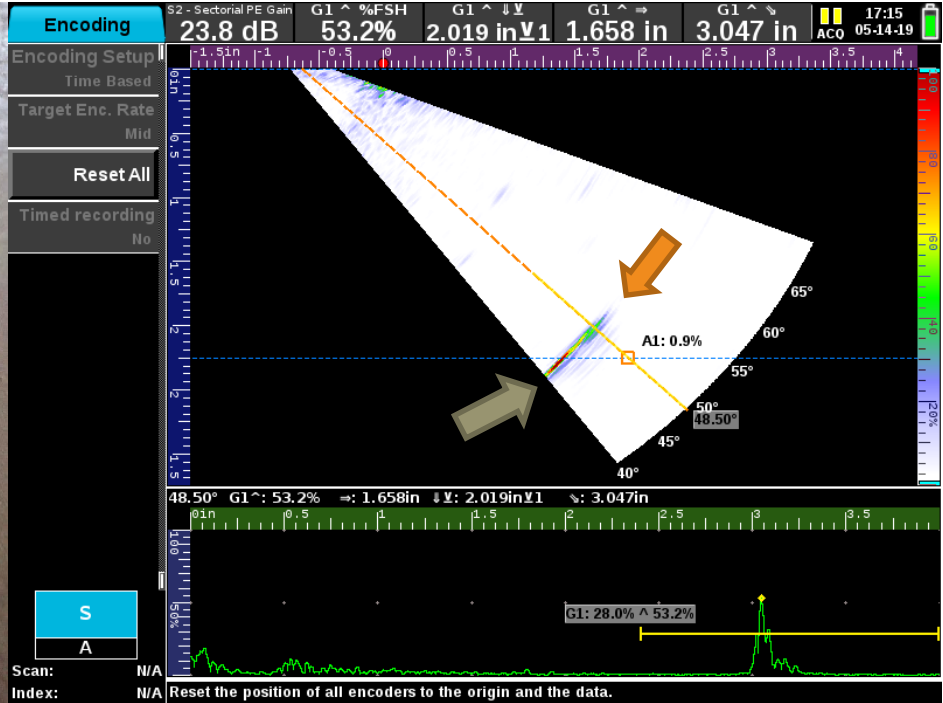
Nondestructive Evaluation of Cracks

- Visual observations could not detect the cracks
- Hydrogen-induced cracking the likely cause
- No evidence of crack growth over nearly 40 years
- High restraint and plate thickness contributed
- No strict controls in place on base metal surface cleanliness or weld consumable moisture levels.
- Other structure constructed under FCP

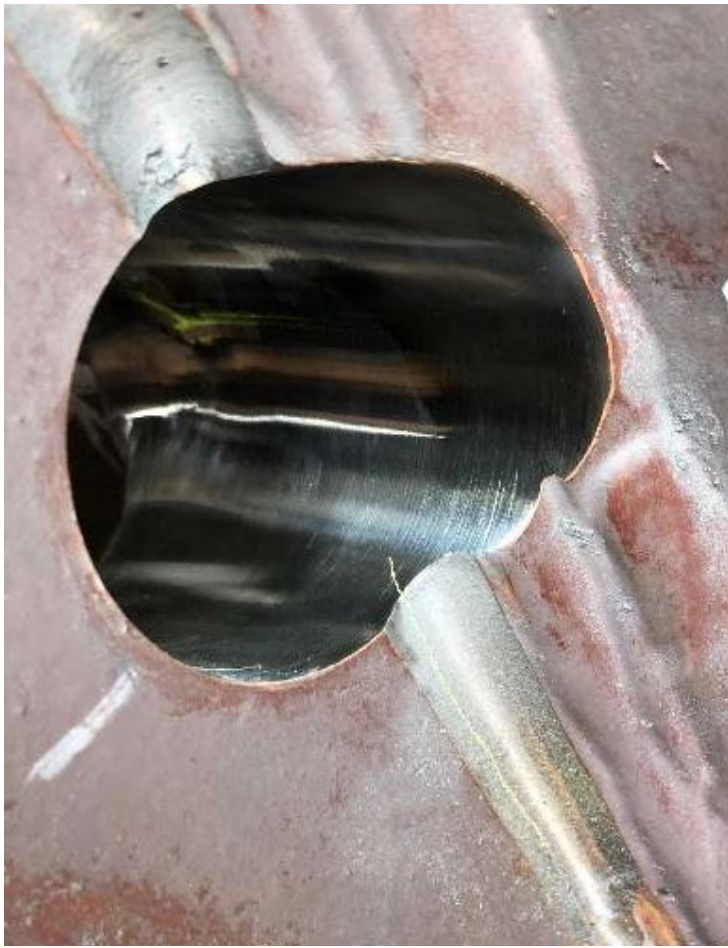
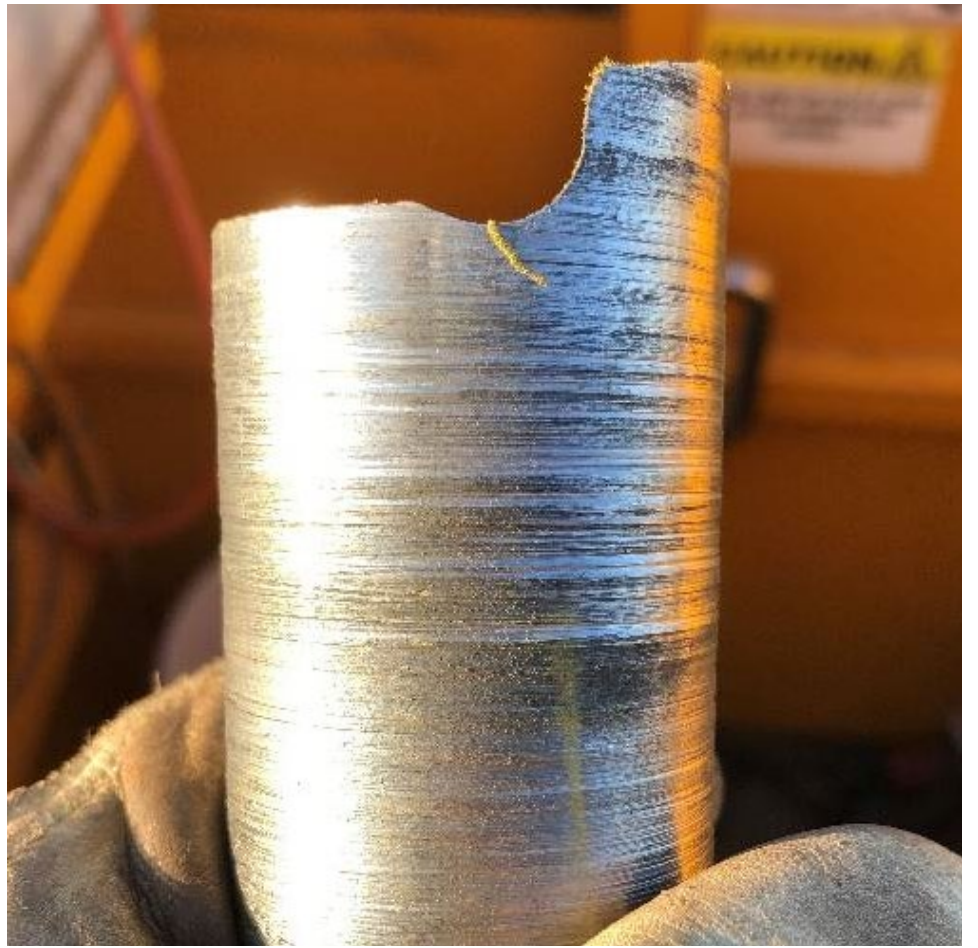
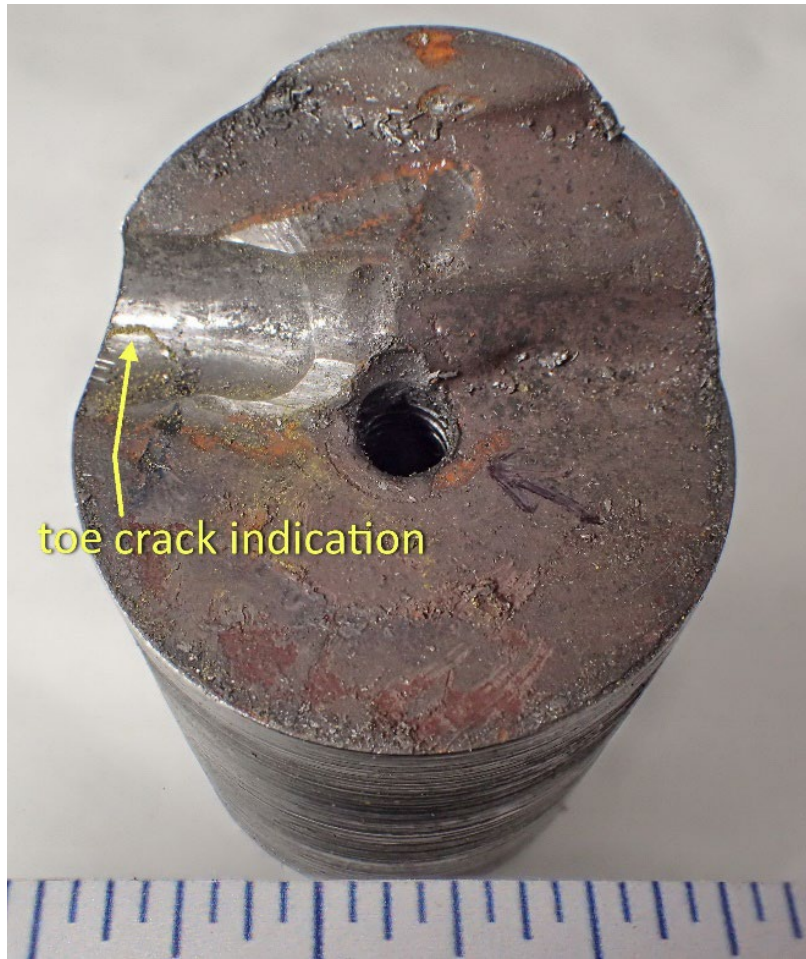
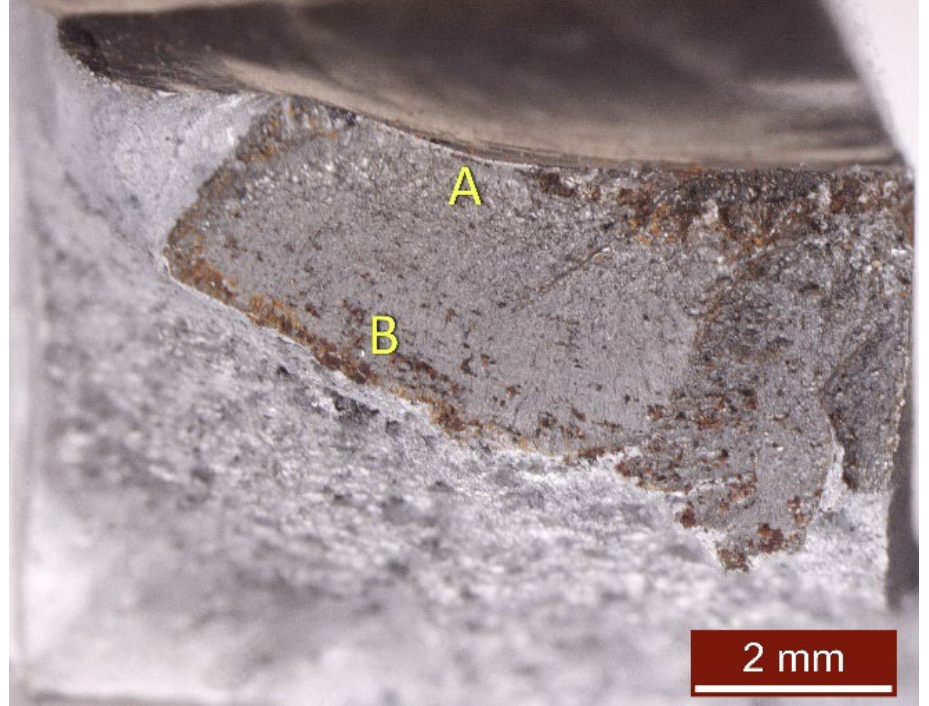
Core Extraction, Laboratory Evaluation, and Material Studies

- No evidence of crack growth by fatigue.
- Bridge can be reopened to limited traffic.
- Cracks should be repaired to avoid brittle fracture
