Design and Construction of Route 86 over Table Rock Lake

TEAM CONFERENCE

March 14, 2024

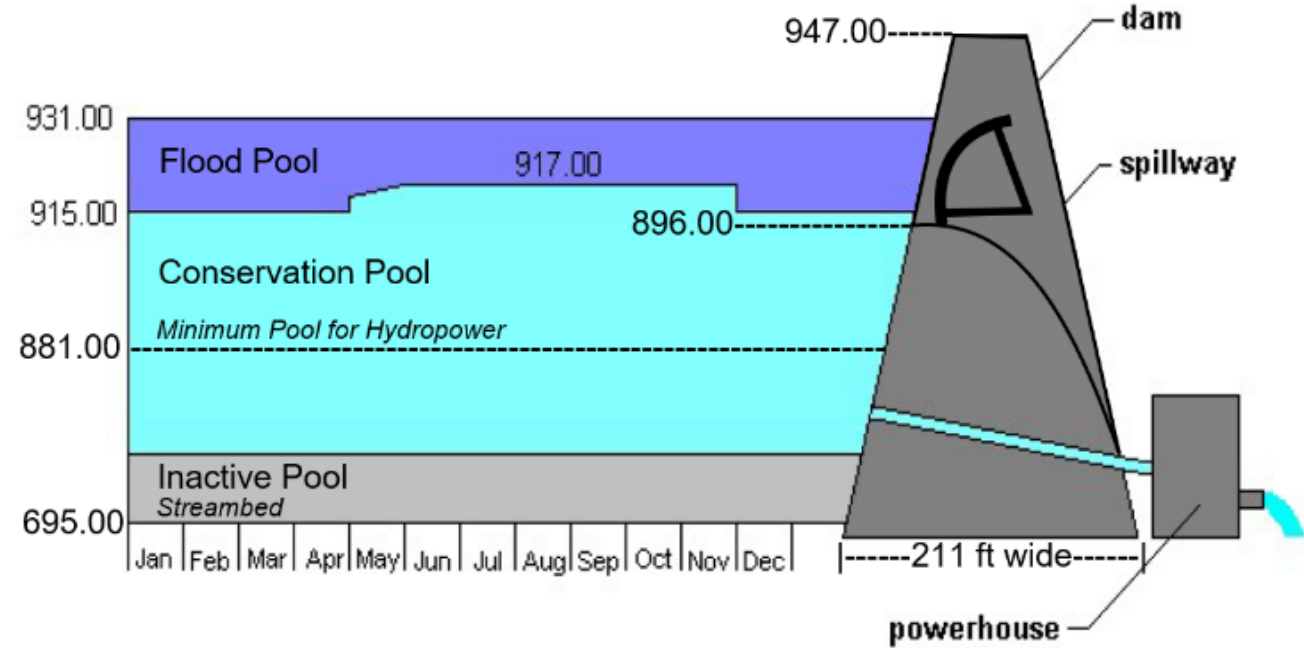
Operational Zones by Month

Pool Zone Elevations (NGVD 29)

- 881 – 915
- 915 – 931
- 931 – 936

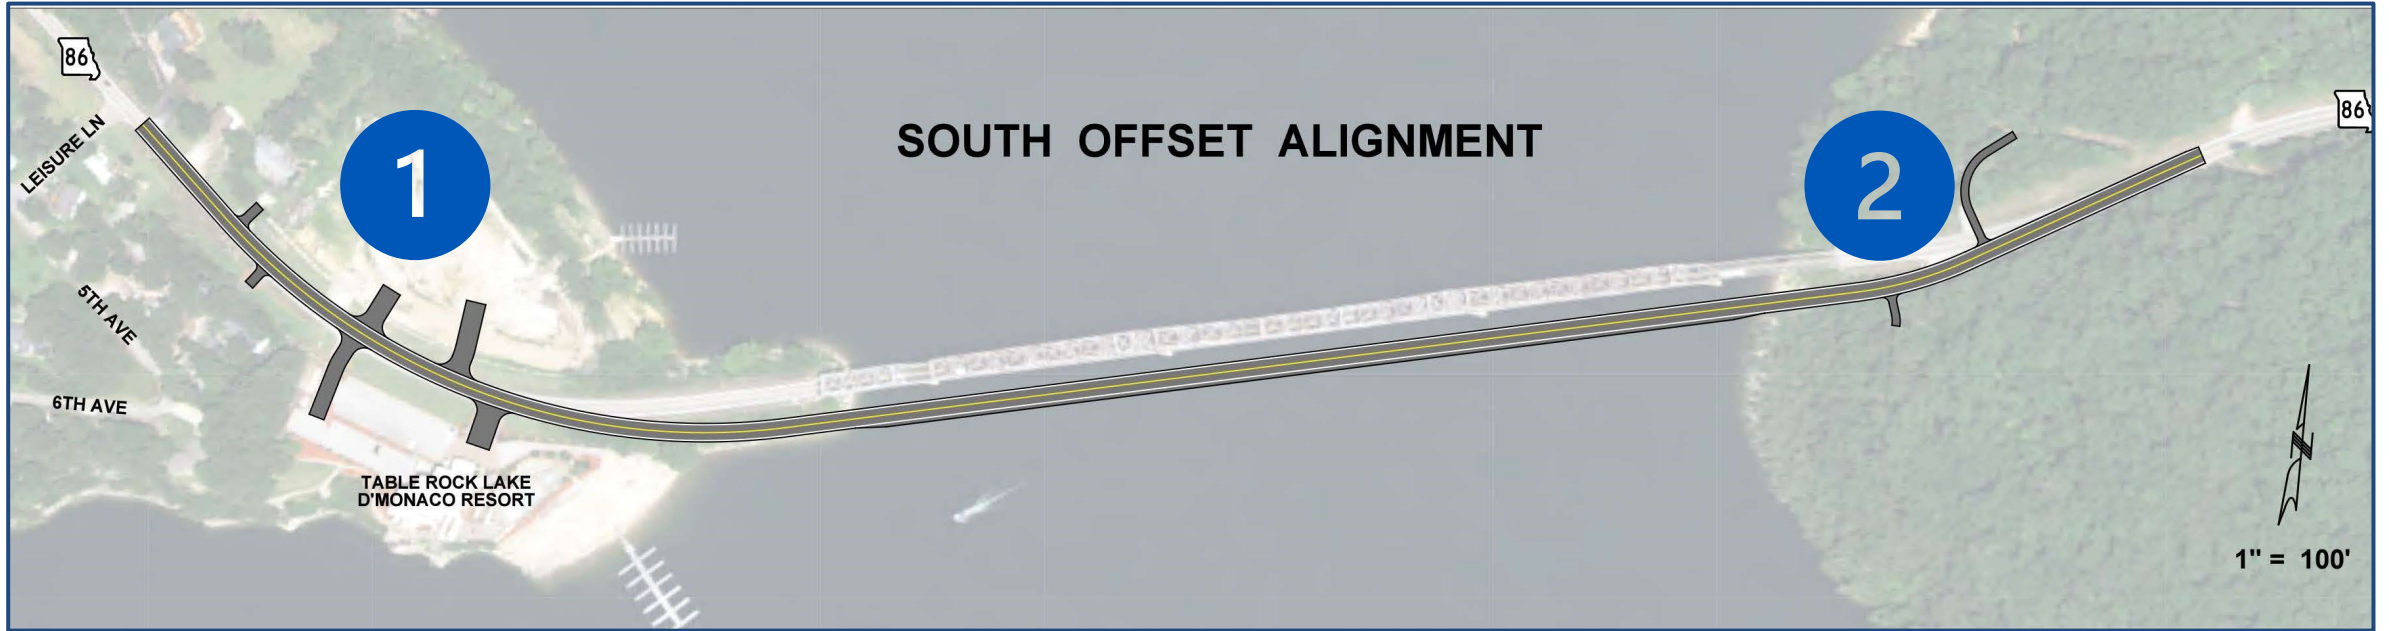
Horizontal alignment alternatives

1. Avoid impacts to property in northwest corner of bridge site
2. Less desirable for access on east side of the bridge

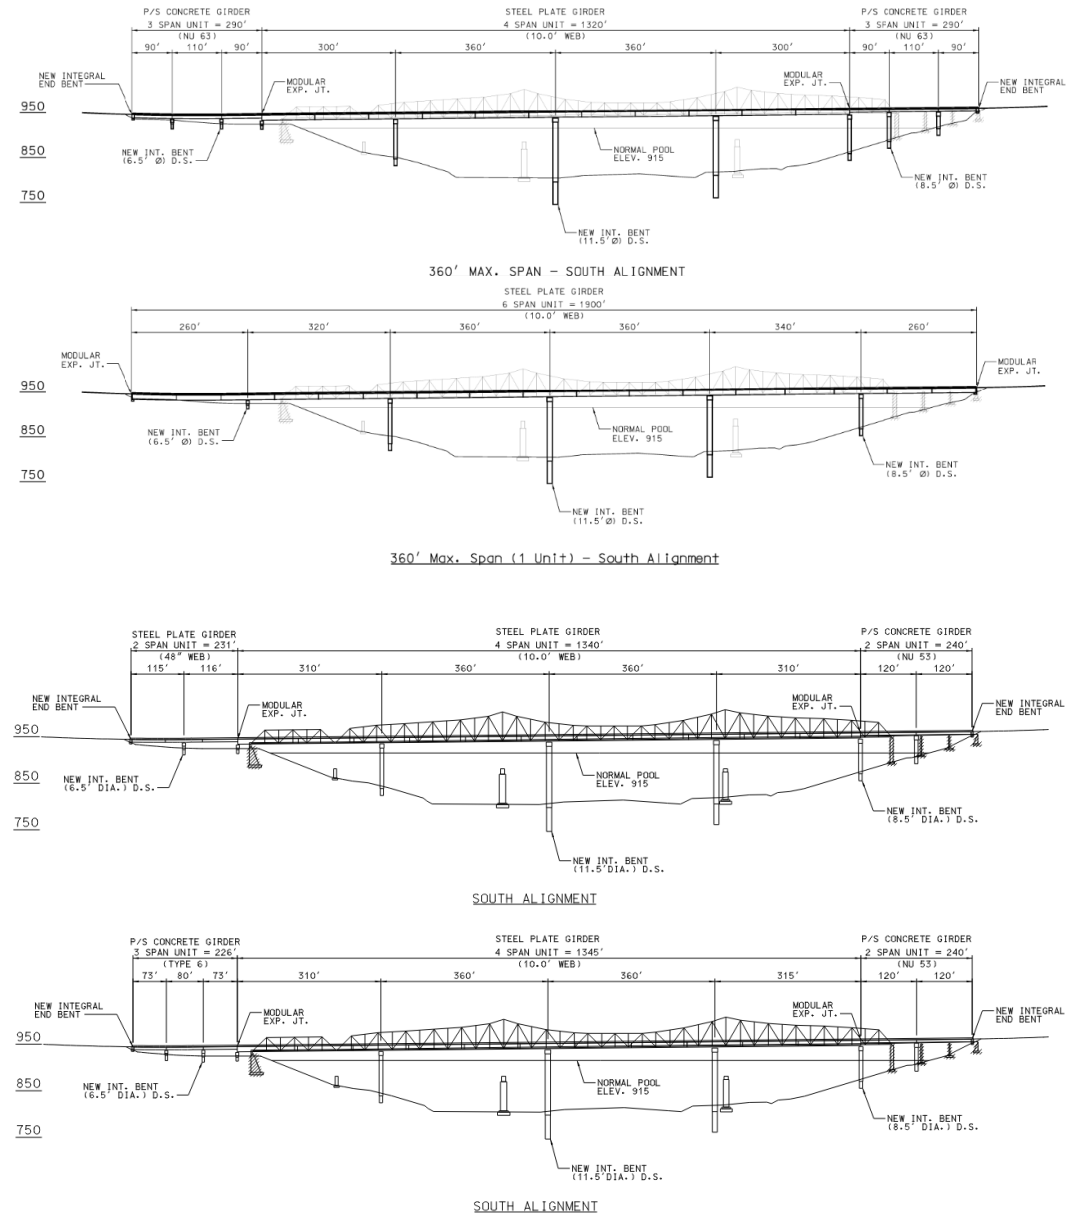
Preliminary span layouts

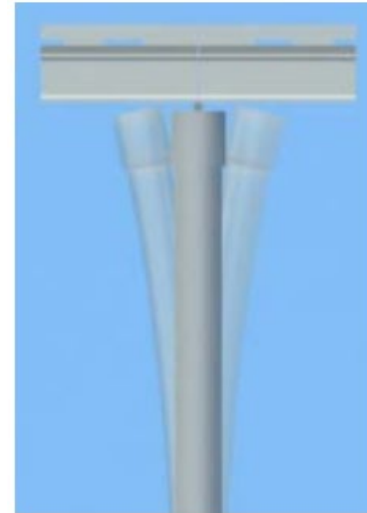
- One value engineering item discussed was to post-tension the superstructure to the substructure at the top of the tall intermediate bents which changes the fixity condition.
- If utilized, the end condition of the tall bents would shift from a flagpole condition (e) toward some degree of framed fixity between (e) and (d).
- Final design followed LRFD 5.6.4.1: $KL/r < 100$ and designed by the approximate procedure for evaluation of slenderness

Flagpole Condition

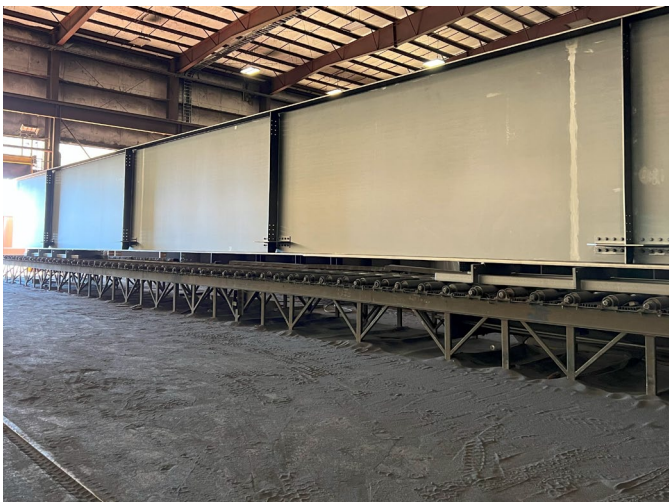
- Unit 2 girder webs 10'-6" deep
- Grade HPS 70W flanges over the piers

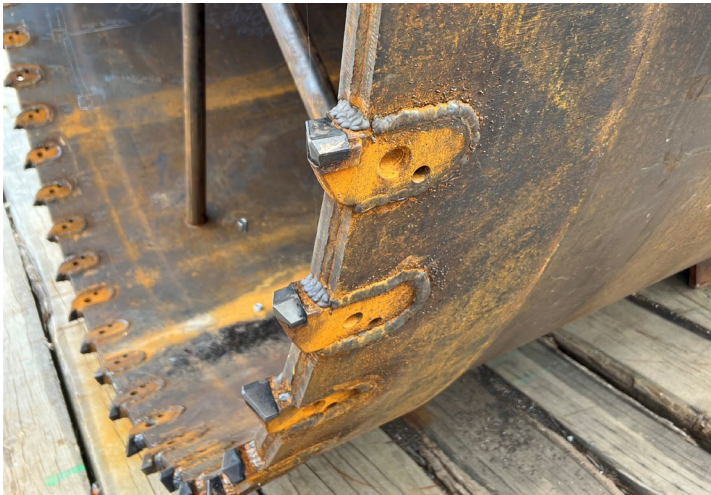
ELEVATION OF DRILLED SHAFT

- Rock slope with minimal overburden
 - Rock must be benched to prevent casing from sliding down the hill.
- Minimal overburden
 - Permanent casing may be seated 3 – 5 feet into rock for bottom stability.

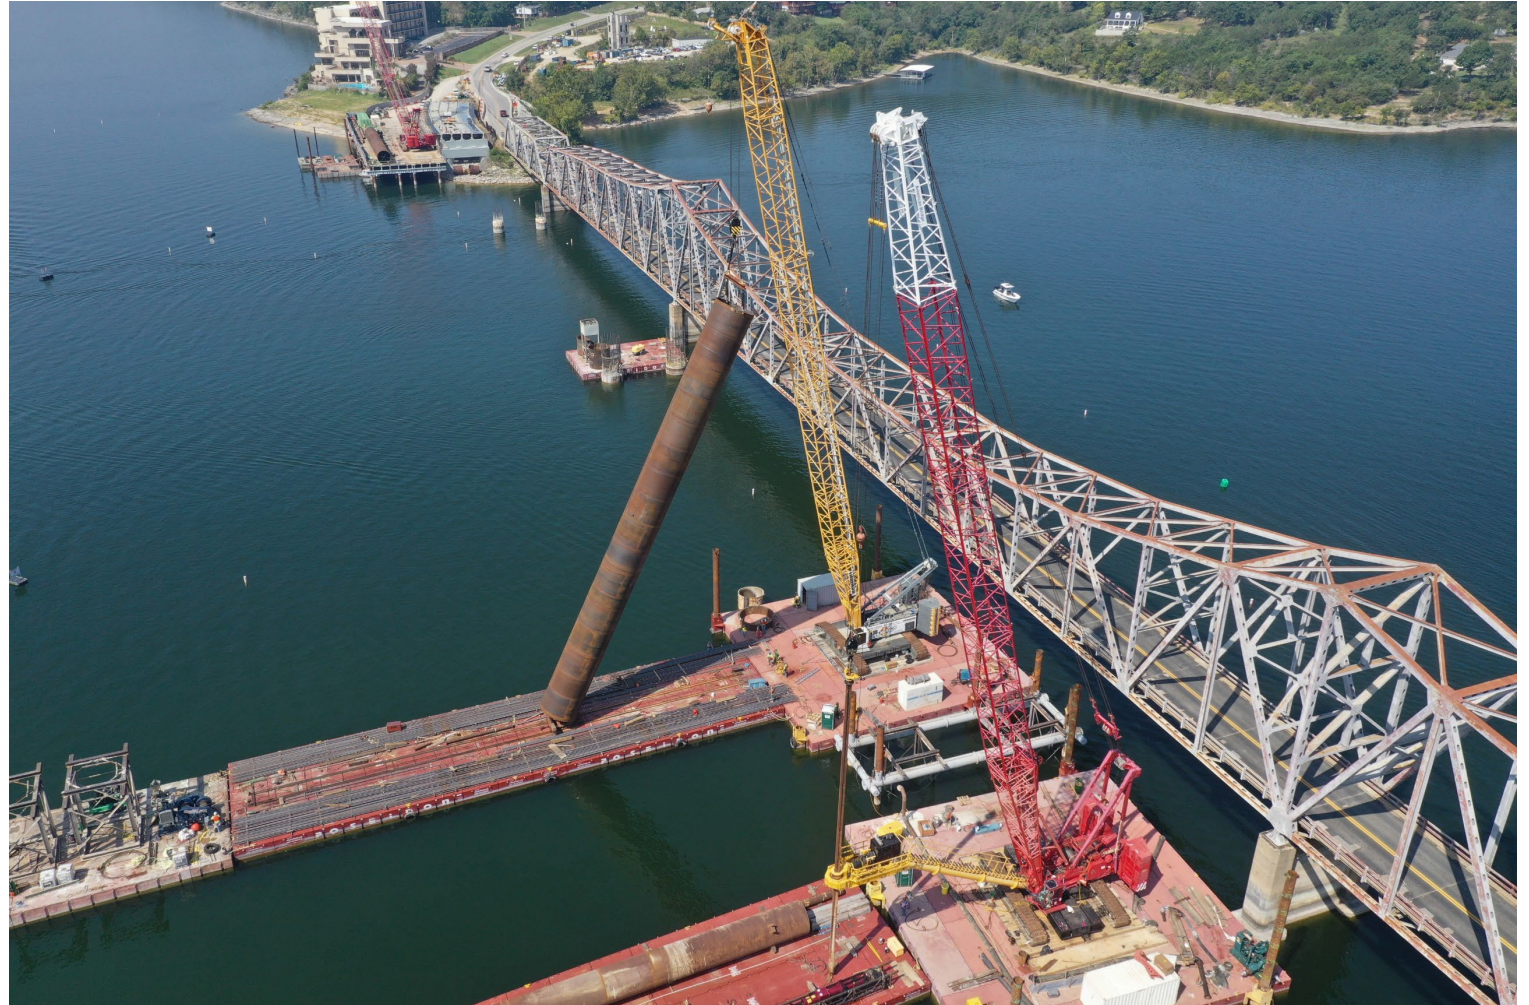
- Picking 11.5' diameter casing 134.5' in length
- Rough template with spuds
- Fine template

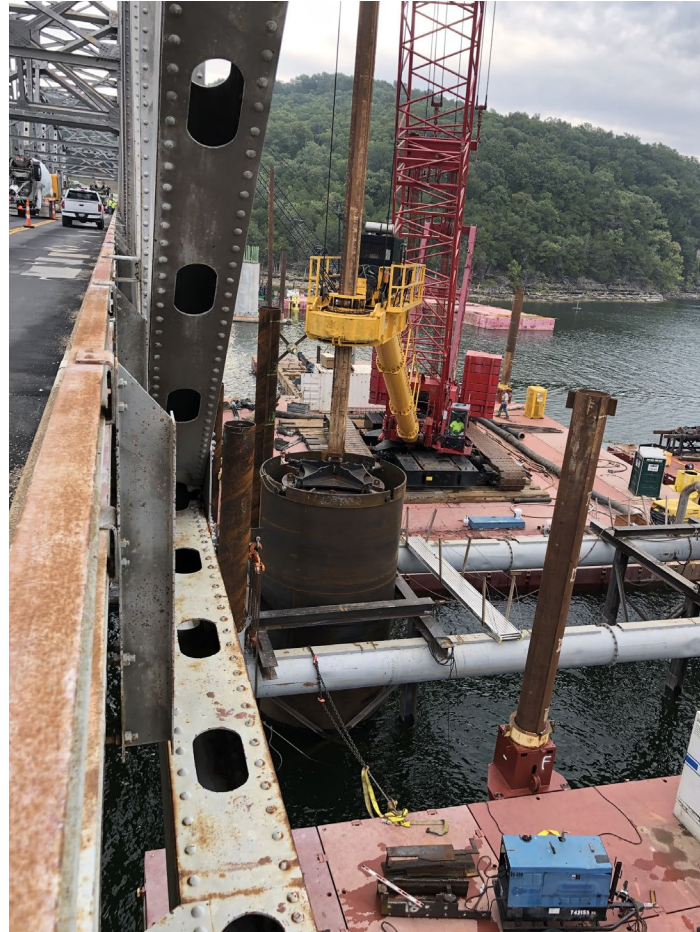
- Buoyancy tube used to reduce weight of casing which reduces load on the drill as it seats the casing

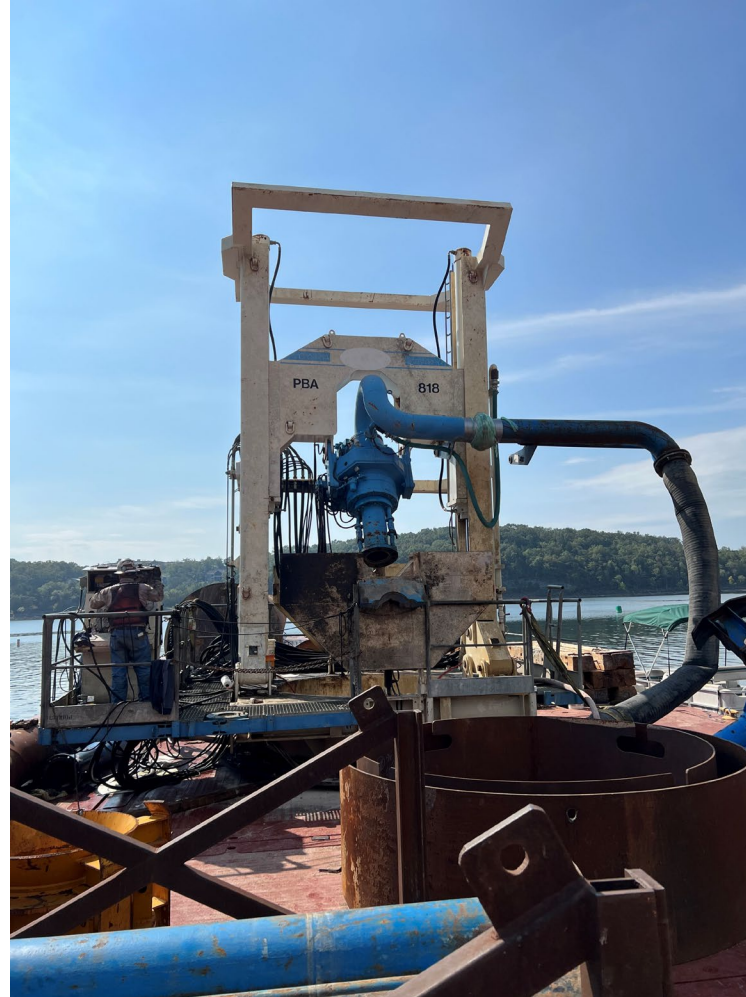
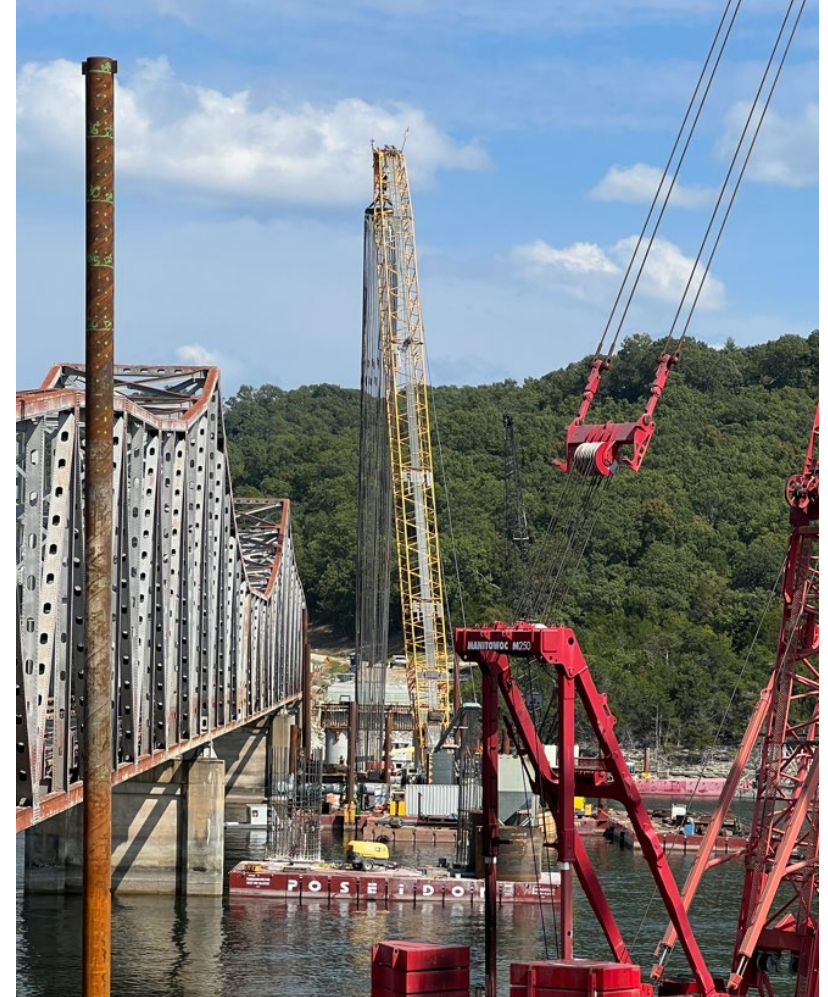
- Airlift performed to get debris out of the bottom of the rock socket prior to video inspection of the rock socket
- Rebar cage installed using the chandelier/wind chime method

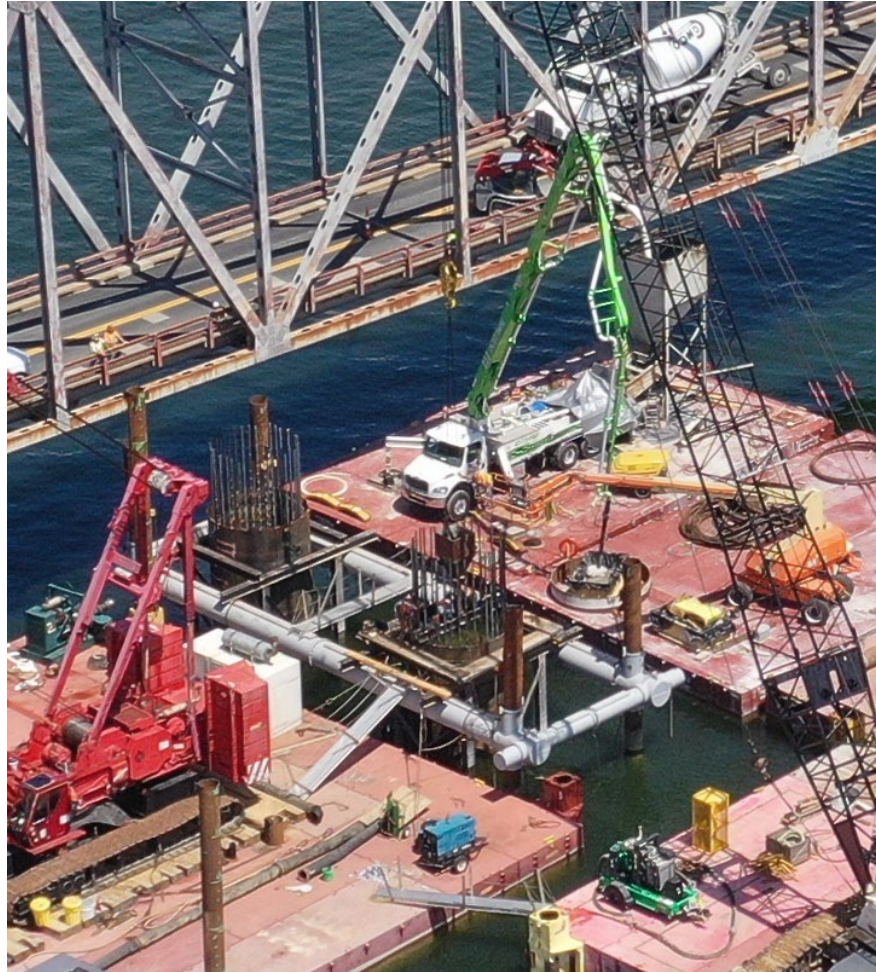
- Drilled shaft concrete placement operation
- As the water rises inside the casing it discharges through the pipe and exits ~20' below the water surface elevation
