EMERGENCY BRIDGE REPAIRS

A look at Emergency Repairs due to Critical Findings and Truck Impacts in Missouri, Illinois and Kansas

Scott Moeder, PE & Ryan Hagerty, PE

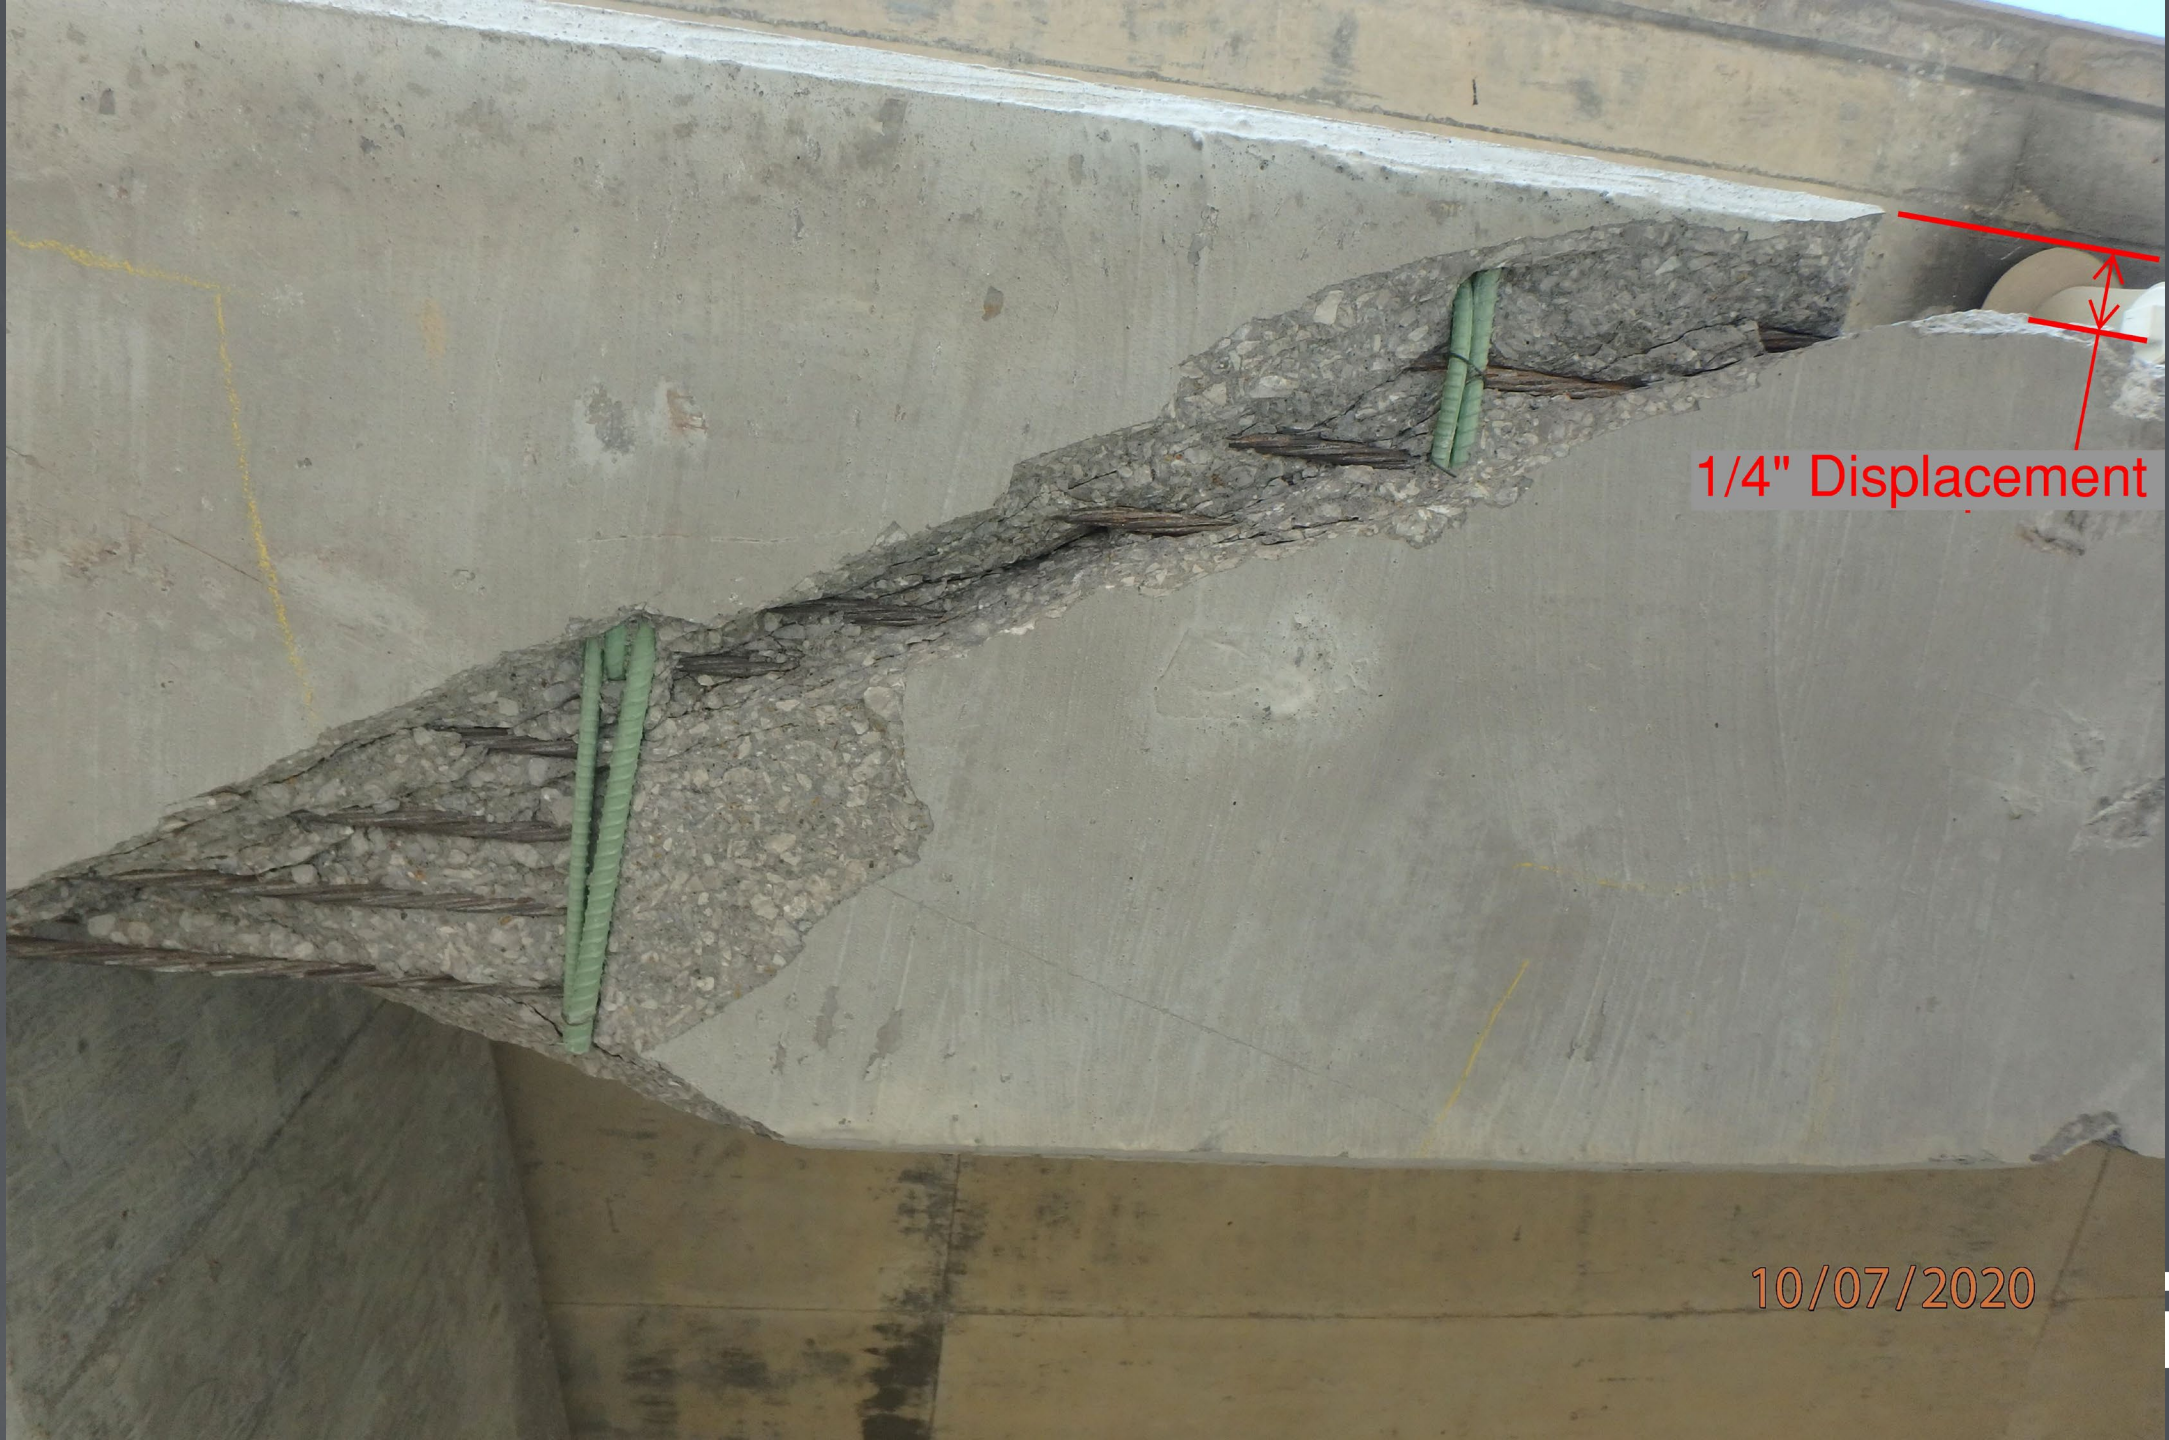
1/4" Displacement

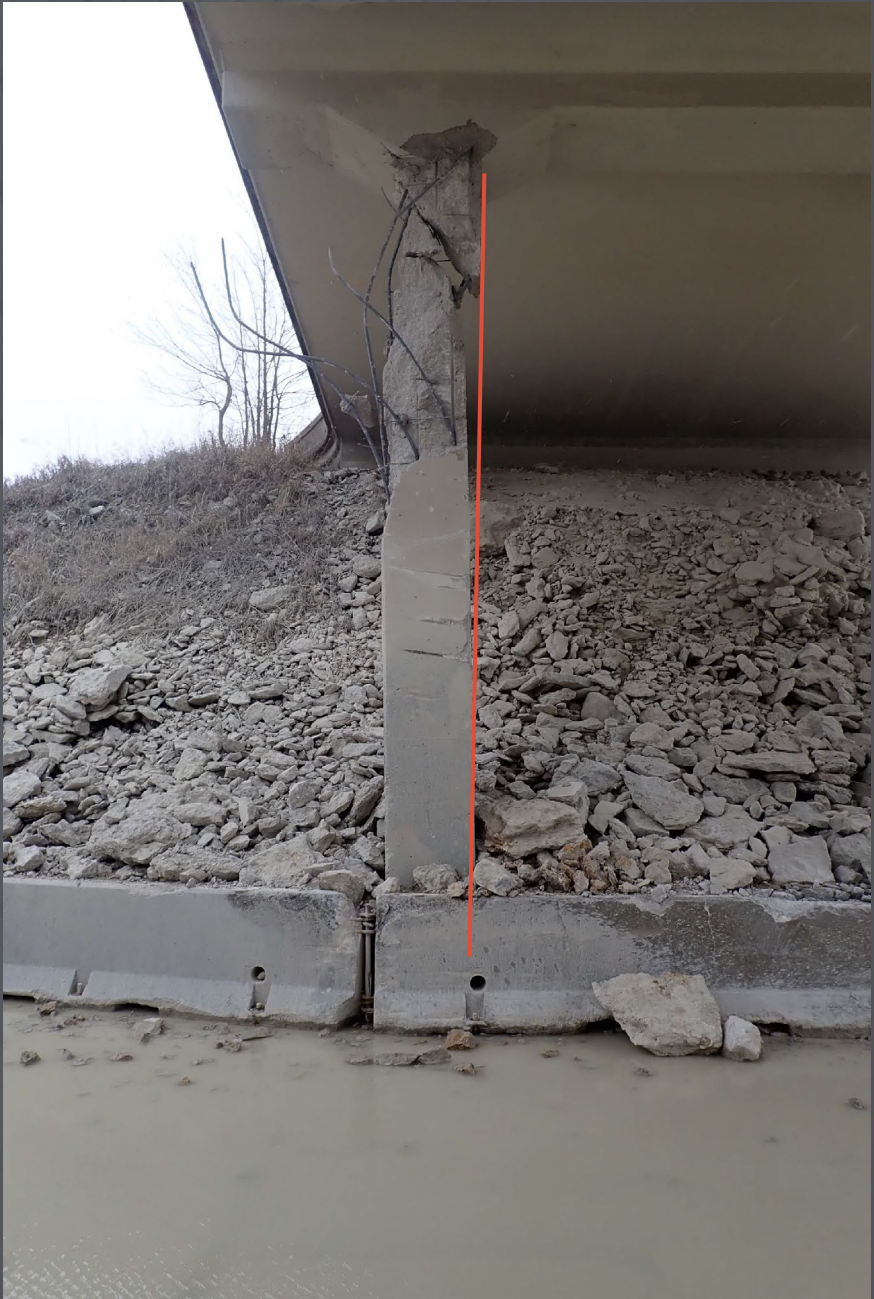
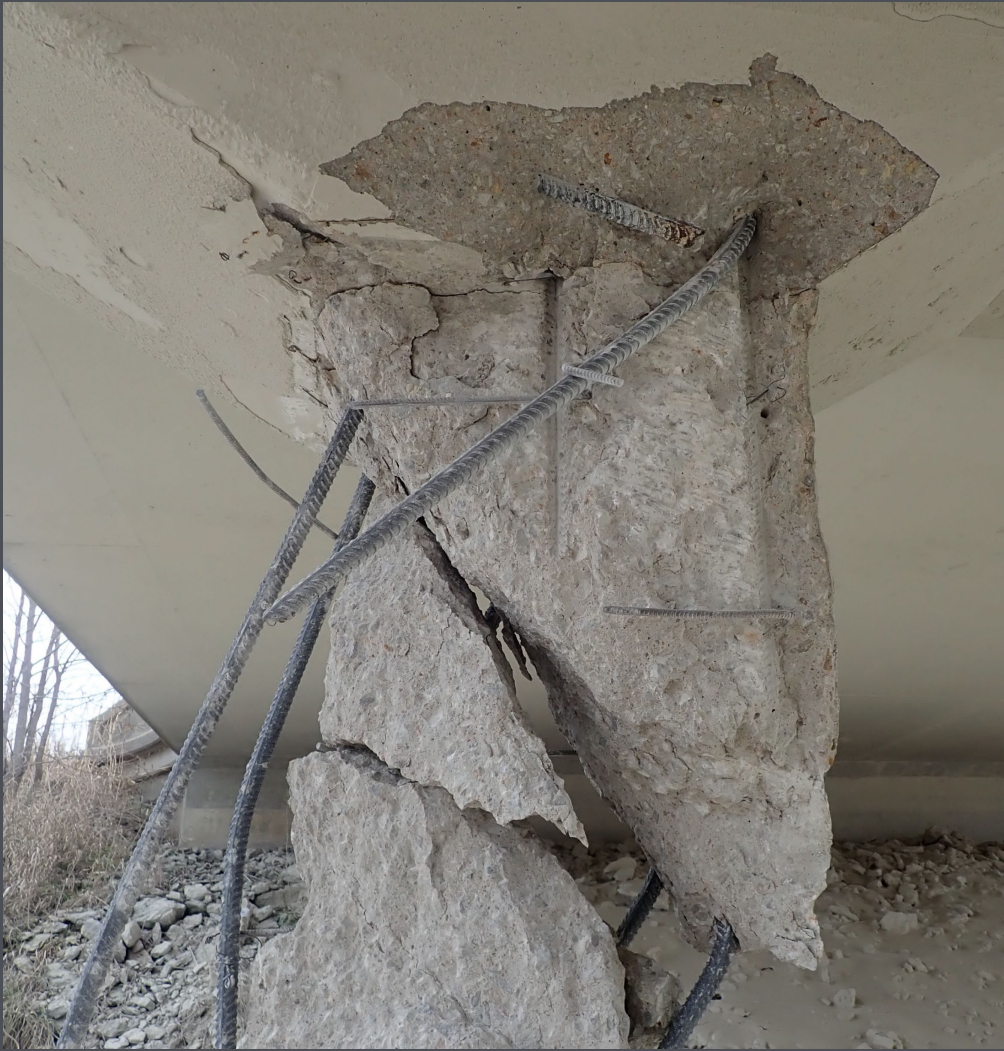
- Slab bridge with a ~~2 column pier~~ 1 column pier

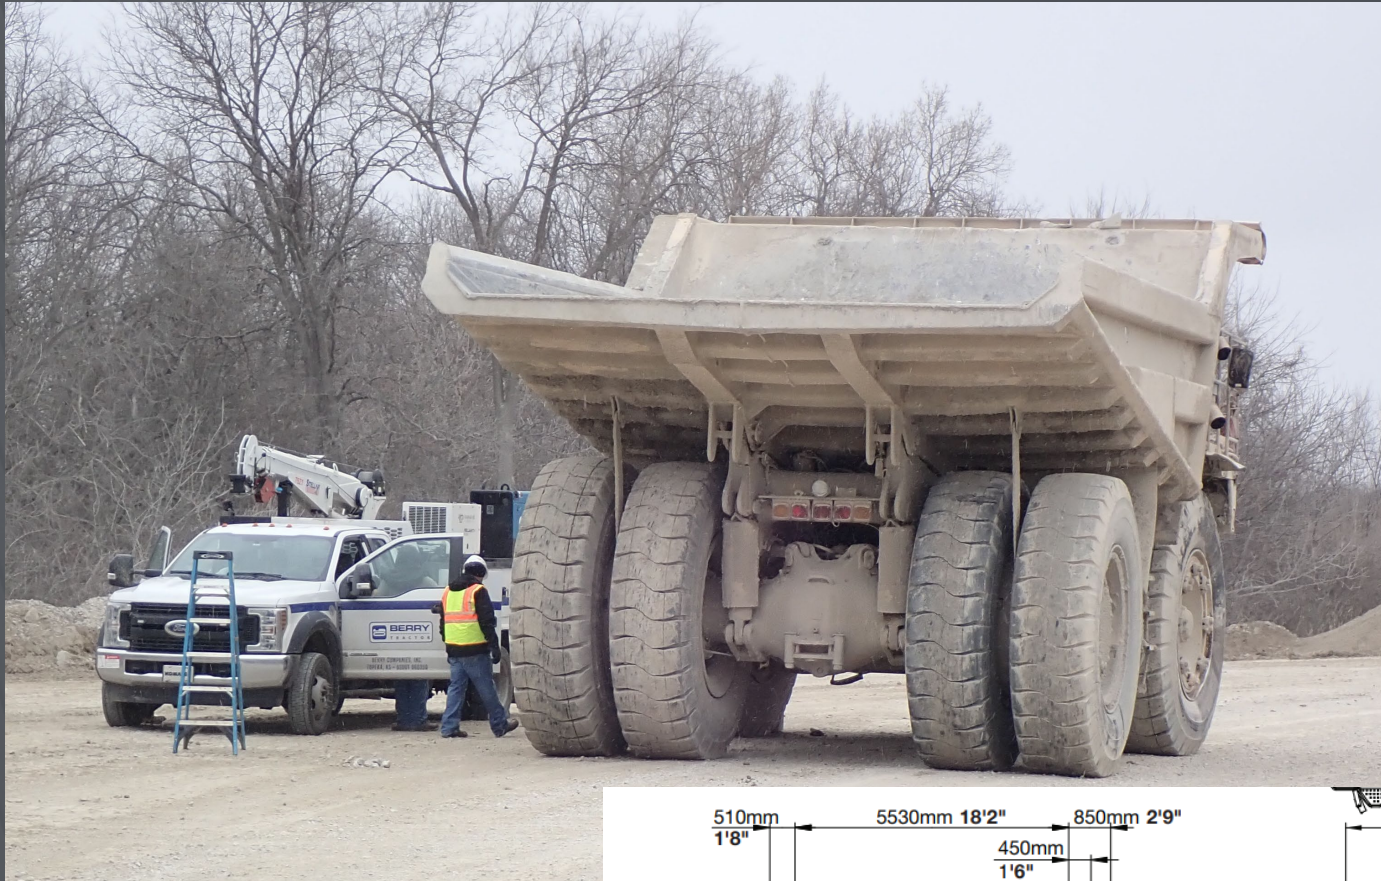
- Column concrete completely broken
- More than half of column steel broken

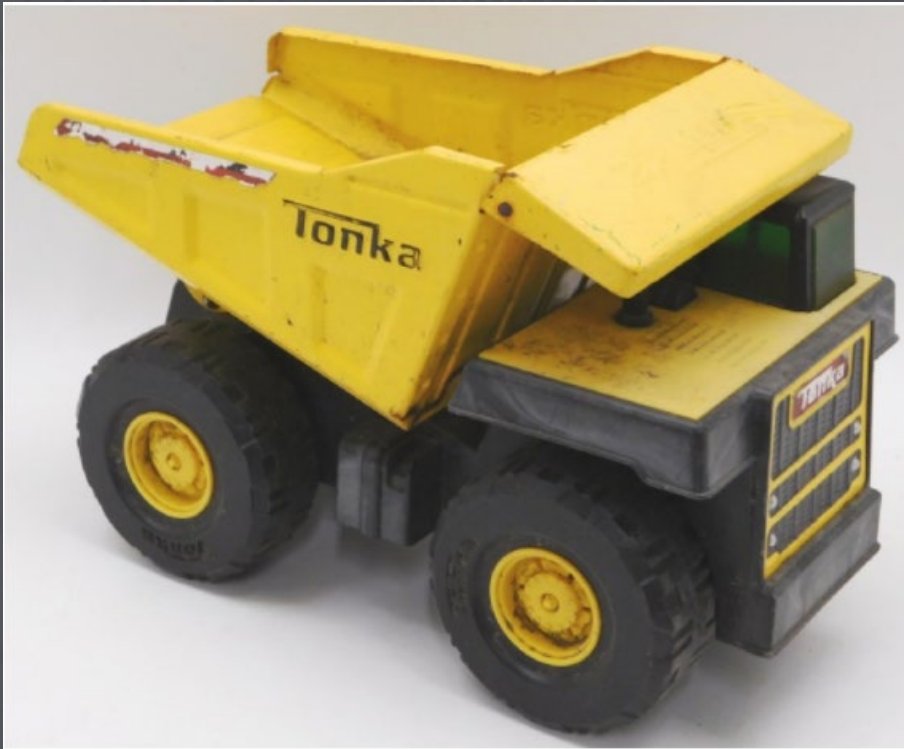
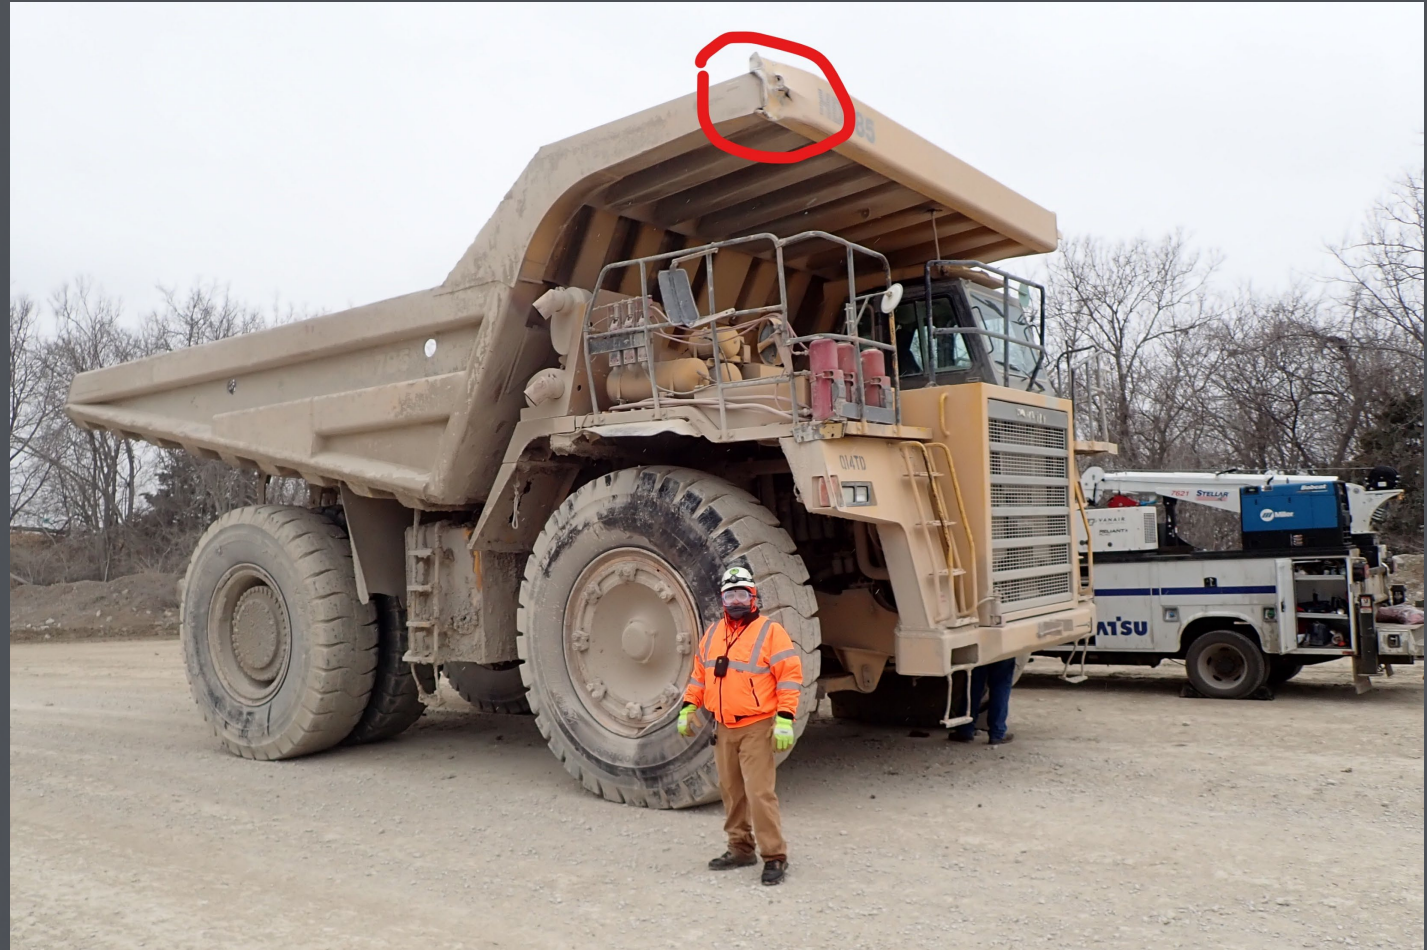
- Damage to truck...
- Toy version is less than \$50 on ebay...

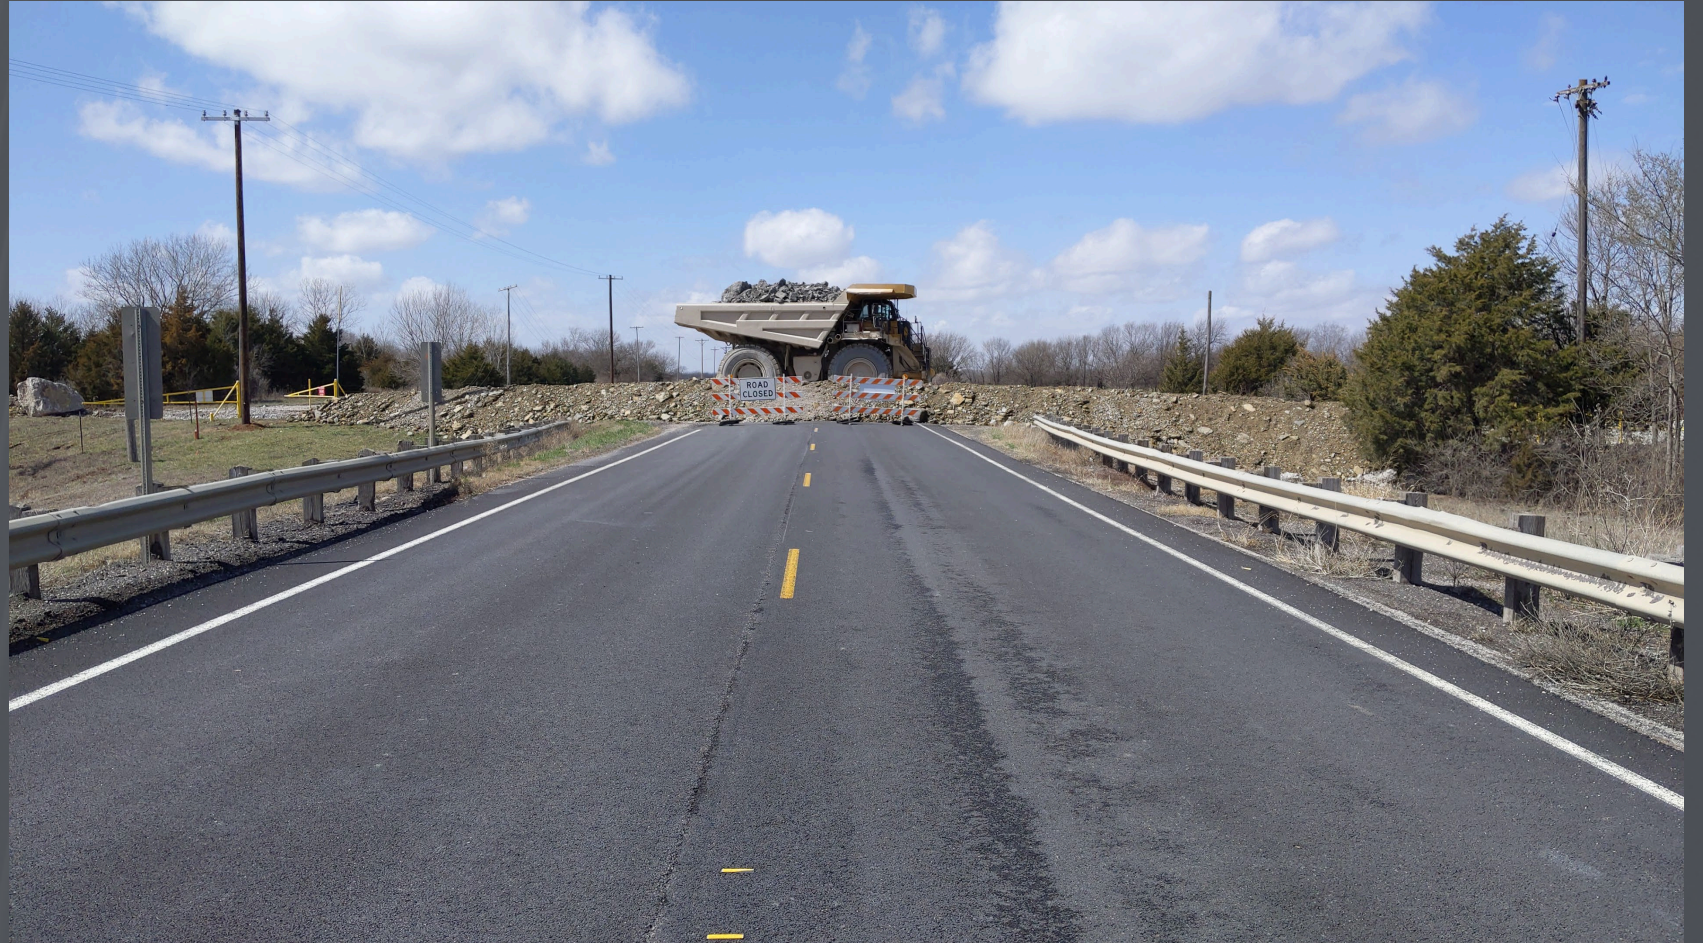
K-39 was closed during construction. This caused problems for other projects...
